**Edisto Beach, South
Carolina
Coastal Storm Risk
Management Project
Validation Report**

**US Army Corps
of Engineers®**
Charleston District
July 2022

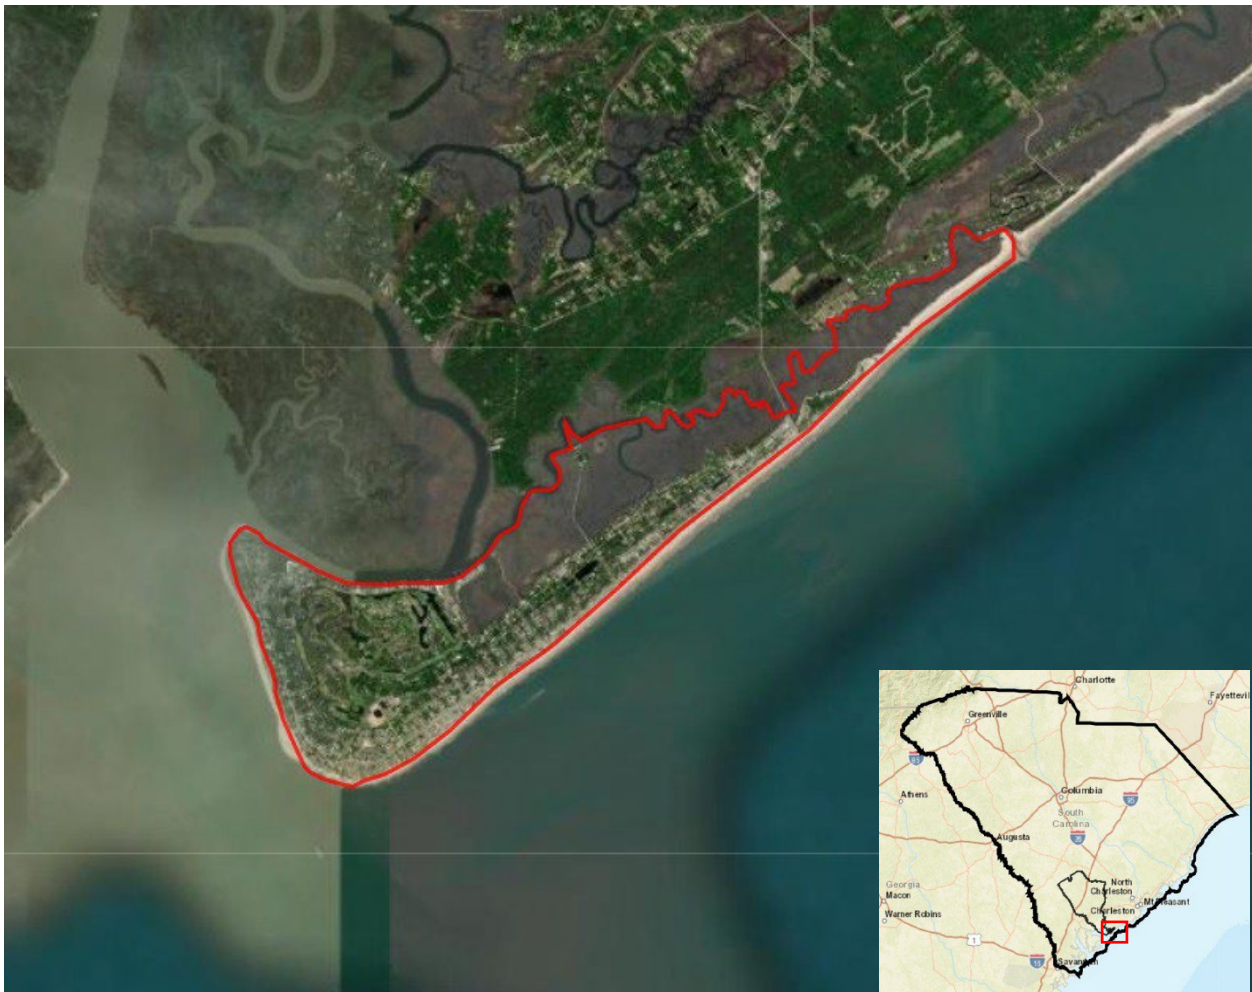
Figure 1. Edisto Beach, South Carolina

Edisto Island is a barrier island located at the mouth of the South Edisto River in Colleton County, South Carolina, approximately 20 miles southwest of Charleston, South Carolina and approximately 50 miles northeast of Savannah, Georgia (Figure 1). The incorporated Town of Edisto Beach is located on the southern end of the island and Edisto Beach State Park is located on the northern end of the island. Edisto Beach encompasses approximately 6 miles of shoreline, all of which were studied in the 2014 Feasibility Report.

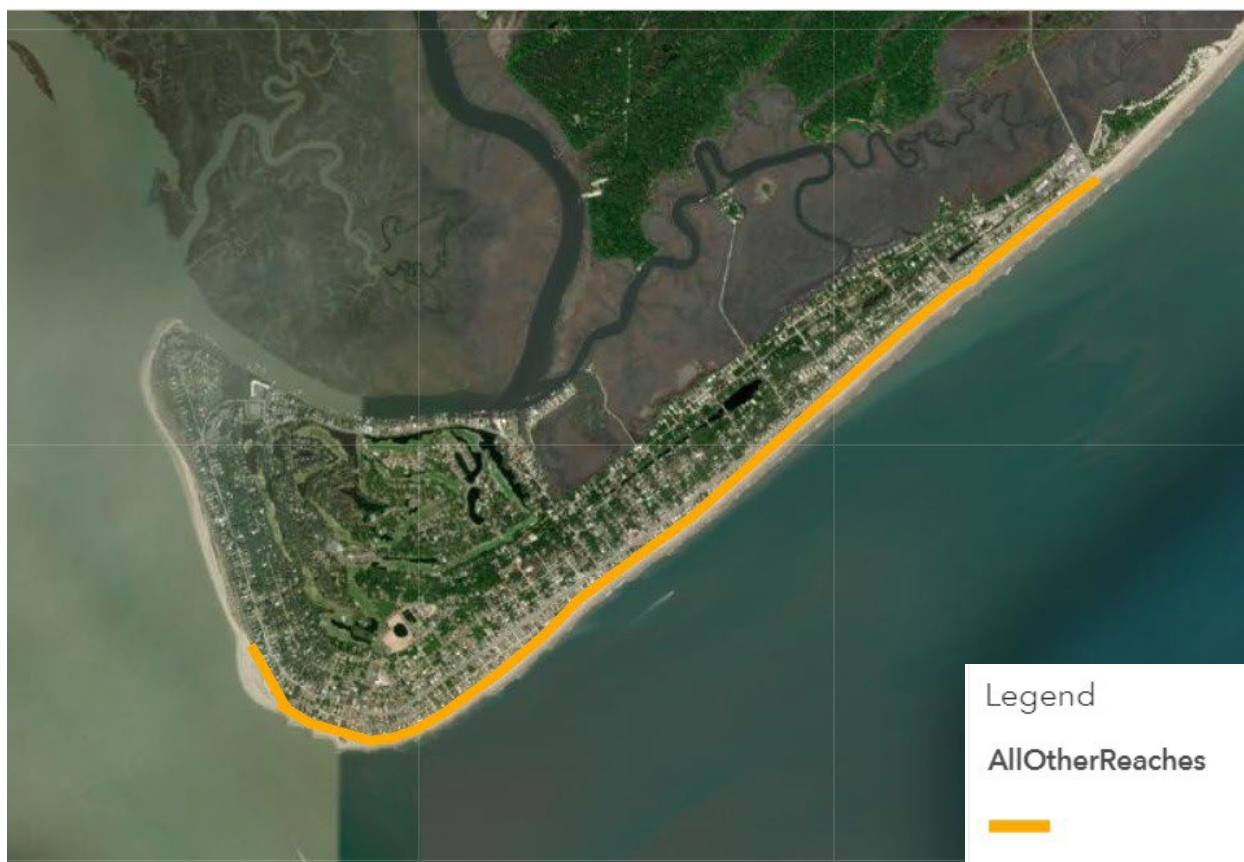
Figure 6: Modified Project Showing Removal of Inlet Reaches

No significant design changes are needed to construct the Modified Project and to receive the authorized level of performance. The benefit-cost-ratio for the modified project was validated using the 2014 authorized benefits for the remaining reaches along with the updated certified costs.

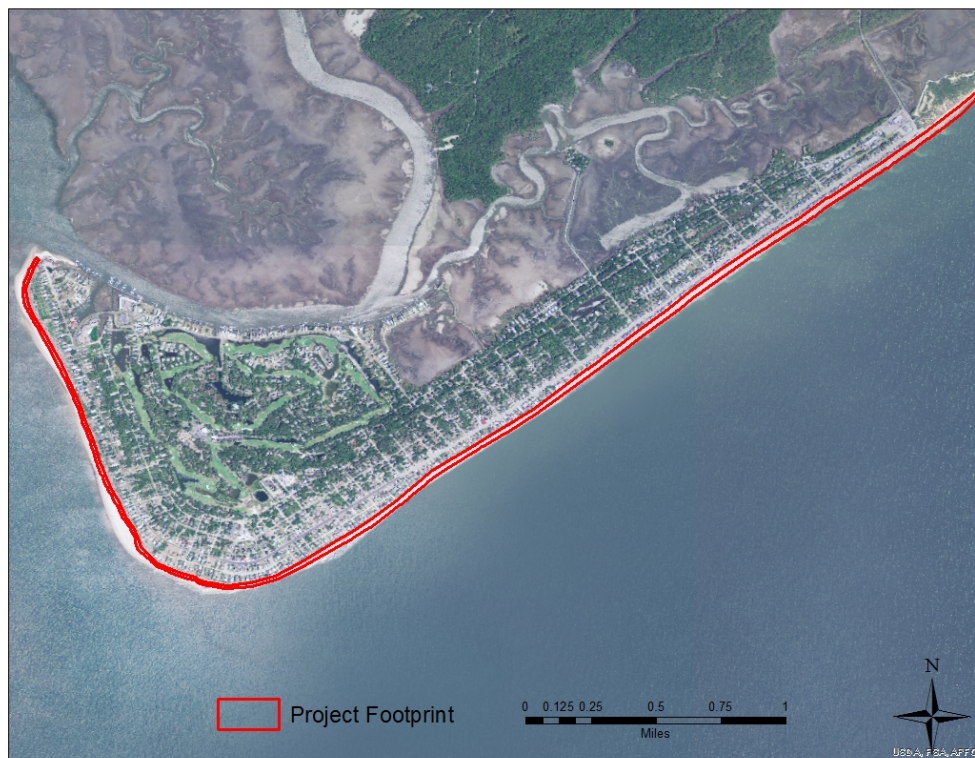
Figure 2. Project footprint from landward toe of dune to seaward berm crest

The proposed project (see Figures 1 thru 4) was determined after a detailed alternatives analysis documented within the Feasibility Study/Environmental Assessment. The project consists of the following elements: 1) A 15-foot high (elevation), 15-foot wide dune beginning at the northern end of the project (i.e., the southern end of the State Park) and extending southward along the beach for 16,530 feet. This dune would be fronted by a 7-foot high (elevation) berm. The first 7,740 feet of berm length would have a width of 75 feet. The width would then taper to a 50-foot width for the remaining length of the berm. The width of each end of the berm would taper to match the existing beach profile; 2) The dune would then transition into a 14-foot high (elevation), 15-foot wide dune that extends around the end of the island for 5,290 feet. No berm would be constructed in front of this dune because the existing beach profile provides an adequate berm; and 3) Approximately 1,130 ft of total groin lengthening across 23 of the existing groins (Figure 5 and Table 1). Results of a coastal engineering analysis determined that this minimal amount of lengthening will not have any downdrift impacts as the design is simply to stabilize the proposed berm width. Because the distance between the landward toe of the dune and the seaward edge of the berm for the beach design exceeds the existing condition distance between these same points along certain reaches within the project, the effective length of the groins in these areas will be reduced. Consequently, the length of some groins will need to be increased in order to create beach width necessary to maintain the design cross-section. The proposed groin lengthening is not provided as a means for trapping more sand and increasing beach width or significantly changing the rate of sand bypassing the groins. The renourishment interval for the proposed project has been estimated to occur every 16 years.

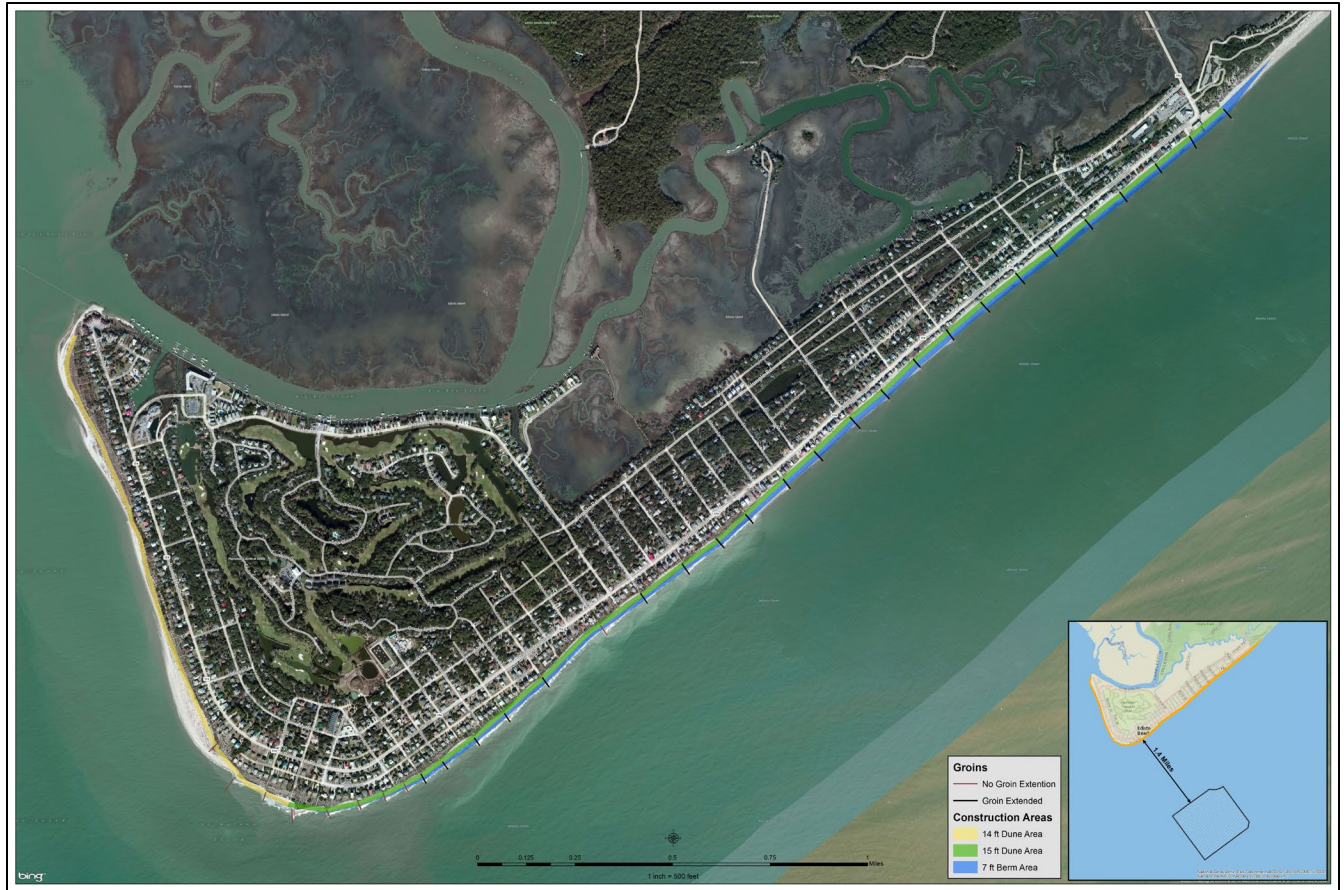
Figure 2. 2014 Authorized Federal Project

The authorized project (Figure 2) would require about 924,000 cubic yards of borrow material for initial construction and about 476,000 cubic yards during each periodic nourishment cycle (based on 16 year intervals). During the projected 50 year project life, this would equate to initial construction and 3 periodic nourishment events. A total of about 2.4 million cubic yards of beach-compatible sand would be needed to construct and maintain the project

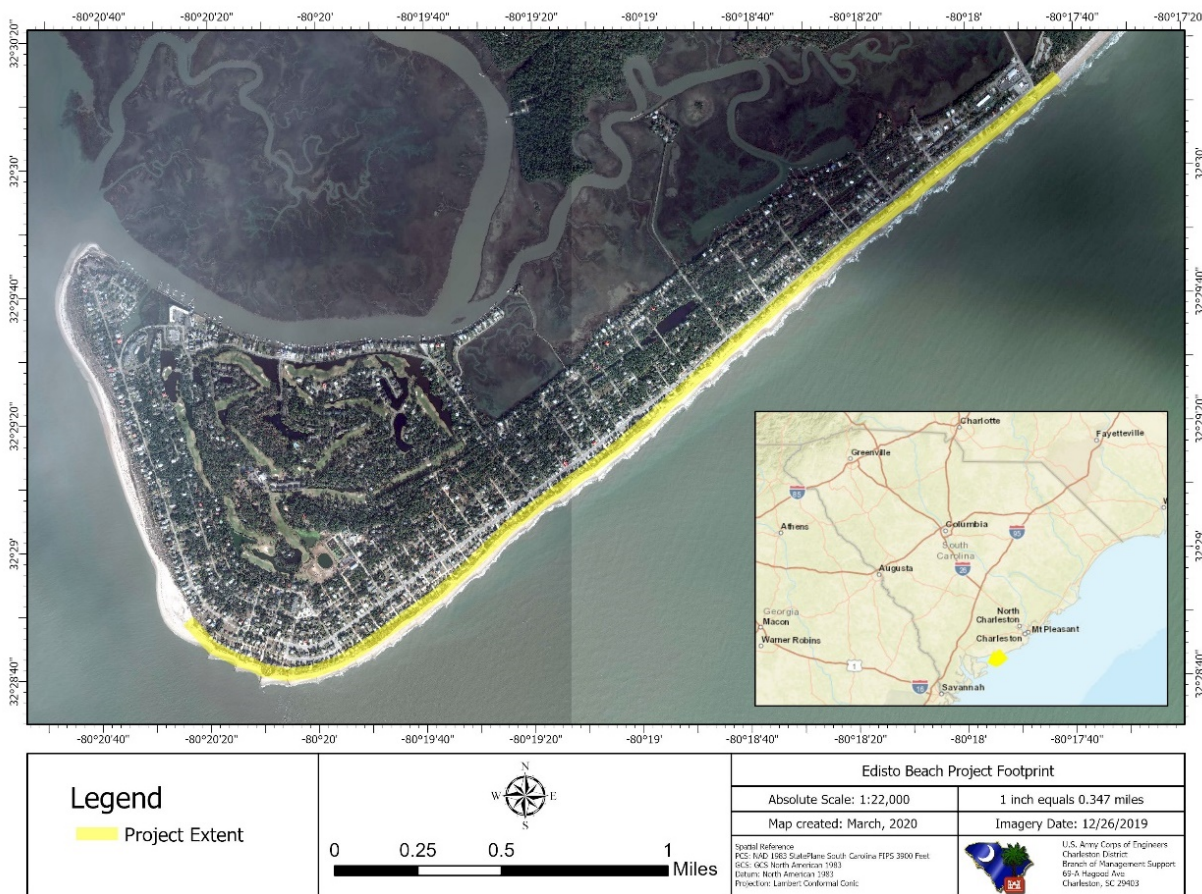
Figure 3. 2020 Modified Federal Project Footprint

would taper to match the existing beach profile. Beginning at groin 29 near White Cap Street, the dune would transition to a 14-foot high, 15-foot wide dune that extends approximately 1046 linear feet around the end of the island to groin 31. Groin 31 acts as a physical boundary to the southern-most end of the project. No berm would be constructed in front of the dune between groin 29 and groin 31 because the existing beach profile provides an adequate berm.

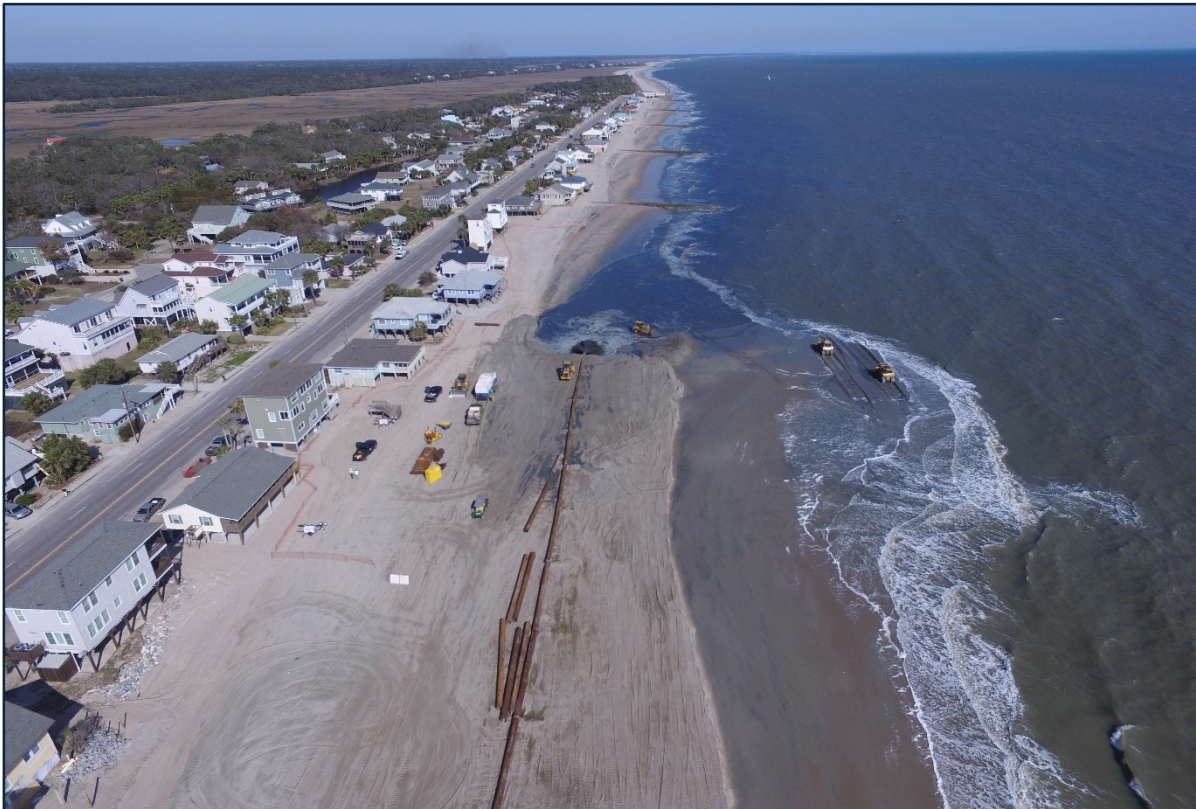
Aerial view of the Edisto Beach project on 31 January 2017. [Photo by SB Traynum]

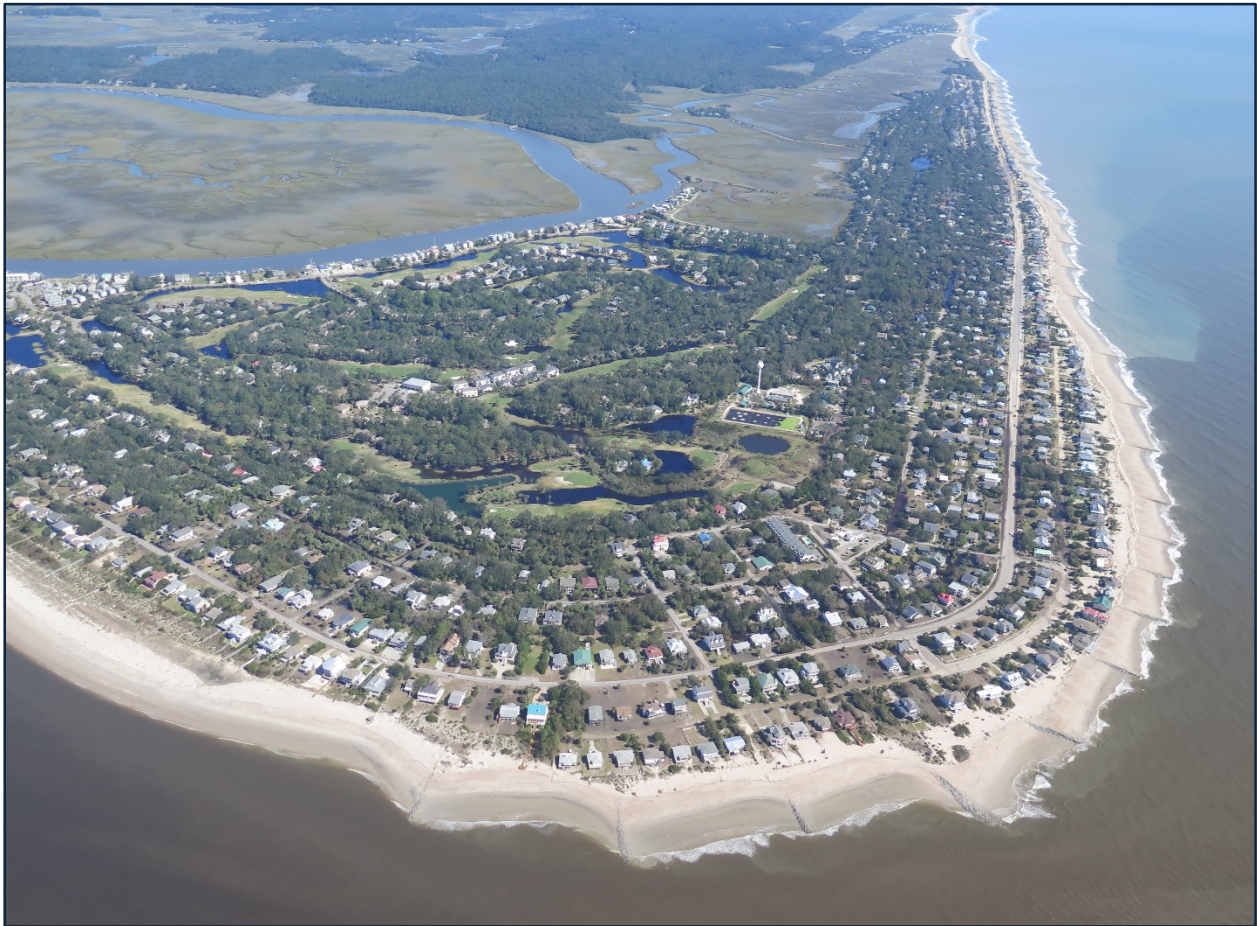
FIGURE 2.1. Aerial image of Edisto Beach in October 2016 following Hurricane *Matthew*.

Edisto Beach is a ~5.8-mile-long barrier island situated on the northern boundary of St. Helena Sound in South Carolina (Fig 2.1). It is bounded by Jeremy Inlet to the northeast and South Edisto River Inlet to the southwest. Edisto Beach makes up the southern half of the larger littoral system which includes Edingsville Beach and Botany Bay. The littoral system encompasses the length between the North and South Edisto Rivers, and there is a general divergence of sediment transport away from the center of the littoral cell (Fig 2.2).

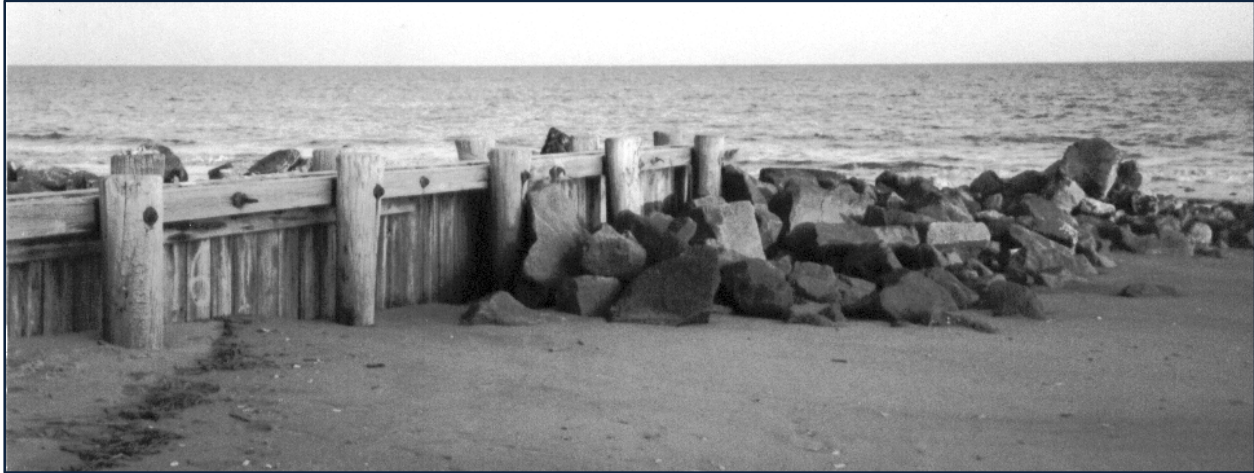
FIGURE 2.4. Typical Edisto Beach (SC) groin prior to the 1995 repair project.

Groin #	Constructed
1	1948
2	1948
3-4	1949
5-8	1954
9-12	1953
13-17	1958
18-19	1962
20-21	1964
22-25	1969
26	1970
27-29	1972
30-33	1974
34	1975

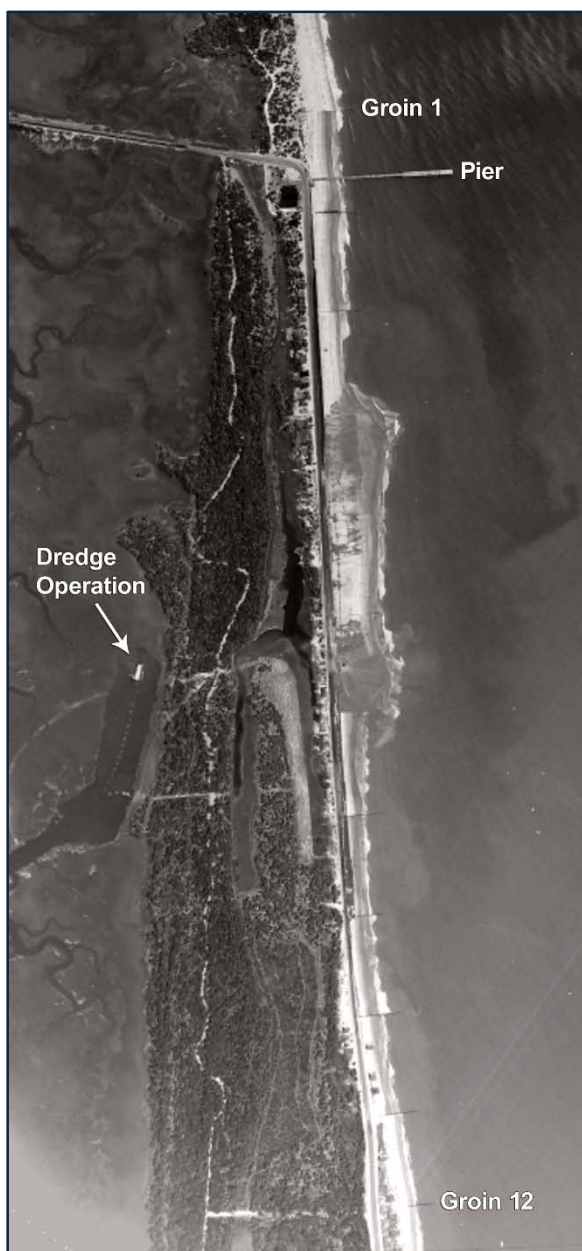
FIGURE 2.5. Aerial image (1954) of Edisto Beach showing the first restoration project. The dredge is visible in the marsh.

In the mid-1950s, erosion near the Pavilion had progressed so far that groins alone were not sufficient to protect Palmetto Boulevard. The South Carolina Highway Department combined groin construction with the first nourishment of Edisto Beach in 1954 using sand, shells, and mud from the marsh behind the island (Fig 2.5). Excavations created the “boat basin” and reclaimed nearly 1.2 miles of shoreline between Groins 1 and 12. Although dredging volumes totaled 830,000 cy, much of the material was unsuitable for the beach, washing away quickly because it was too fine. The coarser sand and broken shells remained, adding to the accumulations of sediment derived from Edingsville Beach.

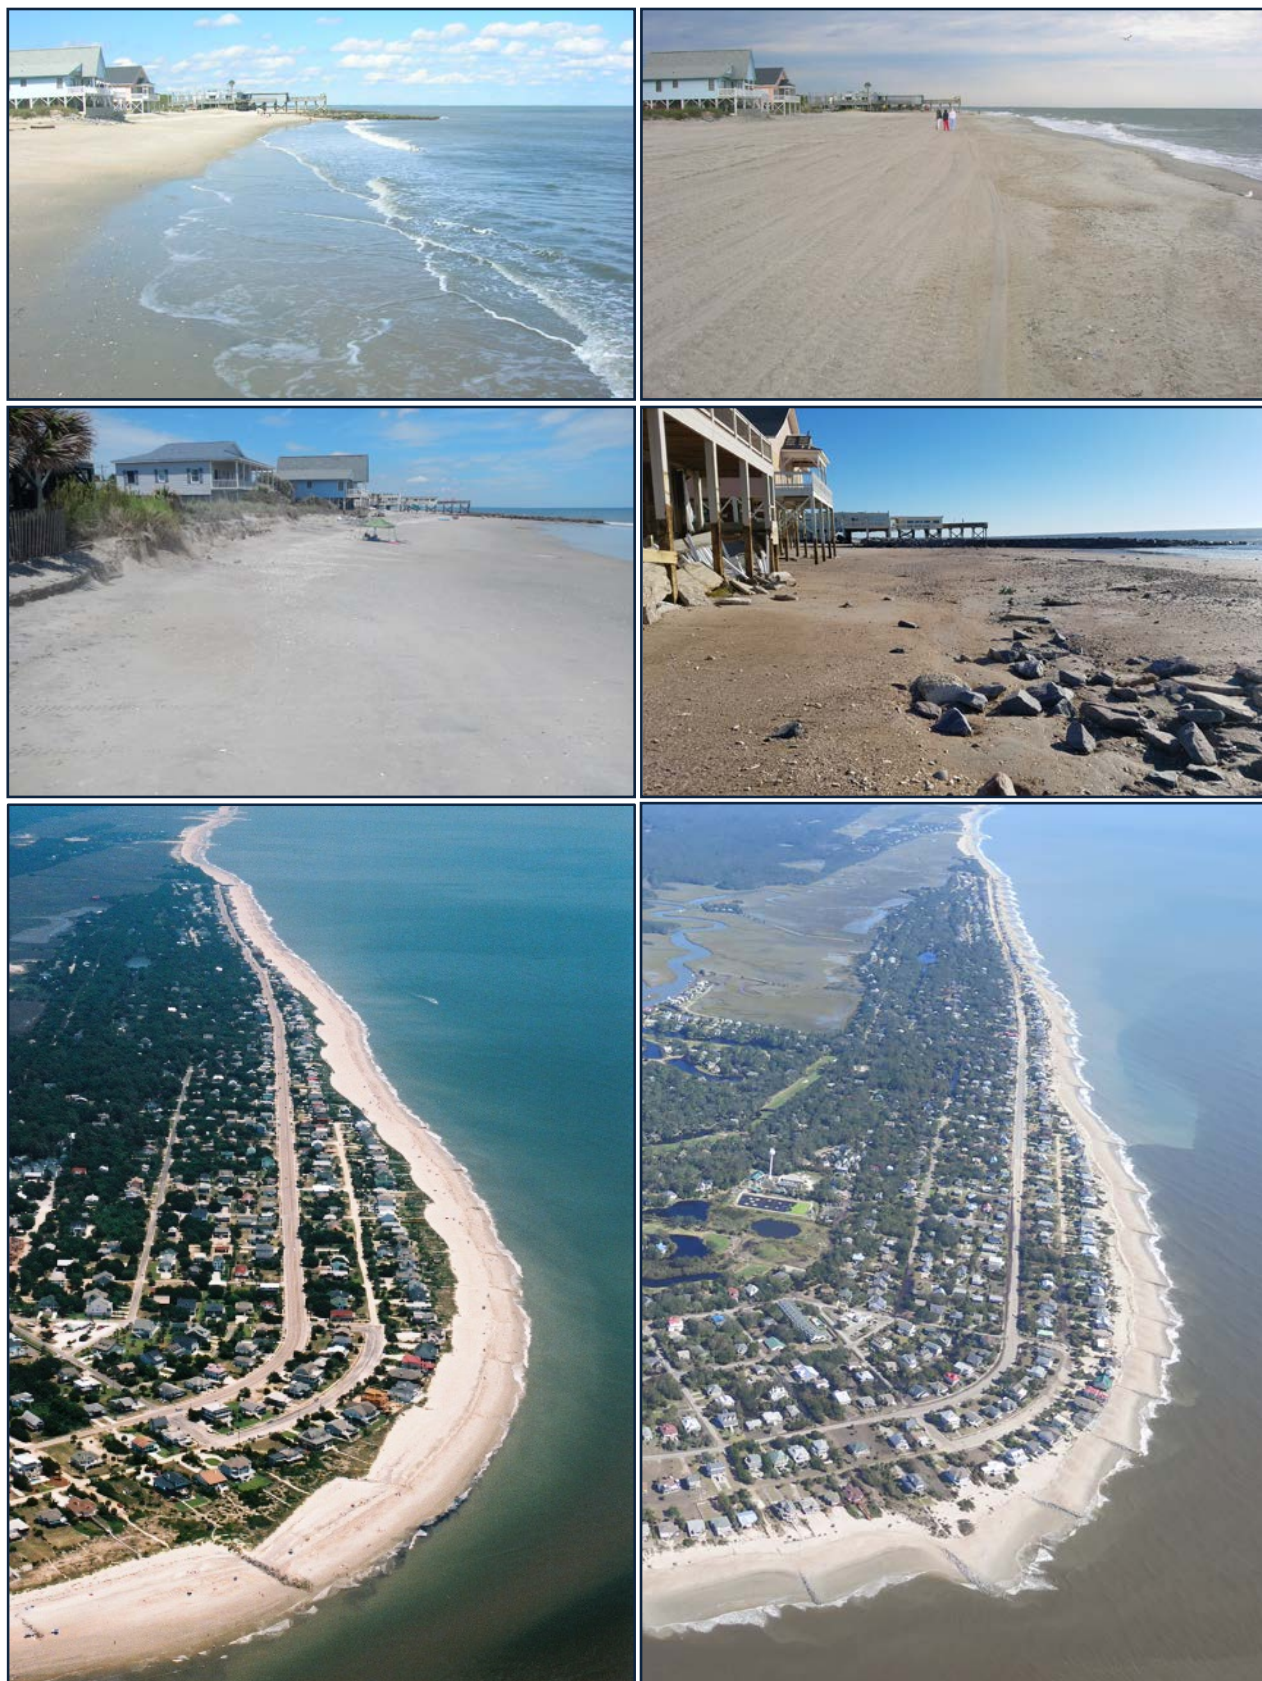
FIGURE 2.9. Image of the beach in the 100 block before (top left) and after (top right) the 2006 project. The middle left and right photos show the same locations in 2016 before and after Hurricane *Matthew*. The aerial photos show the beach after the 2006 project (lower left) and after Hurricane *Matthew* in October 2016 (lower right).

Photos of the beach condition near the 100 block before and after the 2006 project are shown in Figure 2.9 as well as the 2016 pre- and post-*Matthew* conditions. Immediately following nourishment, the majority of the groins were mostly buried by sand. Initial adjustment of the profile led to more exposure of the structures, and over time, additional sand losses resulted in significant exposure of each groin (typically 4–6 ft high). Aerial images show that the first several groin cells had little-to-no vegetative buffer between the houses and the high-tide line by the time Hurricane *Matthew* hit in October 2016. Little dune also existed near the point (cells 25–28).

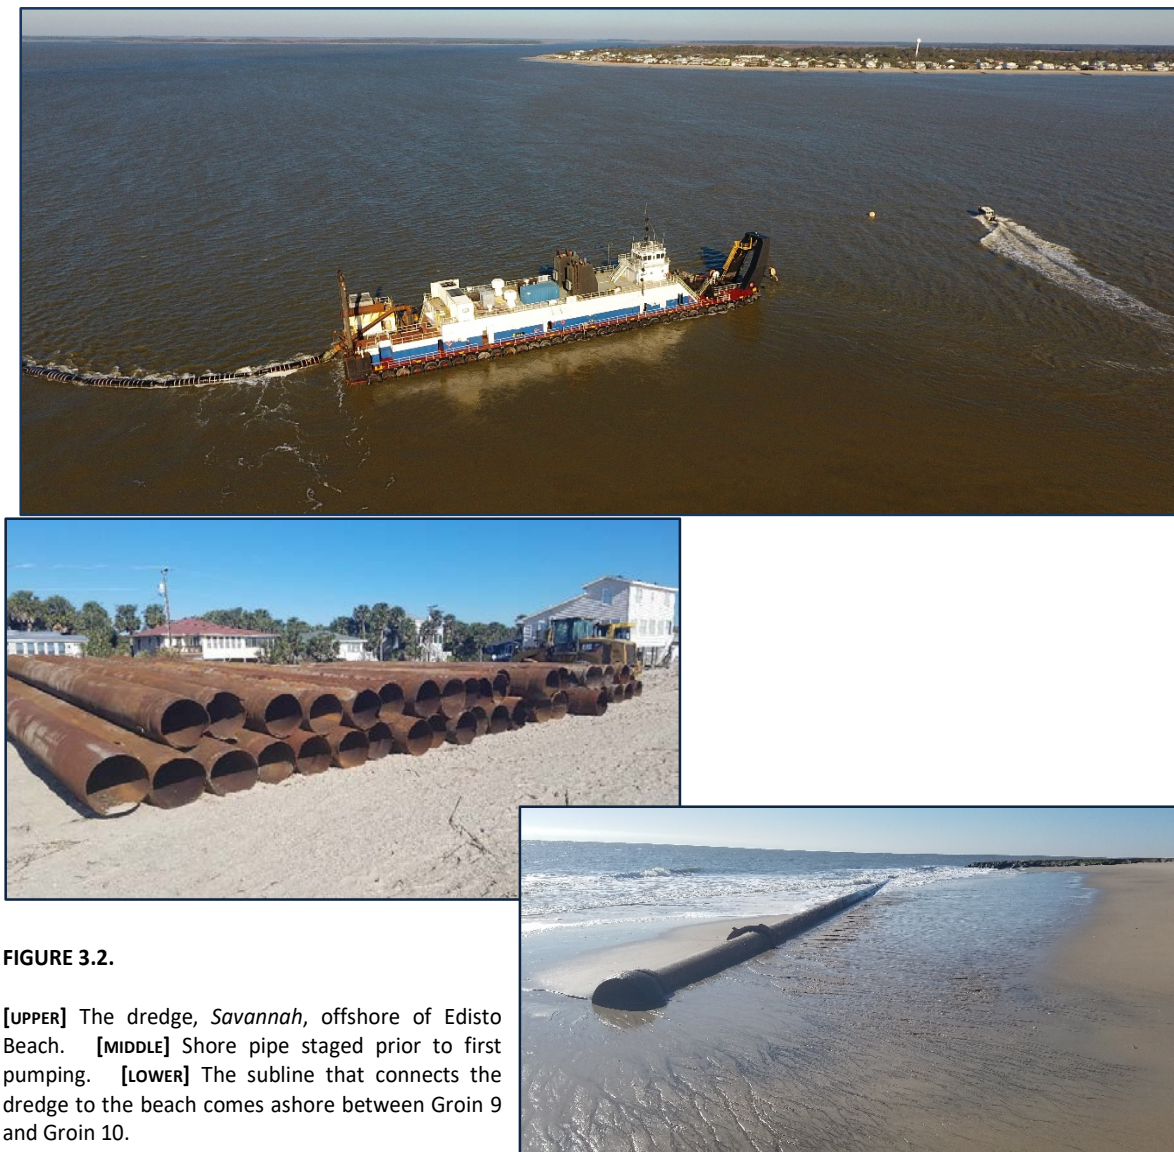
FIGURE 3.2.

[UPPER] The dredge, *Savannah*, offshore of Edisto Beach. [MIDDLE] Shore pipe staged prior to first pumping. [LOWER] The subline that connects the dredge to the beach comes ashore between Groin 9 and Groin 10.

Mobilization for the nourishment project began on 4 January 2017 with delivery of a bulldozer to the beach. Additional equipment continued to arrive over the next several days, along with the first shore pipe on 7 January. Marinex focused delivery of equipment and pipe near the 500 block, and effort was made to ensure that material was staged off vegetated areas (Fig 3.2). A total of ~10,000 lf of shore pipe was mobilized to the beach. The dredge *Savannah* arrived at Edisto Beach on 16 January and staged along the South Edisto River. Pumping started the night of 25–26 January in the 500 block between Groins 9 and 10. The initial work sought to build a “pad,” which is a broad platform used as a landing site for the subline and begins the berm at the design elevation. Once the pad was complete, pipe was placed on the new berm directed to the north to begin the normal fill plan (Fig 3.3).

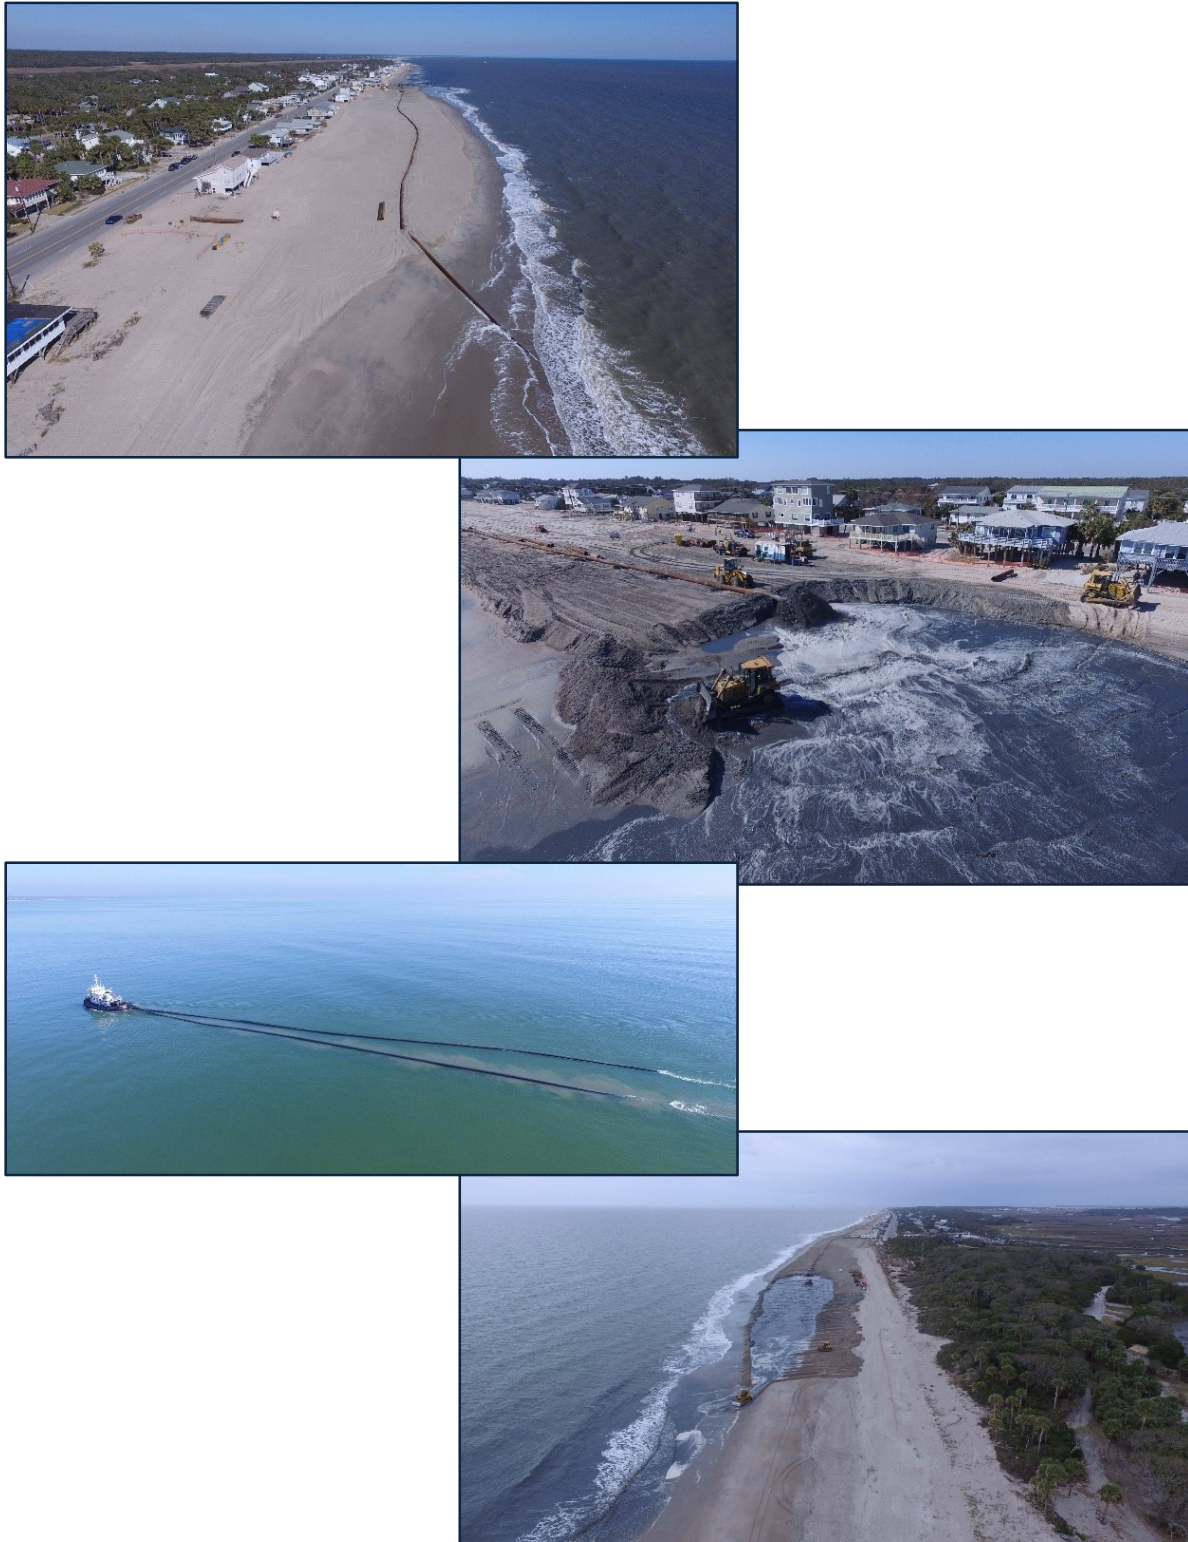
FIGURE 3.3. [UPPER LEFT] Early in the nourishment project, showing the subline coming onshore and the nourishment fill moving north. [CENTER RIGHT] The active fill area showing slurry coming from the discharge pipe. [CENTER LEFT] A tug towing new 500-ft sections of plastic shore pipe to the beach. [LOWER RIGHT] Fill in the state park area.

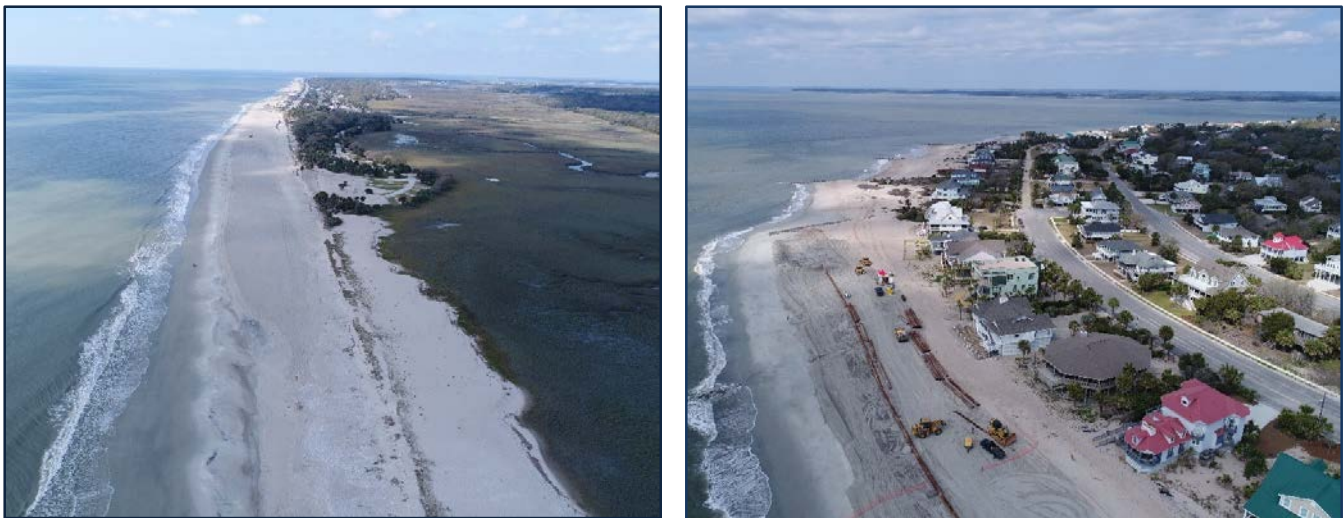
FIGURE 3.4. [LEFT] The completed beach at the state park. [RIGHT] Fill progress around Groin 27 at “The Point.”

Following completion of the state park, Marinex repositioned the subline to the beach between Groins 19 and 20 (near Baynard Street). Pumping resumed on 9 March, building a new pad. Marinex initially pumped sand to the north, reaching Groin 18 before switching back and pumping south. Work continued south to the southern end of the project at Groin 30 (Edisto Street), reaching it on 28 March (Fig 3.4).

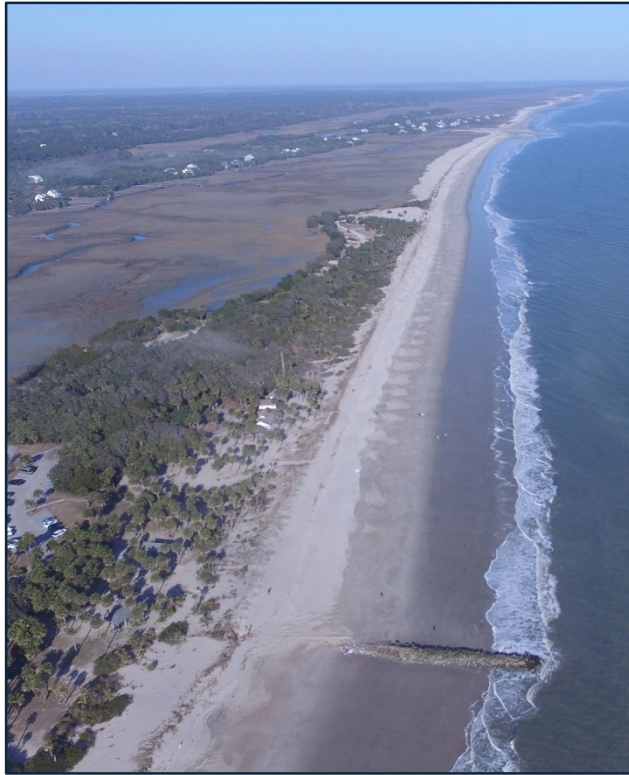
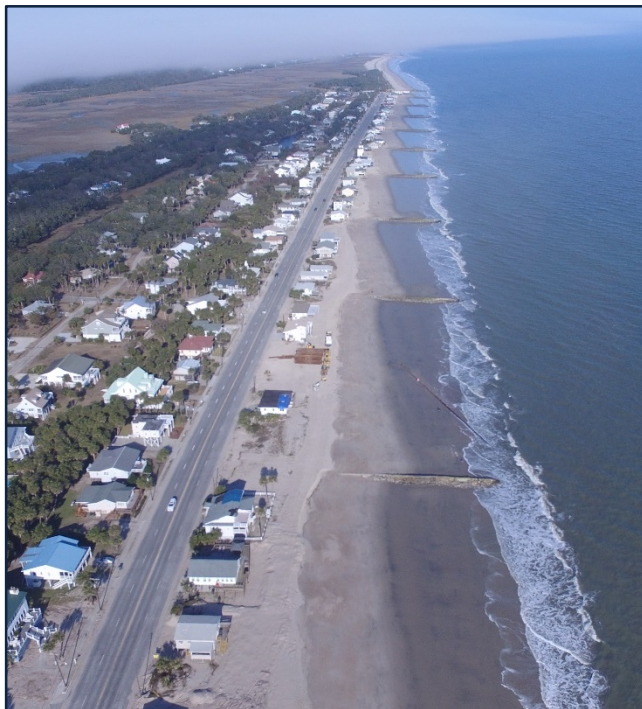
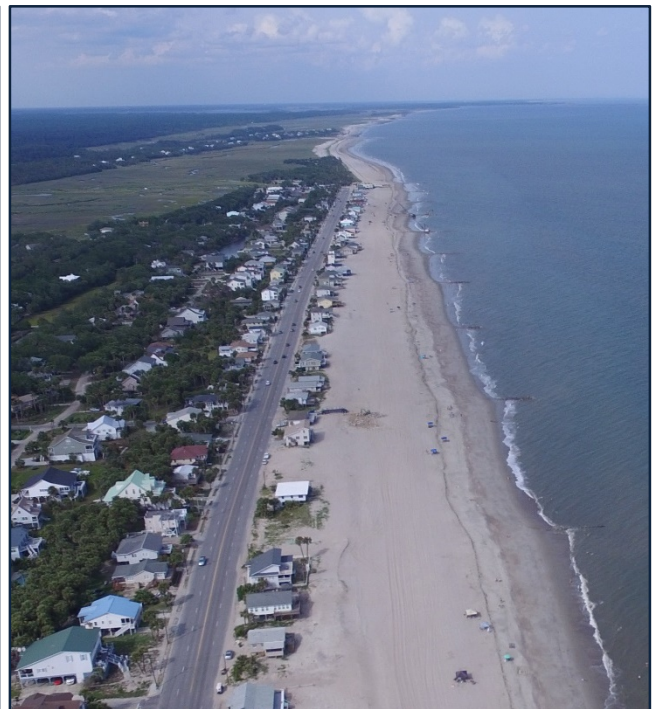
FIGURE 3.5 (page 1 of 2). Before (left) and after (right) images of the beach nourishment project at Edisto Beach (SC). **[UPPER]** Edisto State Park area. **[LOWER]** Reach 1.

The last area of beach to be filled was the area between Groins 9 and 18. Marinex continued working to the north from where they previously left off at Groin 18. The final pumping occurred on 14 April 2017 where the original subline was placed between Groins 9 and 10. A total of 79 working days were required for placement of the 1,006,072 cy fill volume. Production averaged ~12,700 cy per day including all weather and mechanical delays. Marinex submitted daily construction logs that included information on estimated production and delays, quantities and locations of discharge pipe, and weather information (Appendix B). Before and after photos are shown in Figure 3.5.

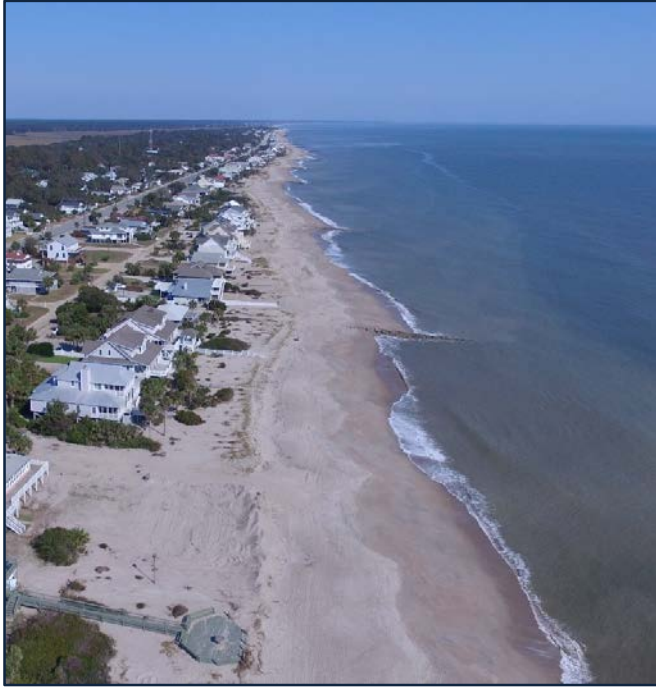
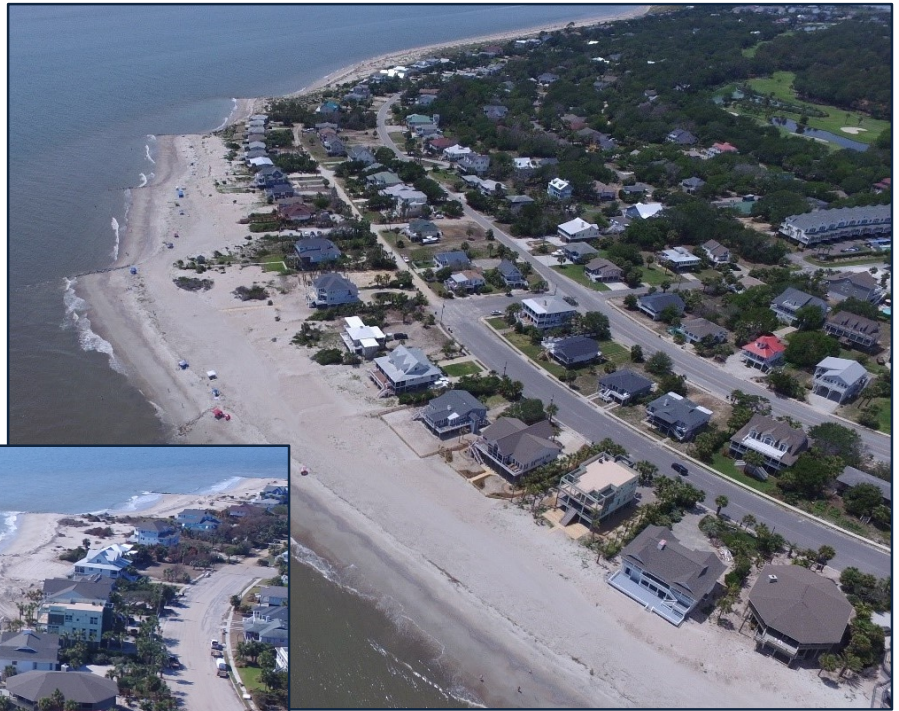
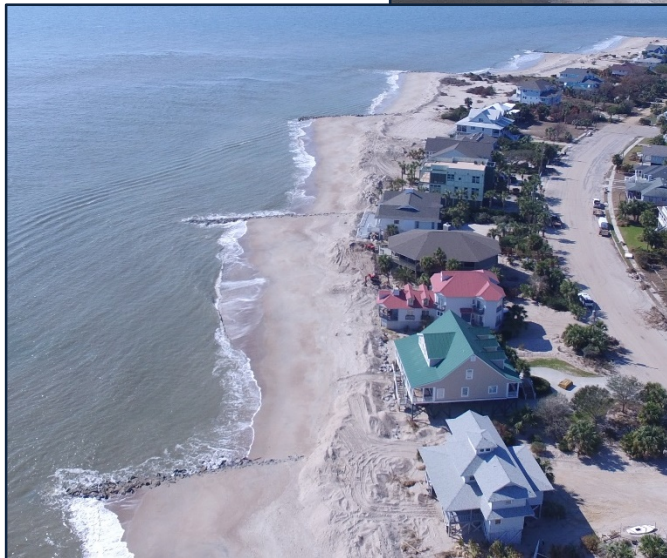
FIGURE 3.5 (page 2 of 2). Before (left) and after (right) images of the beach nourishment project at Edisto Beach (SC). [UPPER] Reach 2 and Reach 3. [LOWER] Reach 4.

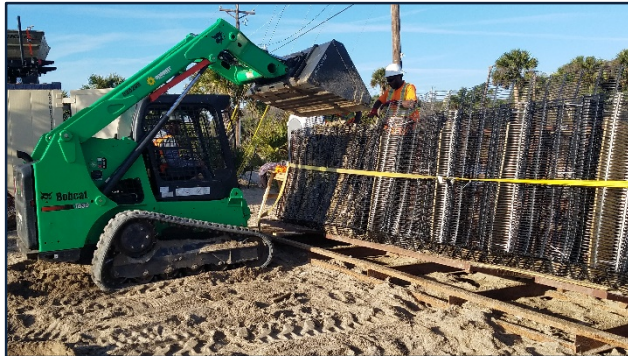
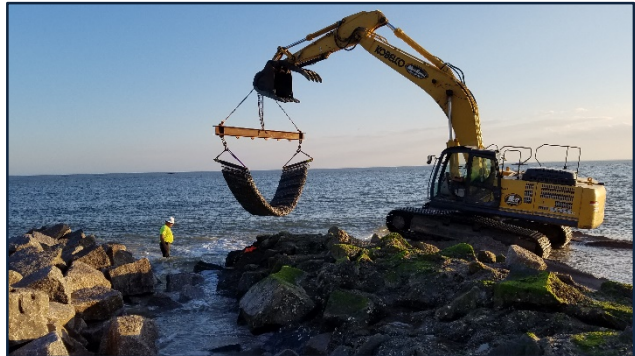
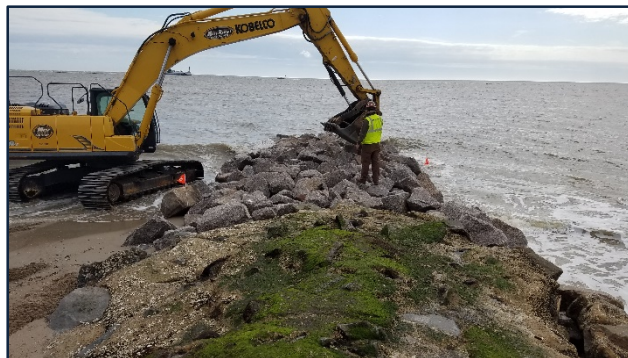
FIGURE 3.7 Images of the groin construction.

Mattresses were filled with stone typically 4–6 inches in size. To fill the mattresses, JLS would tie three sides of each ~20-ft-long unit and position the mattress on a rotating table. The mattress would be rotated vertically, and rocks would be placed in the opened end of each cell (Fig 3.7). Once filled, the top side would be tied closed, and the mattress would be rotated horizontally and

[UPPER LEFT] Filling marine mattresses with small stone.
[UPPER RIGHT] Placing marine mattresses via excavator.
[LOWER LEFT] Placing armor stone.

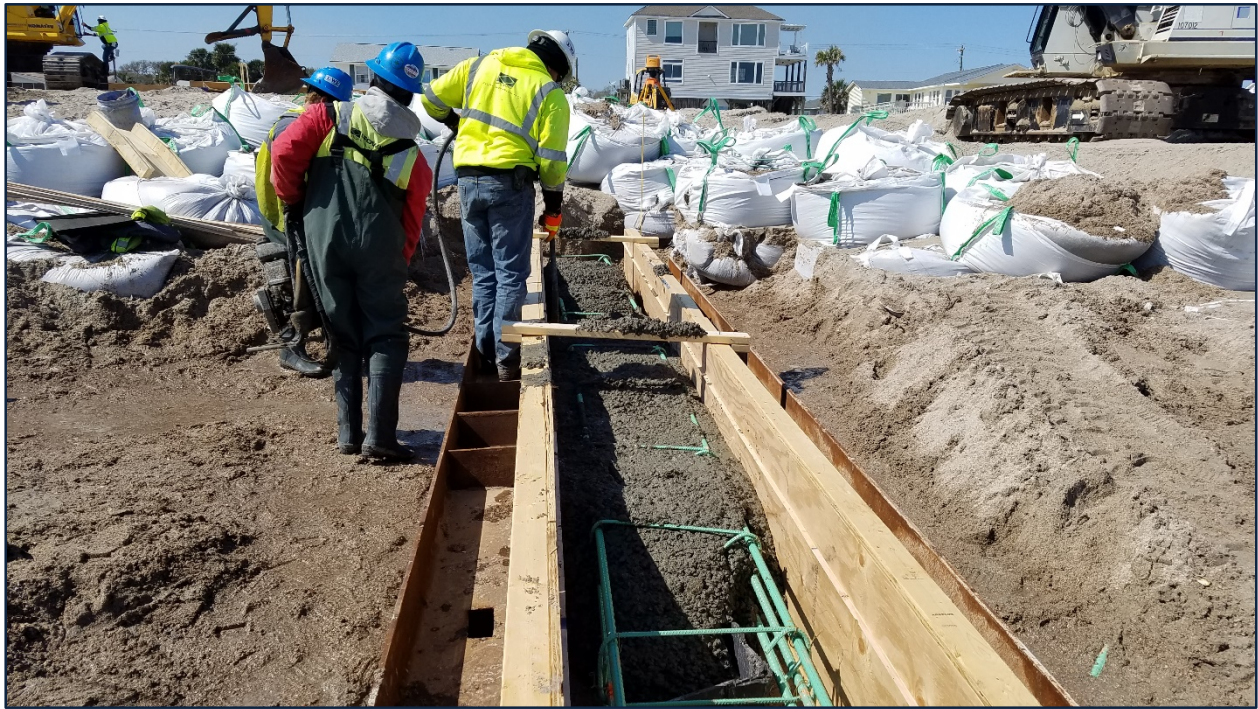
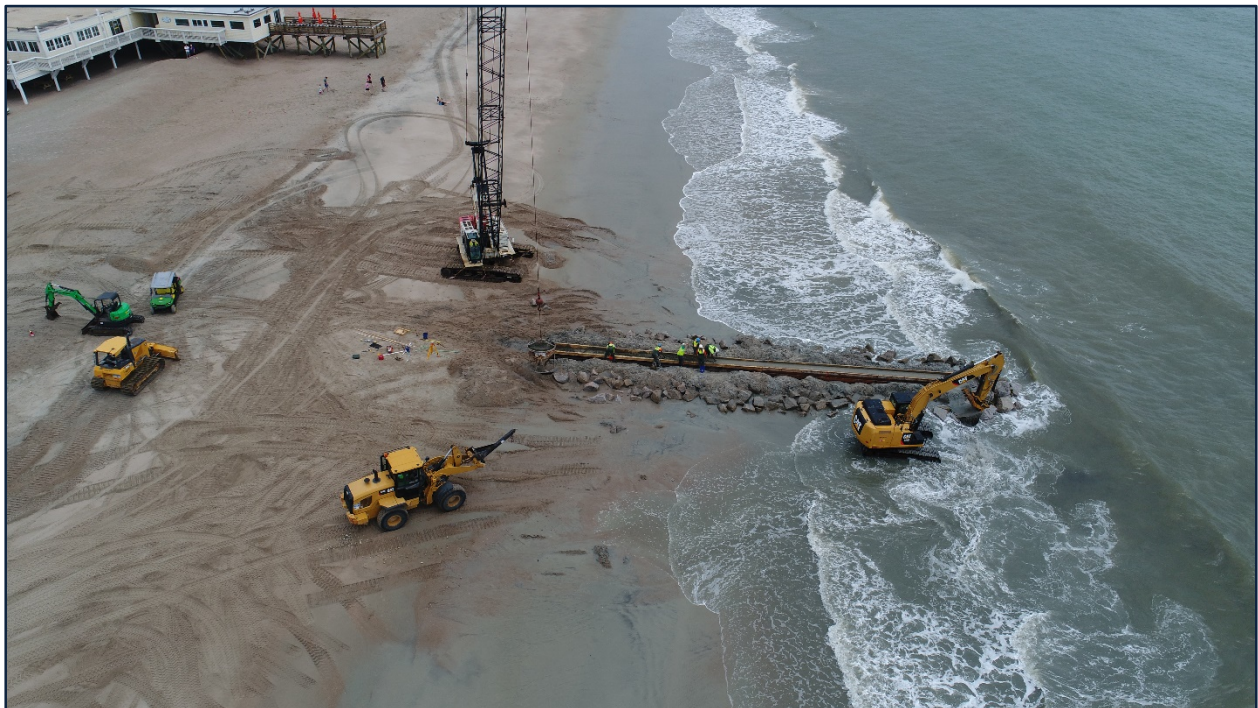
FIGURE 3.9. [UPPER] Pouring concrete into the forms. Note the epoxy-coated rebar (green). [LOWER] Aerial view of groin construction at Groin 2.
