**Edisto Beach, South
Carolina
Coastal Storm Risk
Management Project
Validation Report**

**US Army Corps
of Engineers®**
Charleston District
July 2022

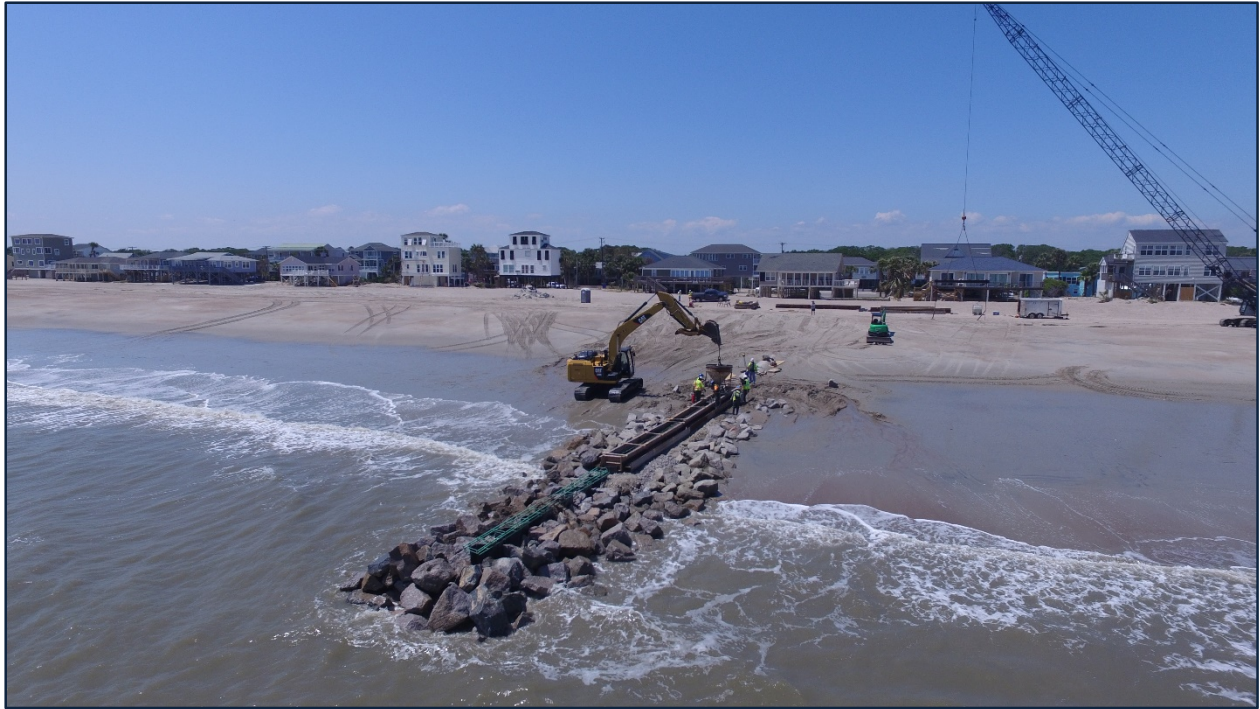
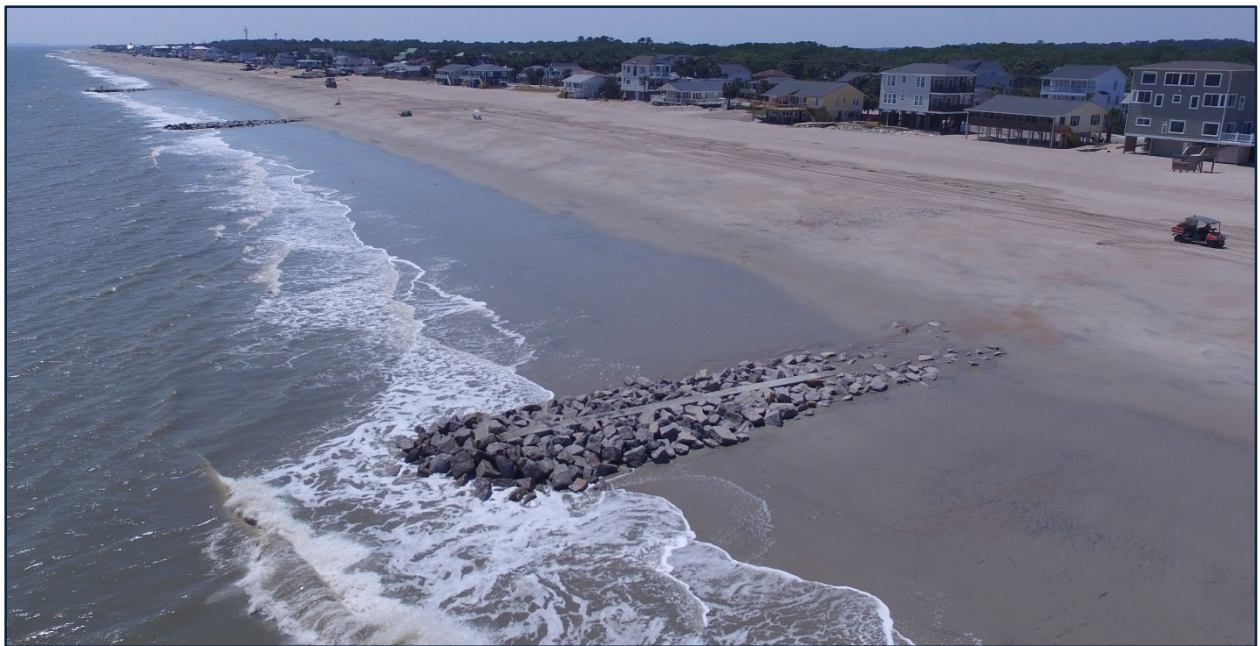
FIGURE 3.10. [UPPER] Pouring concrete cap on the landward end of groin extension. [LOWER] Completed extensions for Groin 7 (foreground), Groin 8 (middle), and Groin 9 (background).

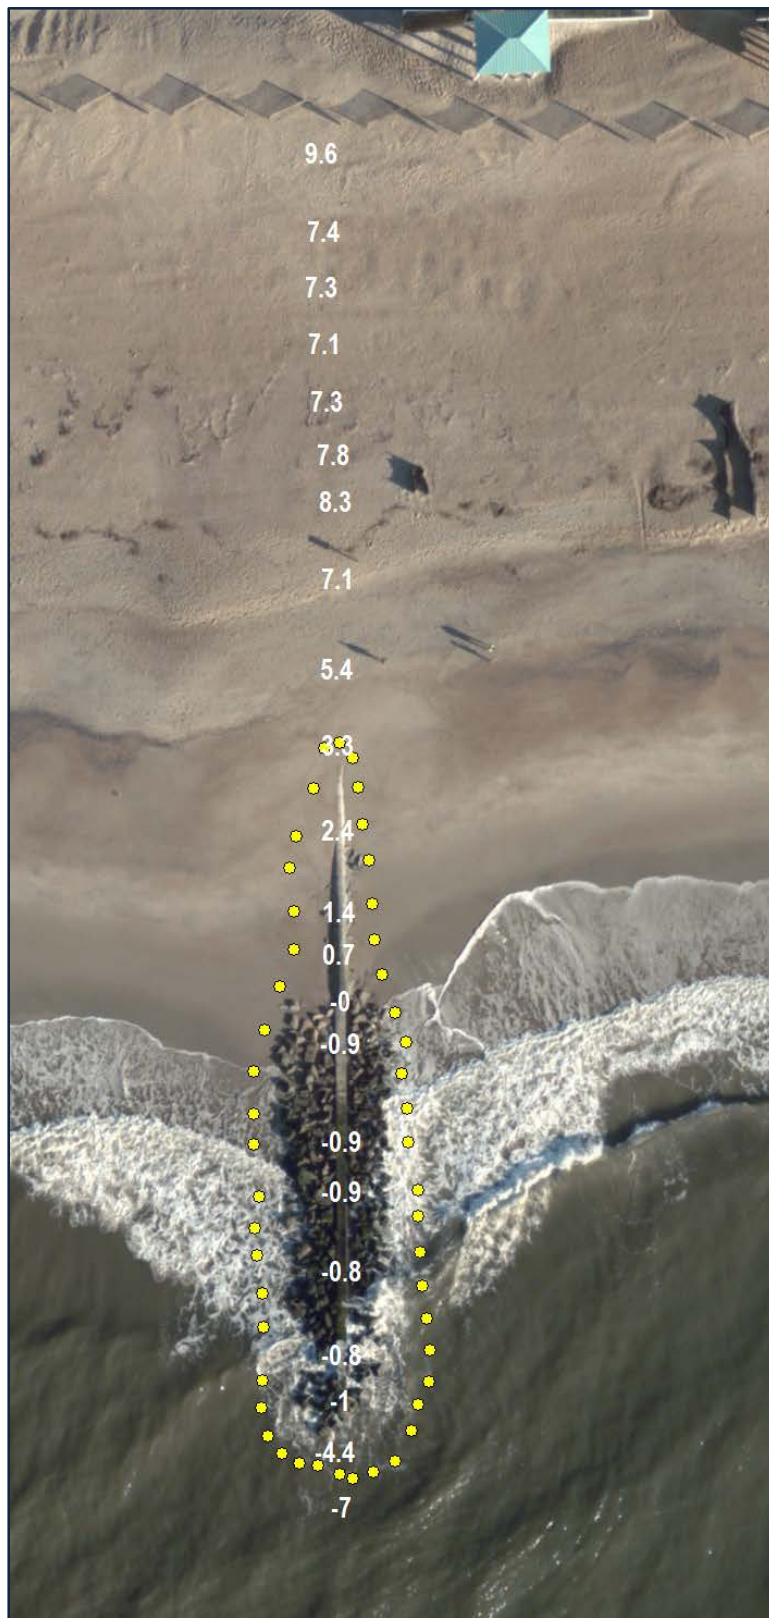
FIGURE 4.6. Plan view of a typical groin extension using sheet pile and concrete cap. Elevations are labeled in white and the footprint of the accessible armor stone is shown in yellow. This extension began near the “0 ft NAVD” contour.

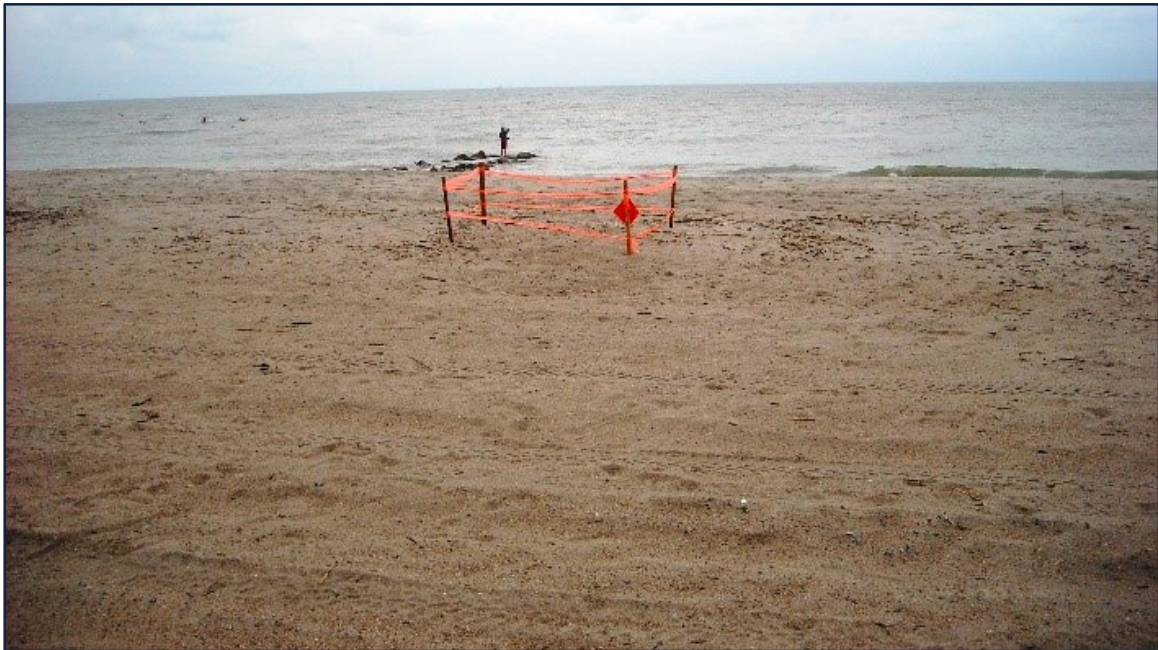
FIGURE 6.1. Example of turtle nest located and marked on the already constructed berm. A completed groin extension is visible in the background.
