Project: William States Lee III Nuclear Station CHEROKEE COUNTY, SOUTH CAROLINA		
Title: KEY MAP		
Drawn By: Atkins	Scale: As Shown	KEY MAP
Job No. 100008697	Date: 11/9/2011

Project: William States Lee III Nuclear Station CHEROKEE COUNTY, SOUTH CAROLINA		
Title: PERMIT AREA COMPONENT "D" OFFSITE TRANSMISSION LINE (WEST CORRIDOR)		
Drawn By: Atkins	Scale: As Shown	SHEET D30
Job No. 100008697	Date: 11/9/2011

Page
PERMIT AREA COMPONENT A	
RIVER INTAKE STRUCTURE	1
SEDIMENTATION POND A INTAKE STRUCTURE	9
SEDIMENTATION POND A REFILL STRUCTURE.....	19
DROUGHT CONTINGENCY POND B INTAKE/REFILL STRUCTURE	29
DROUGHT CONTINGENCY POND B REFILL STRUCTURE	39
DISCHARGE DIFFUSER PIPE	47
PERMIT AREA COMPONENT B	
DROUGHT CONTINGENCY POND C MAIN DAM, SADDLE DIKES, SPILLWAY AND LONDON CREEK	
CHANNEL IMPROVEMENTS	55
DROUGHT CONTINGENCY POND C TEMPORARY HAUL ROAD	89
SC 329 REALIGNMENT	93
LAKE CHEROKEE DAM IMPROVEMENTS	111
PERMIT AREA COMPONENT C	
LONDON CREEK CULVERT REPLACEMENT	119

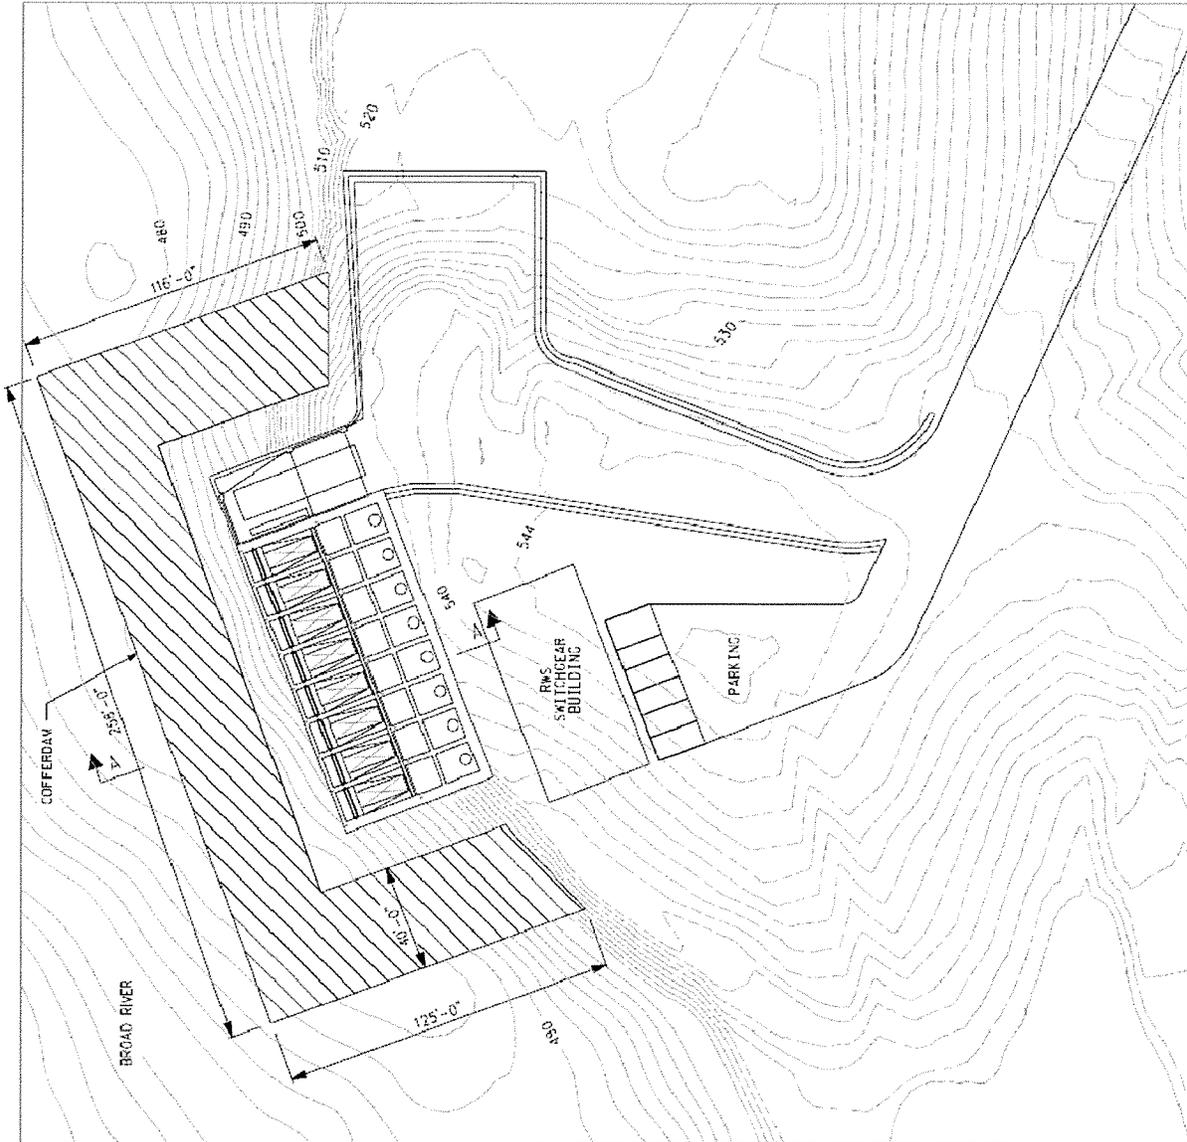
River Water Intake Structure

Limits of Excavation of River Water Intake Structure

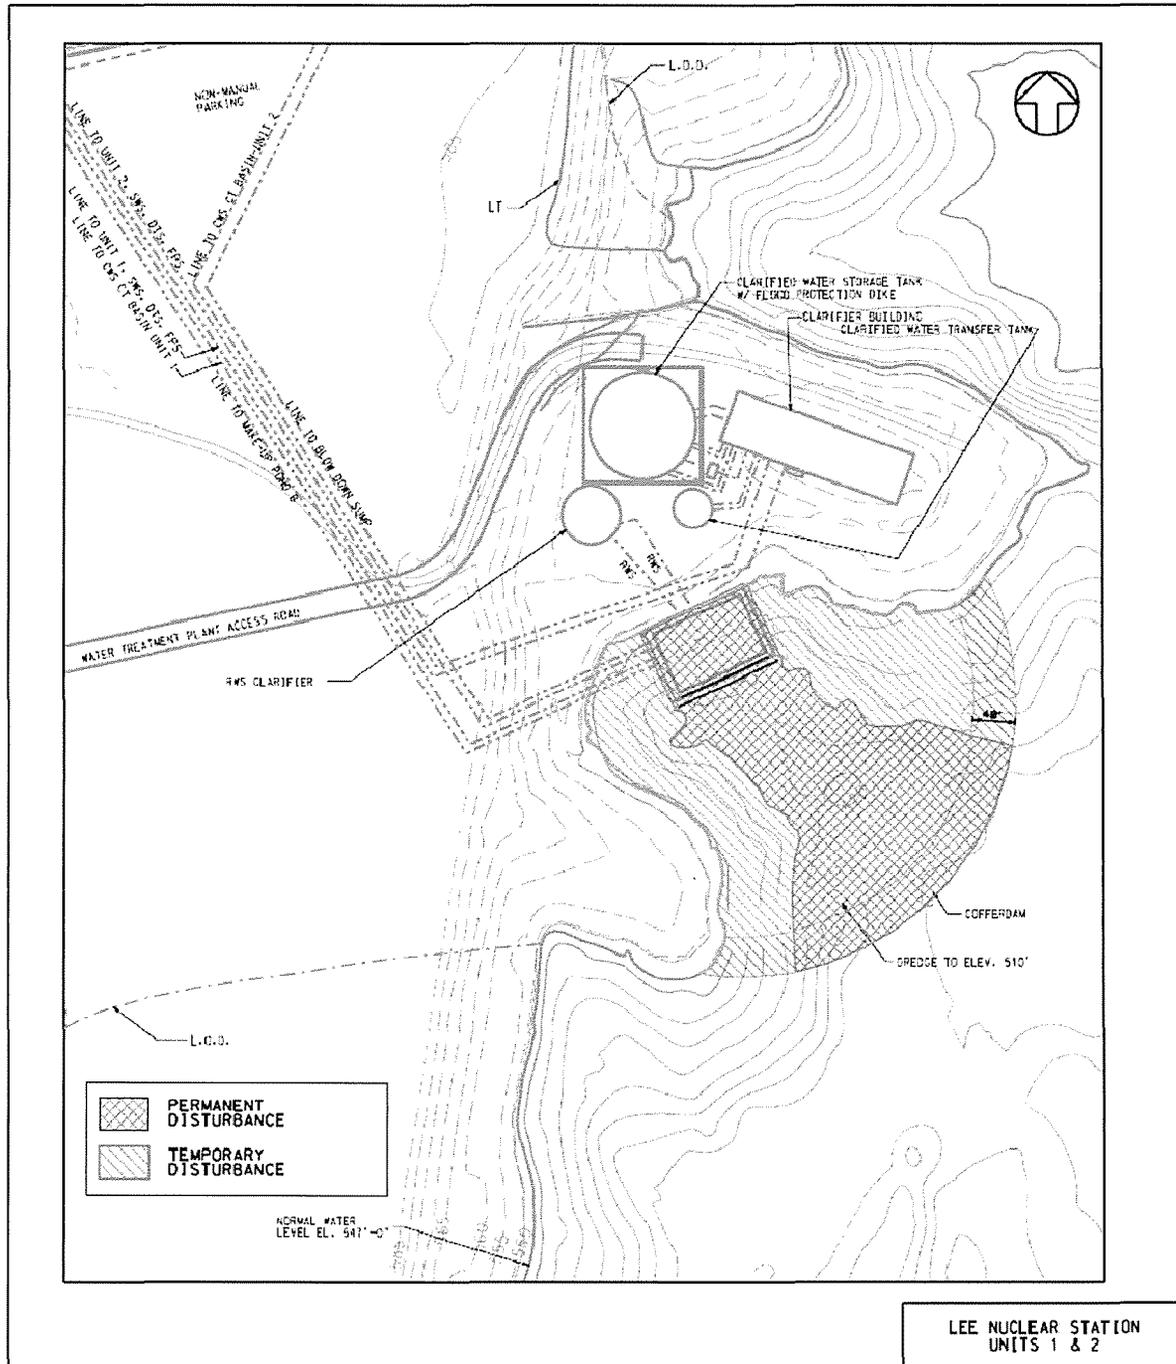
Pond A Raw Water Intake Structure Location Plan

Limits of Excavation of Pond A Raw Water Intake Structure

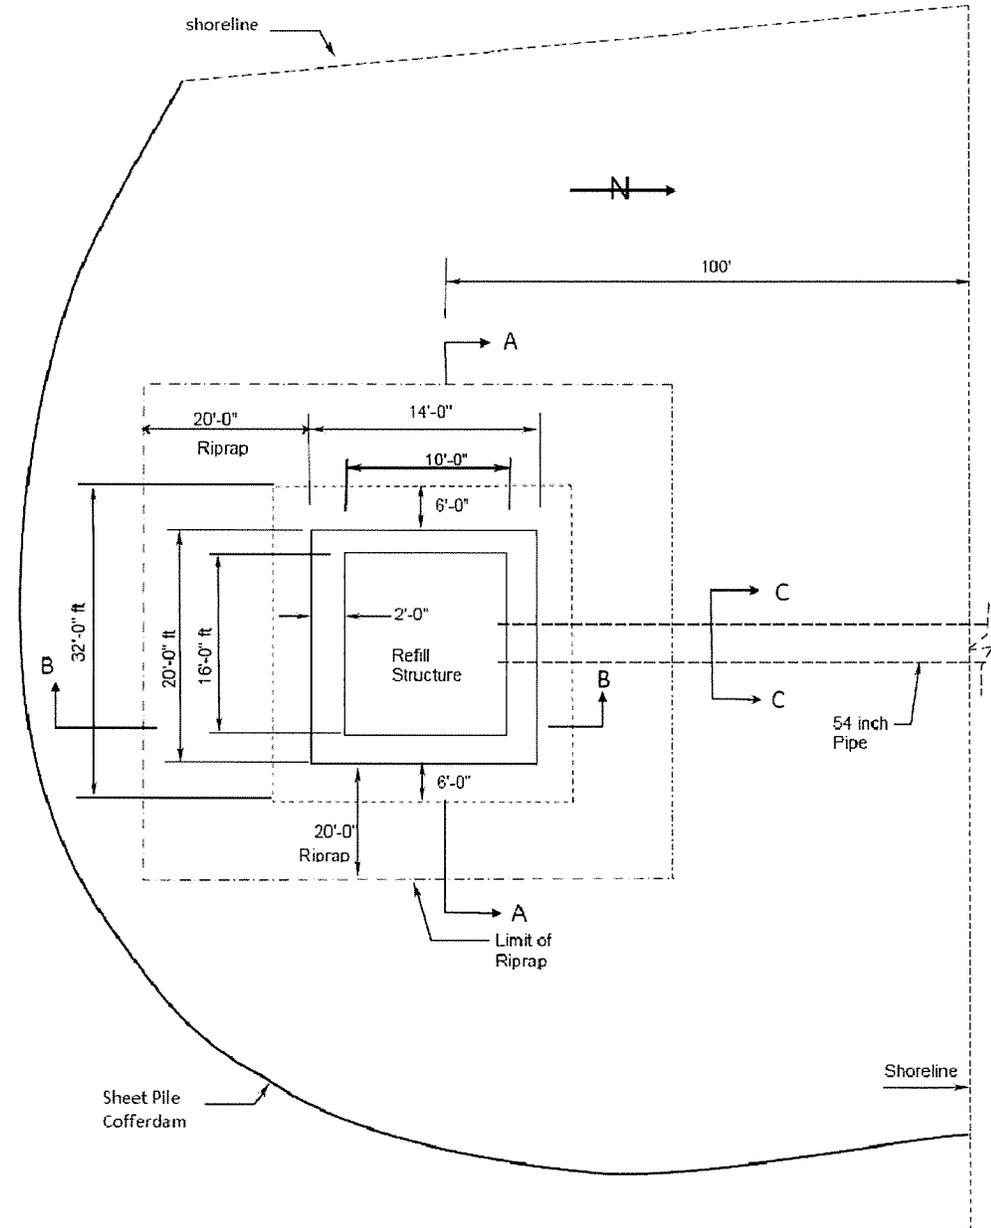
PLAN
(NTS)

Pond A Raw Water Refill Structure Plan and Section

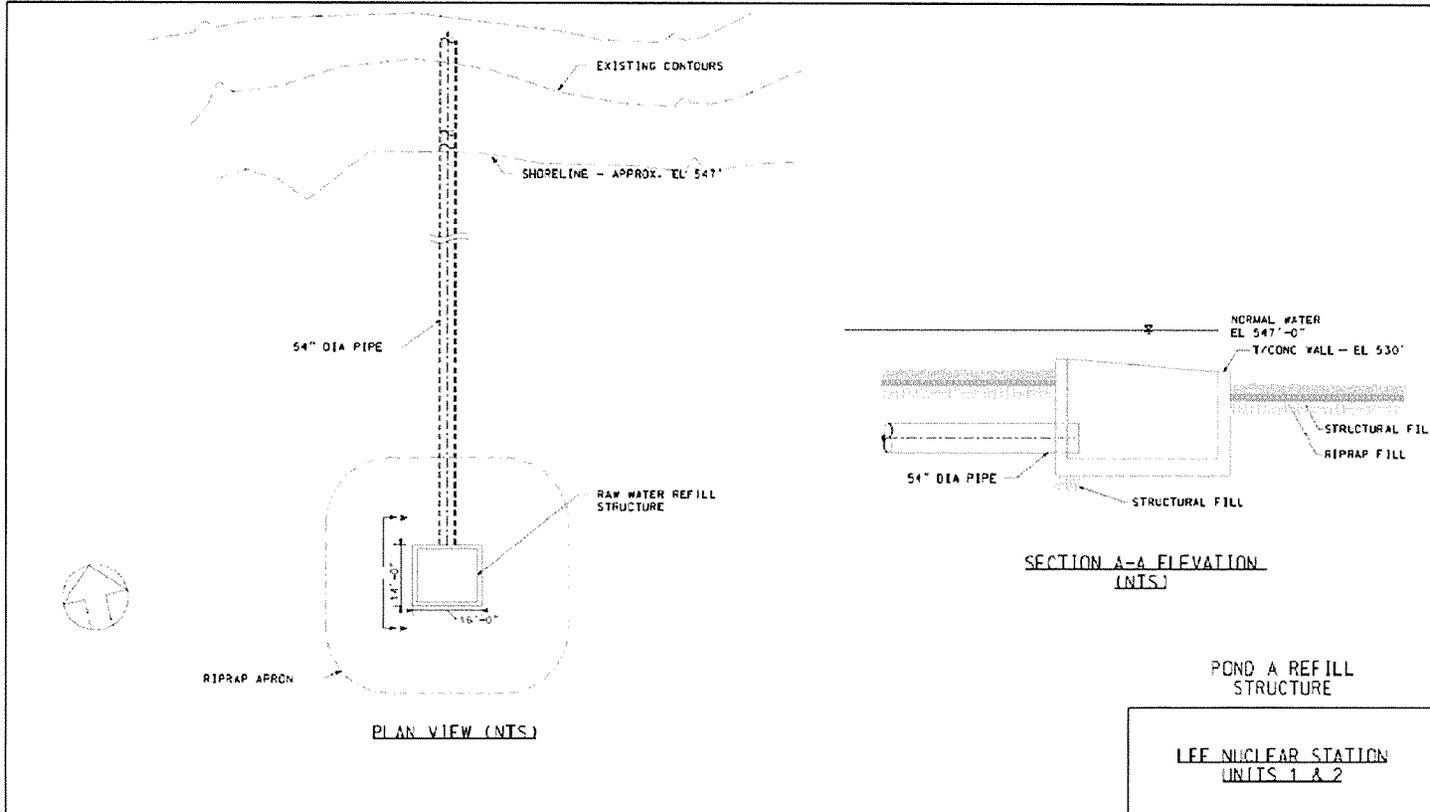
Profile of Pond A Raw Water Refill Structure

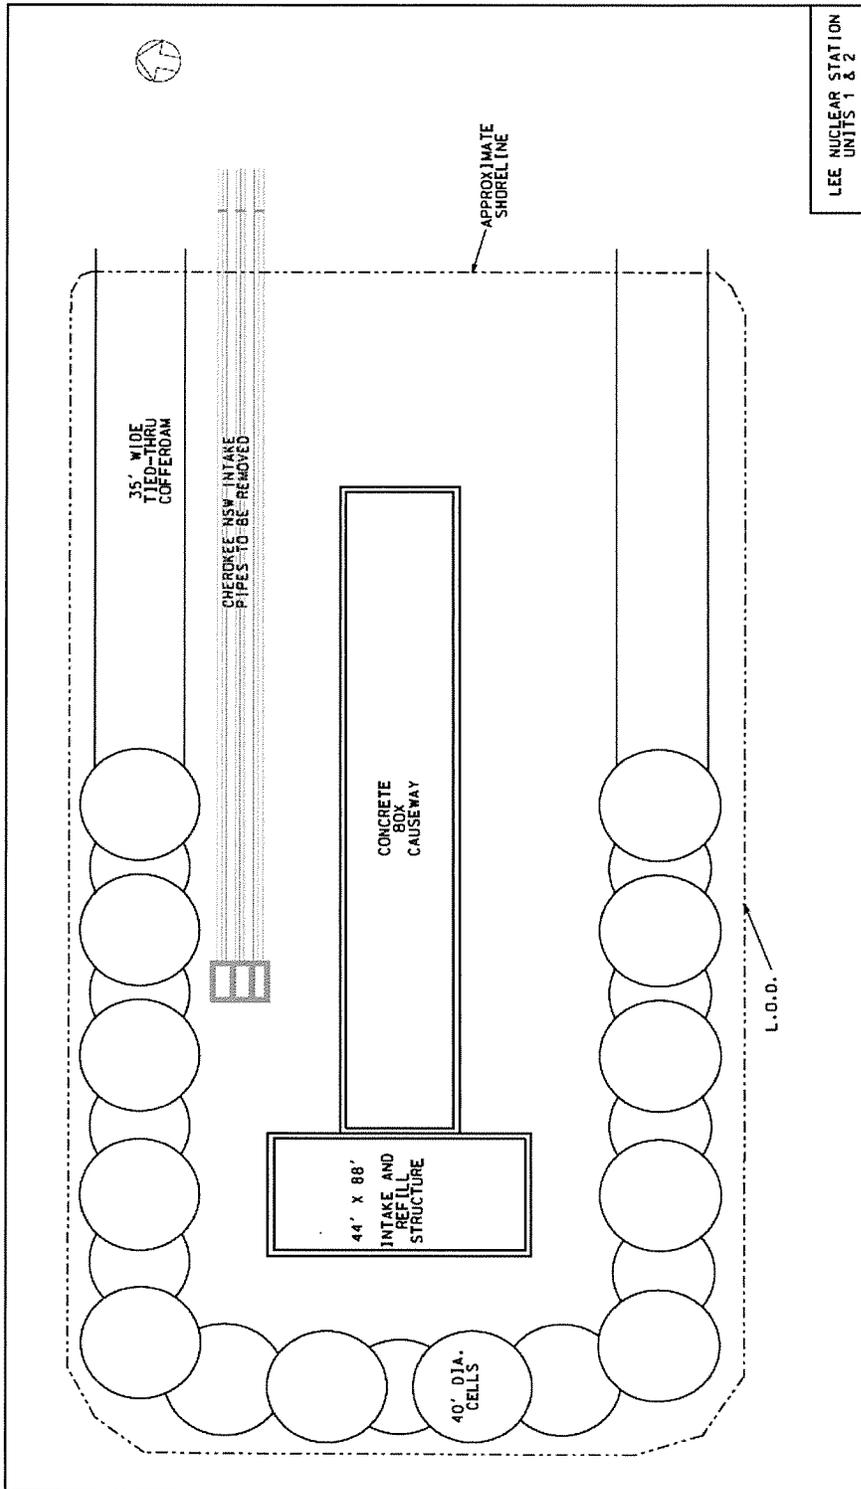
Pond B Intake/Refill Structure Pier Plan

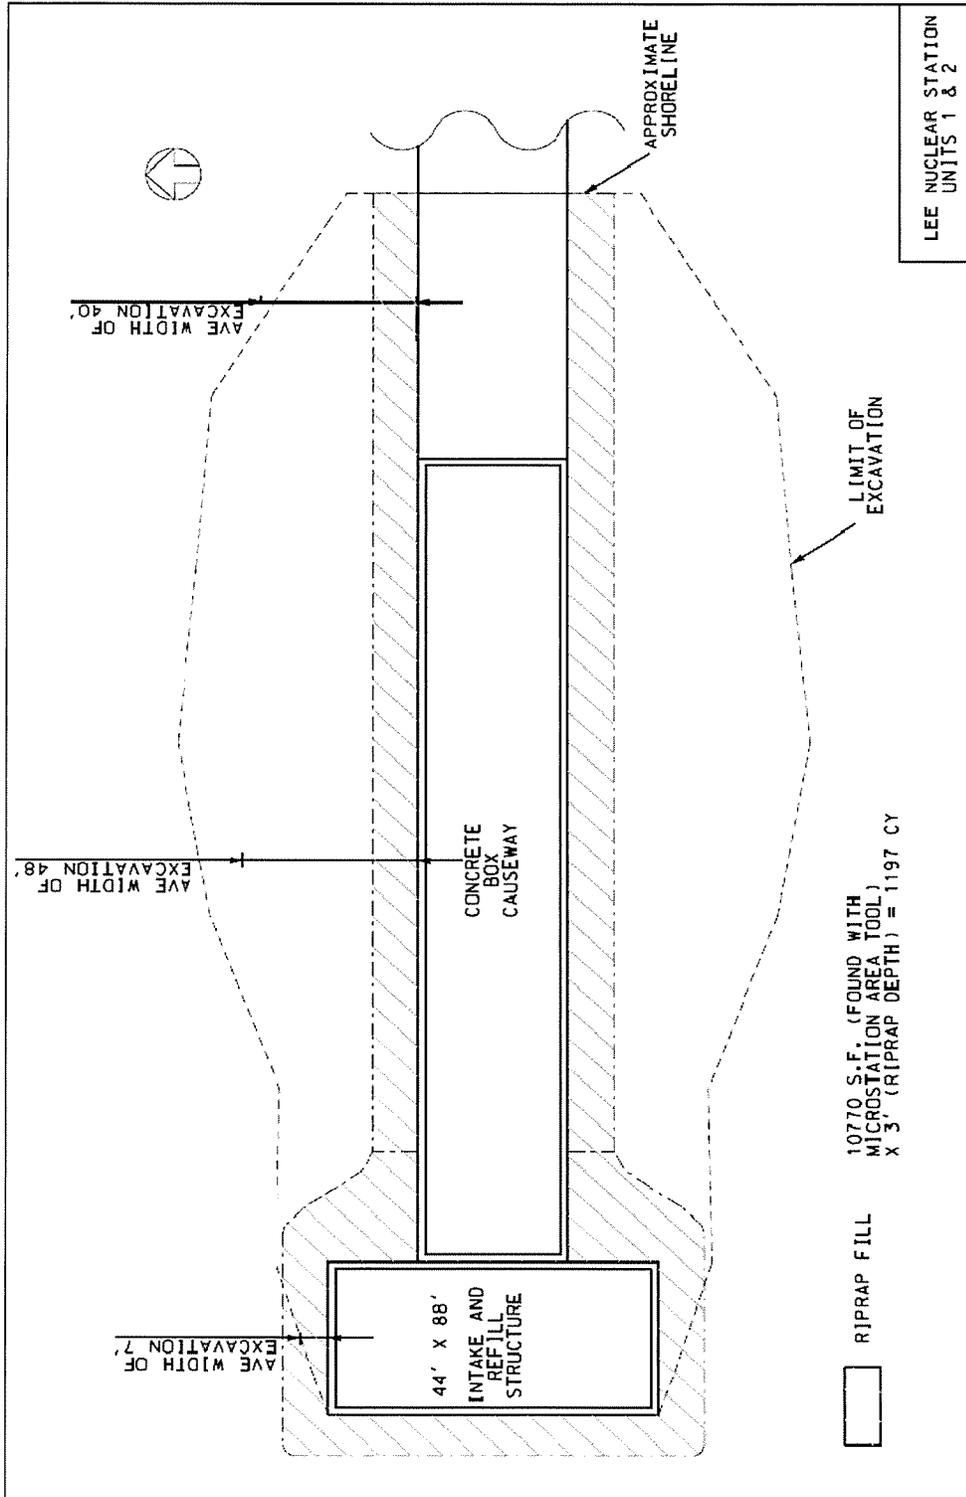
Pond B Intake/Refill Structure Limits of Permanent Disturbance

Pond B Intake/Refill Structure

Limits of Excavation of Pond B Intake/Refill Structure

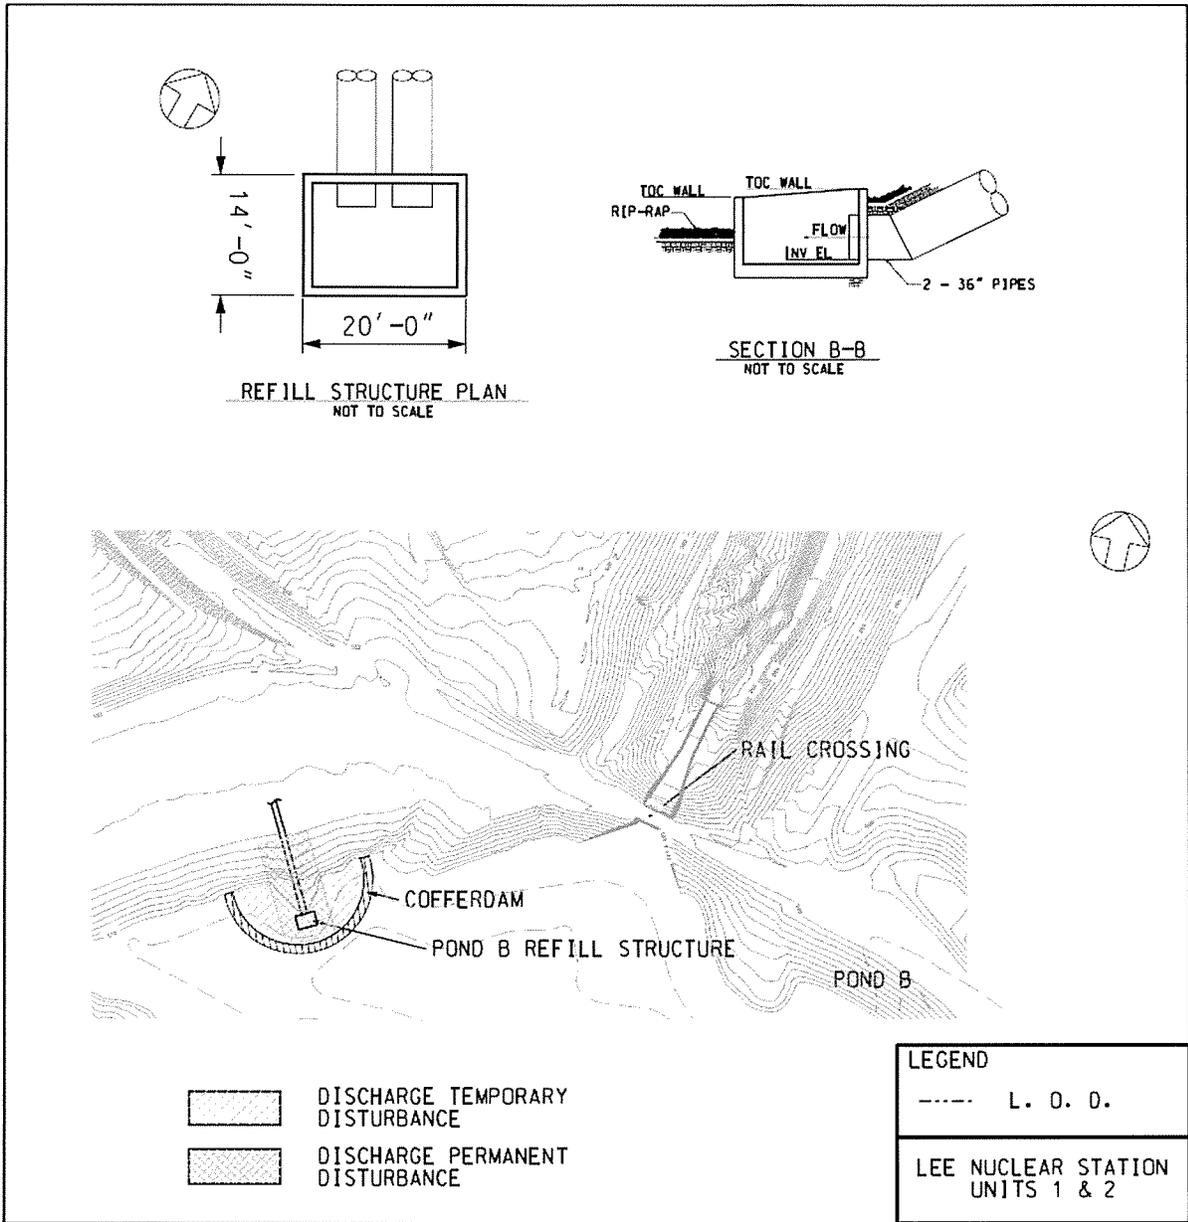
Pond B Refill Structure Location Plan

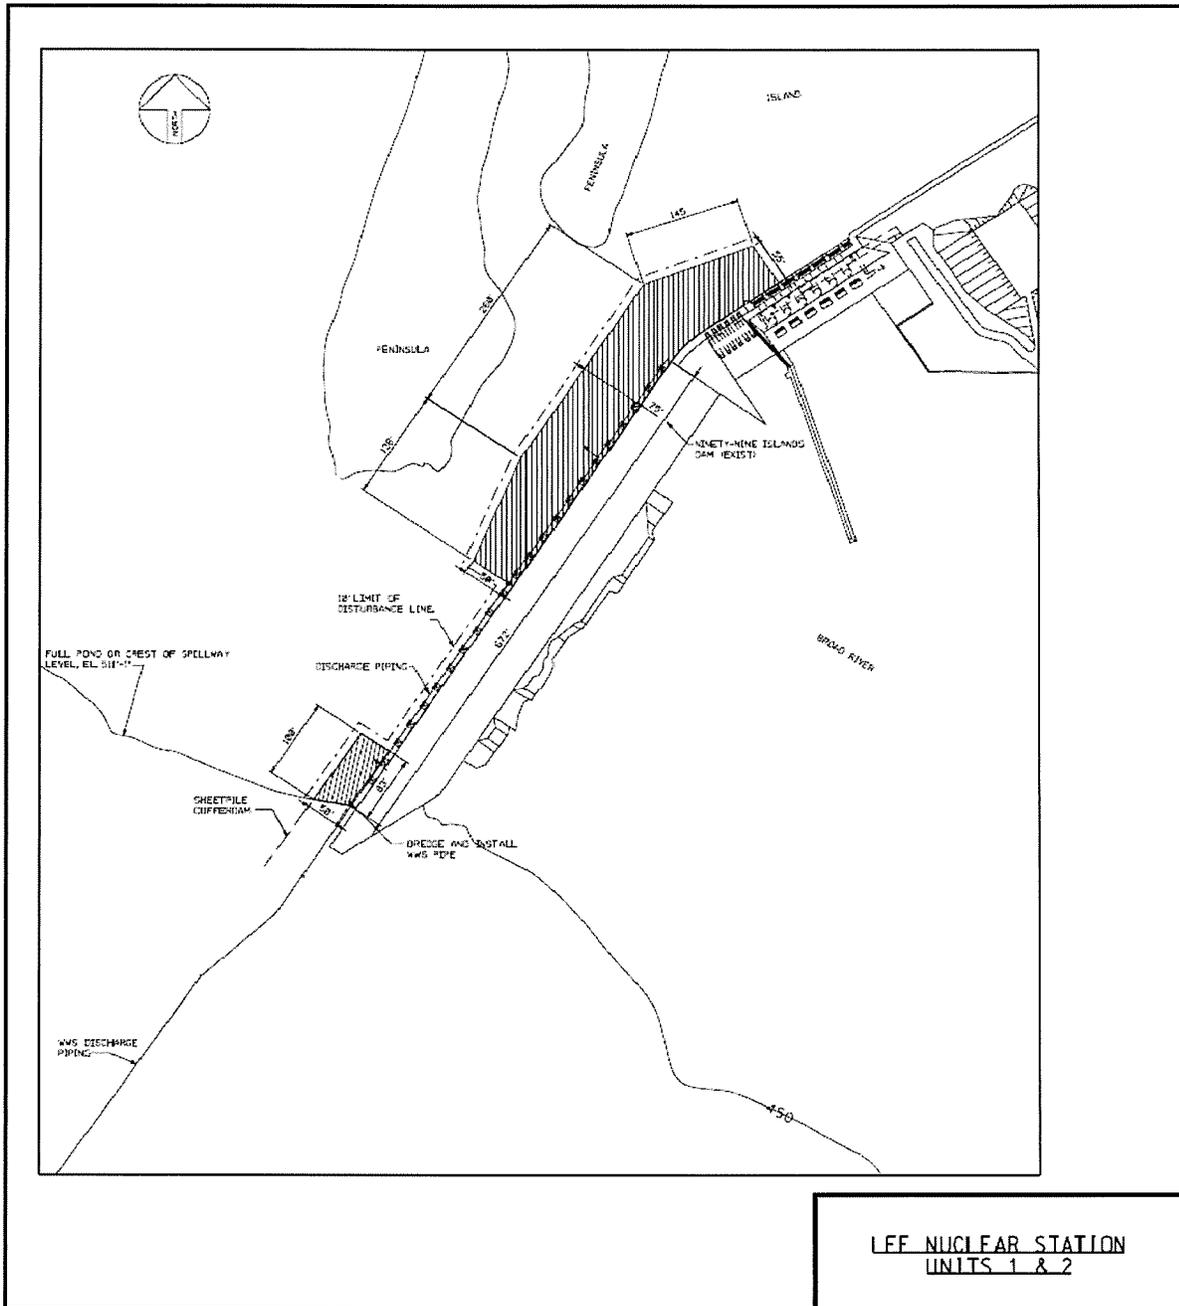
Waste Water System Discharge Diffuser Pipe Location Plan

Waste Water System Diffuser Pipe

Ninety-Nine Islands Dam forebay to be dredged to permit the installation of the diffuser pipe:

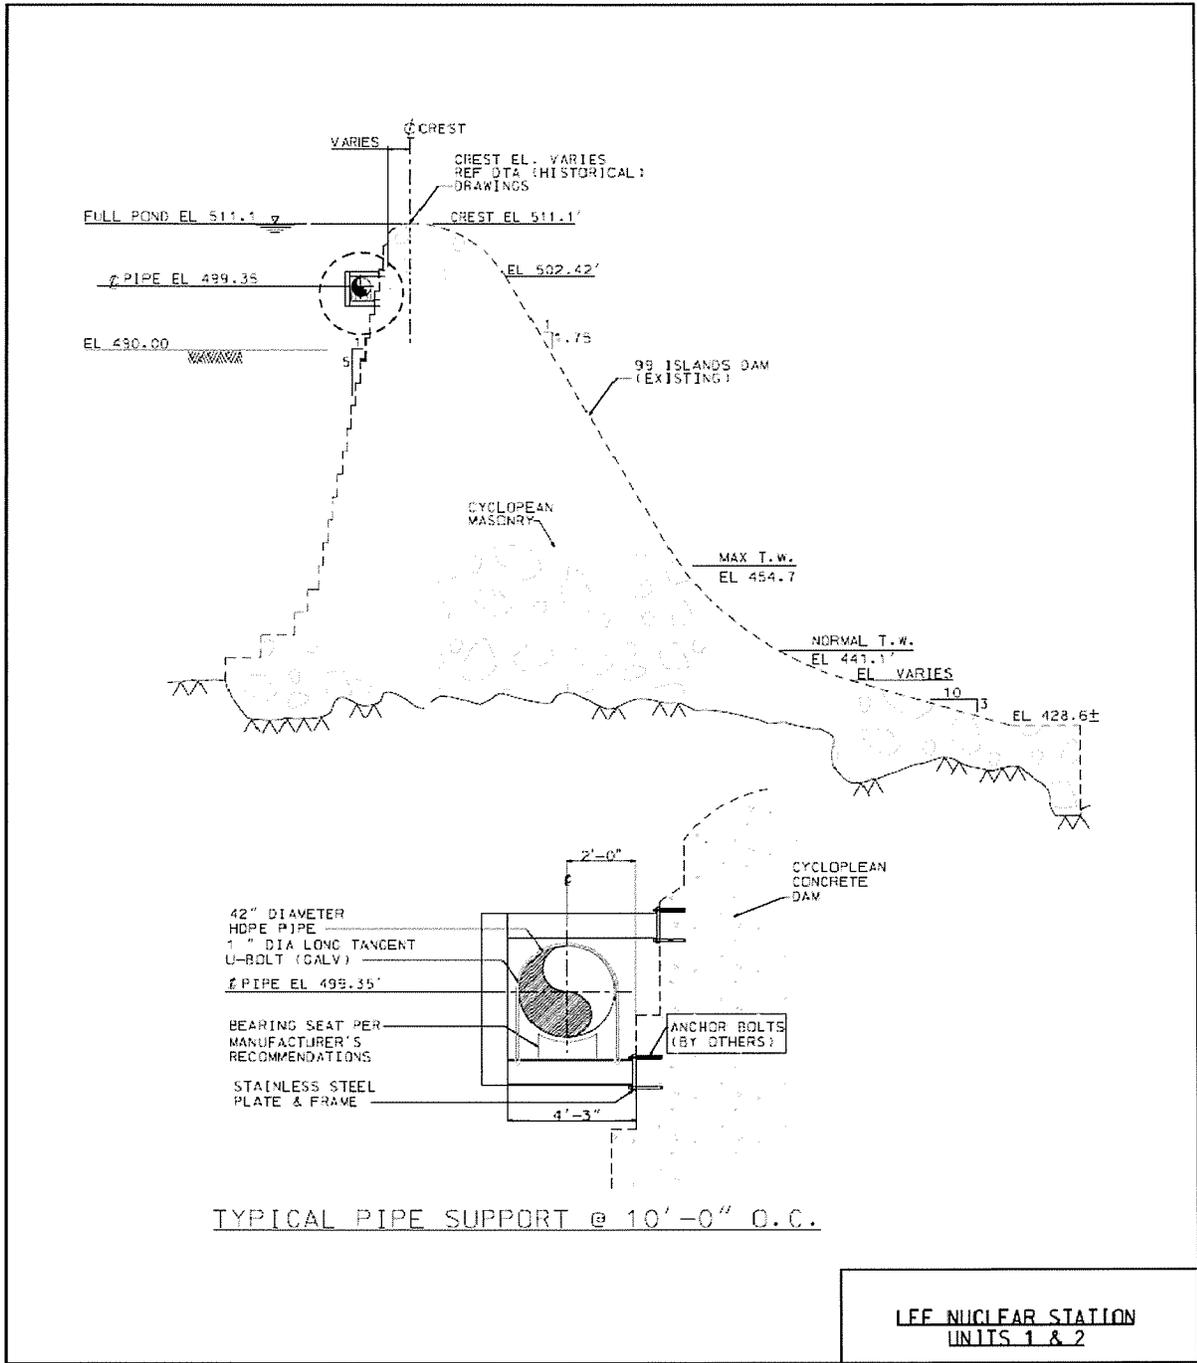
Waste Water System Discharge Diffuser Pipe Support Details

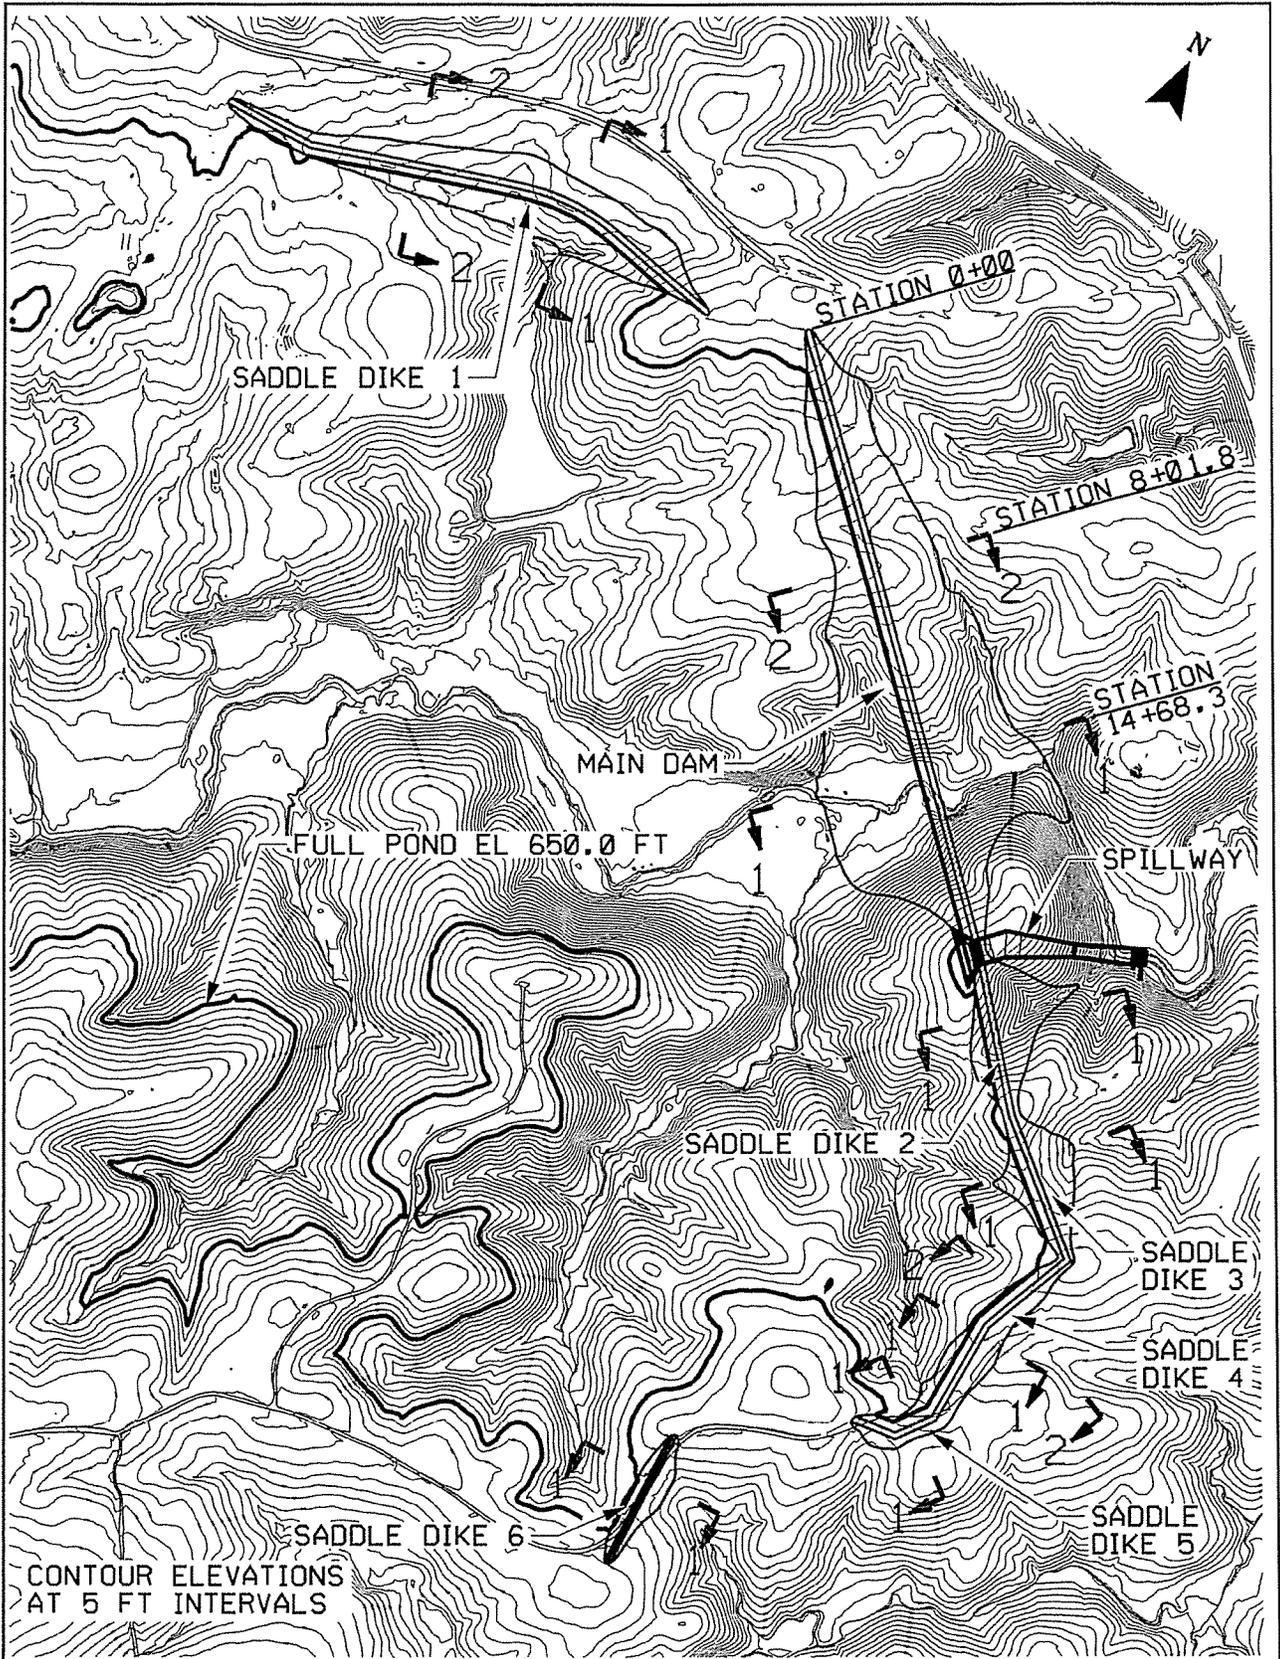
CONTOUR ELEVATIONS
AT 5 FT INTERVALS

POND C
PLAN

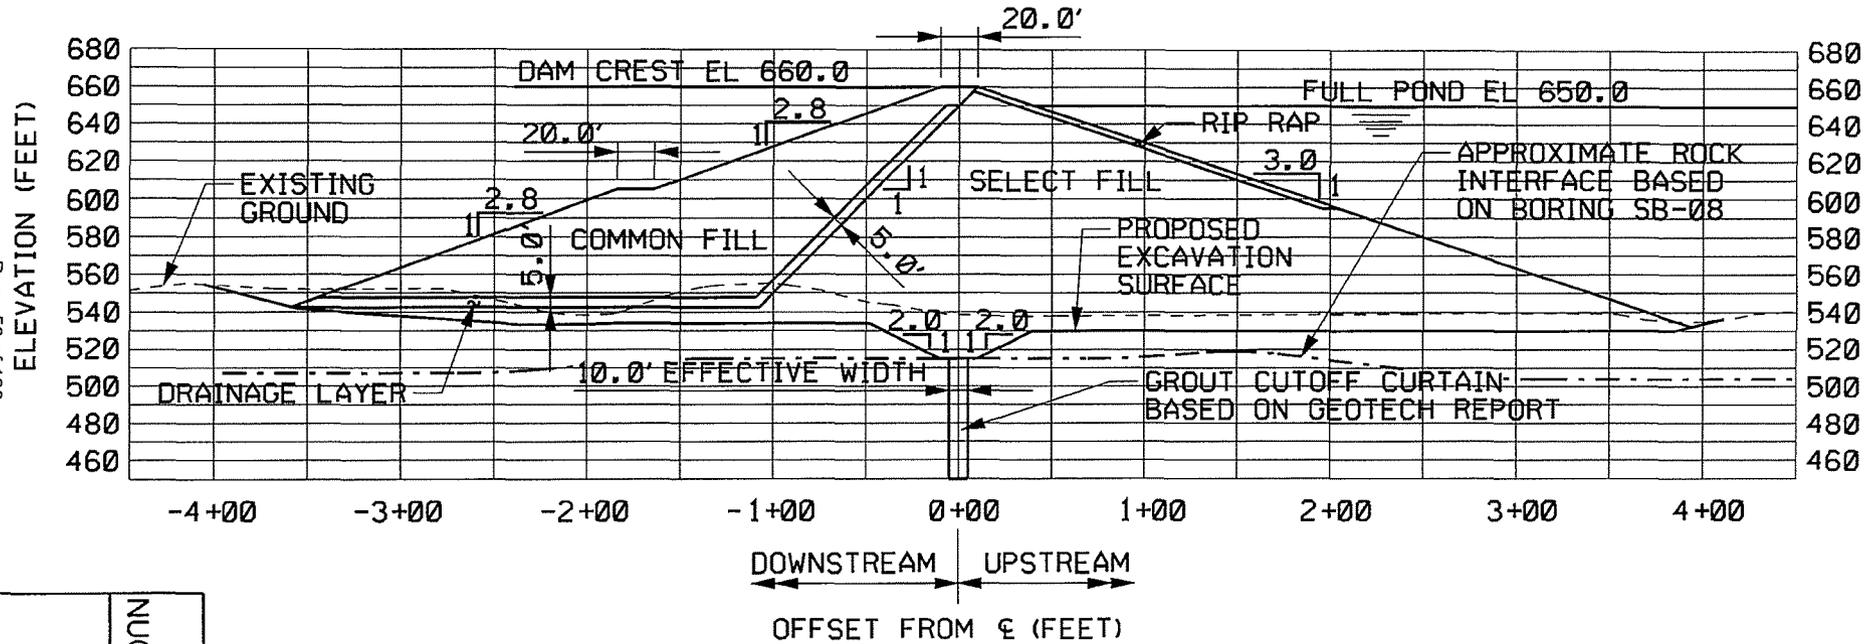
MAKE-UP POND C
 MAIN DAM
 SECTION

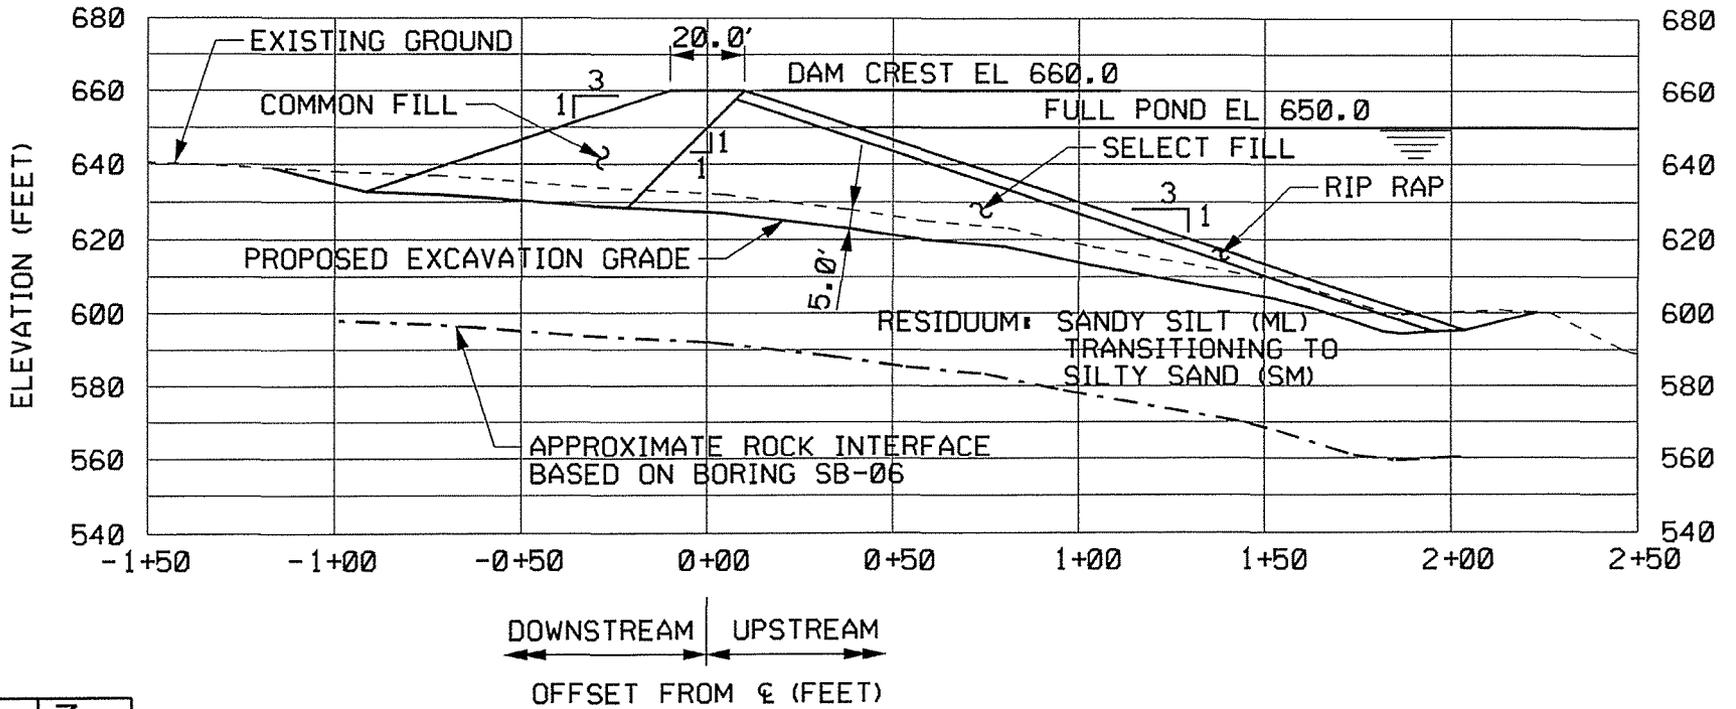
POND C
SADDLE DIKE 1
SECTION

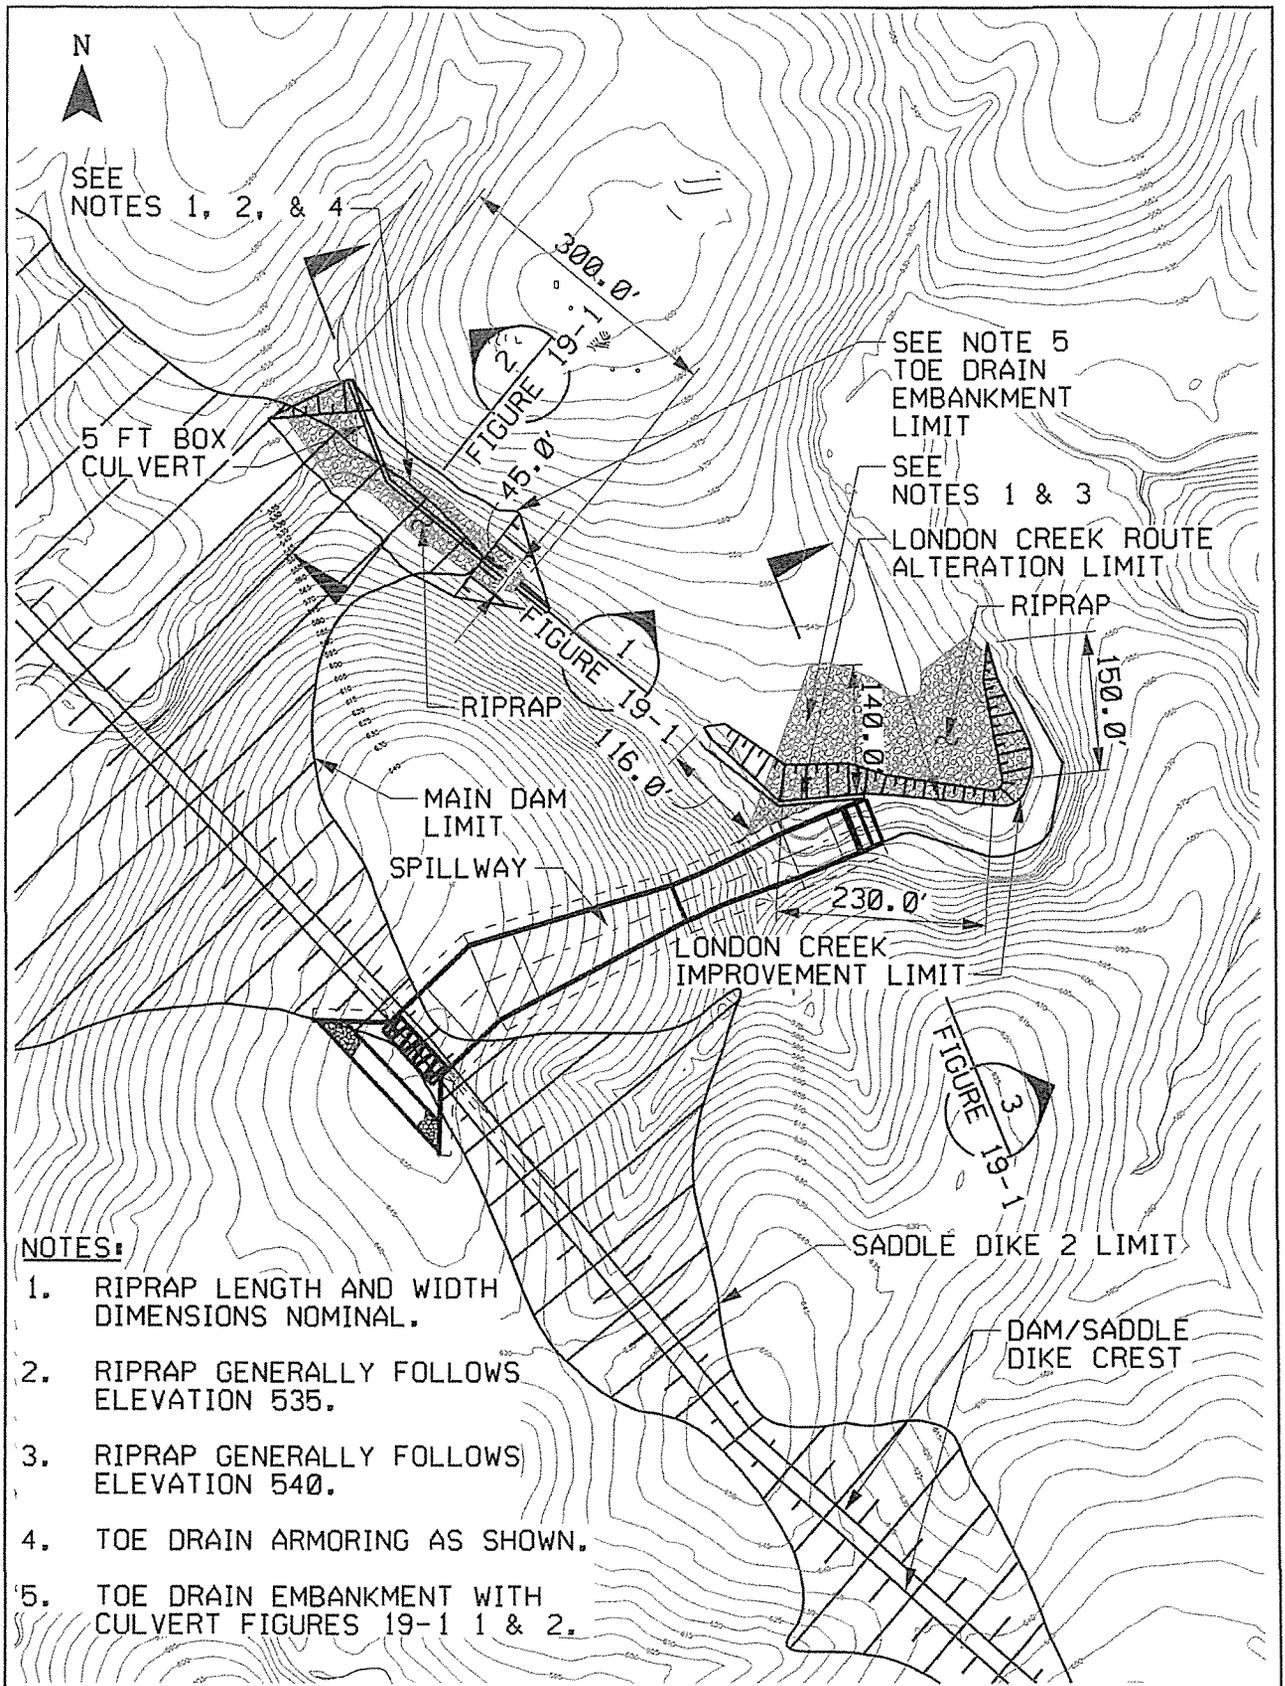
1. RIPRAP LENGTH AND WIDTH DIMENSIONS NOMINAL.
2. RIPRAP GENERALLY FOLLOWS ELEVATION 535.
3. RIPRAP GENERALLY FOLLOWS ELEVATION 540.
4. TOE DRAIN ARMORING AS SHOWN.
5. TOE DRAIN EMBANKMENT WITH CULVERT FIGURES 19-1 1 & 2.

POND C - SPILLWAY
RIPRAP
PLAN

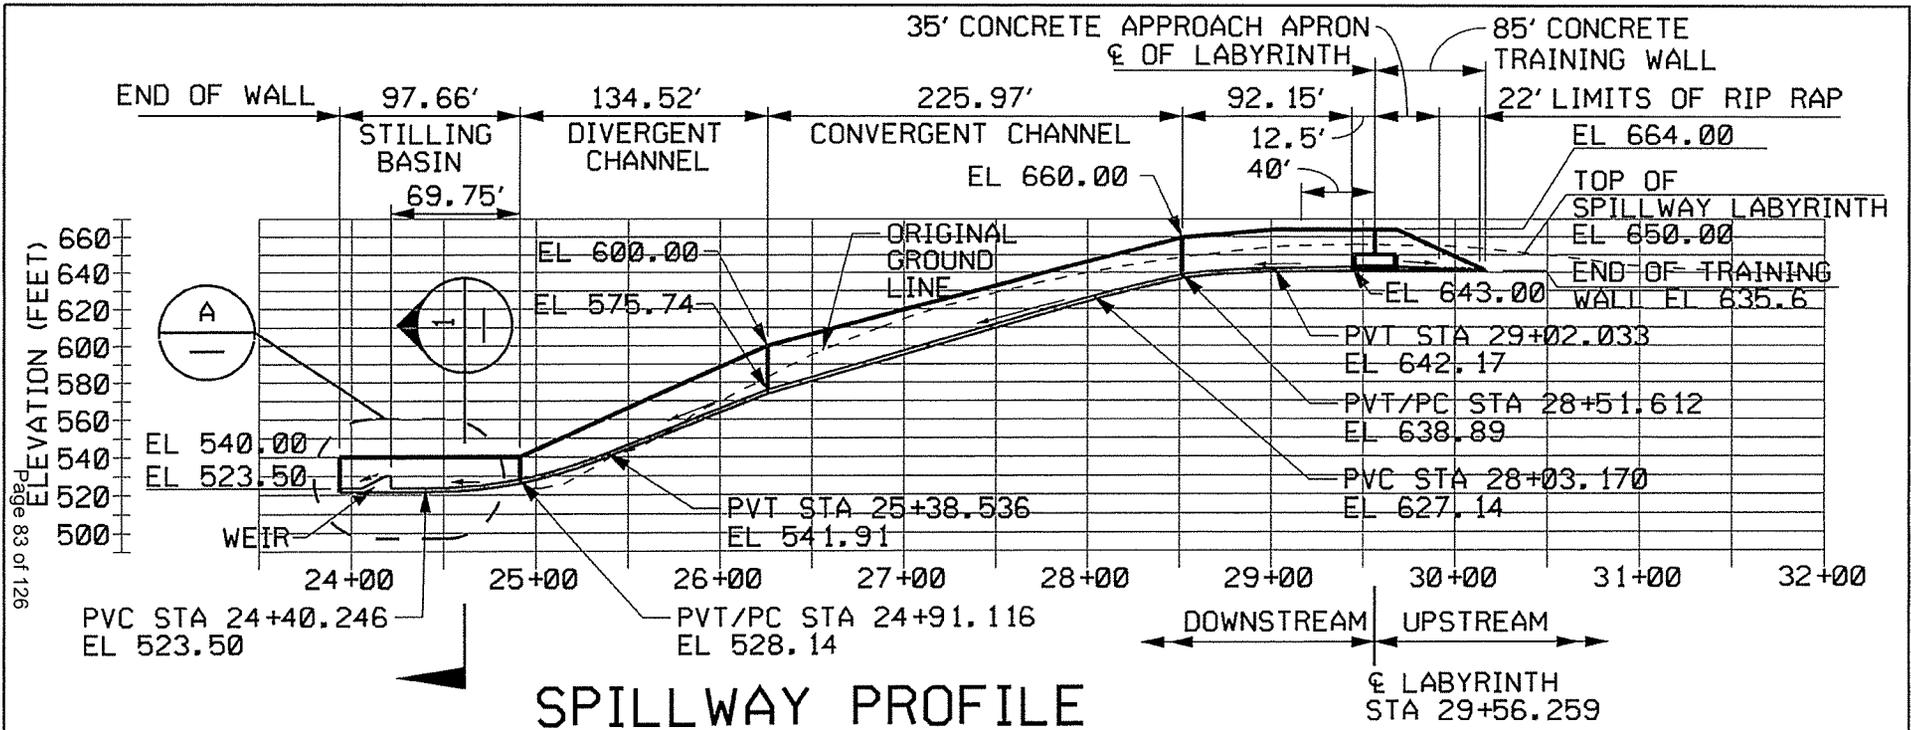
SPILLWAY PROFILE

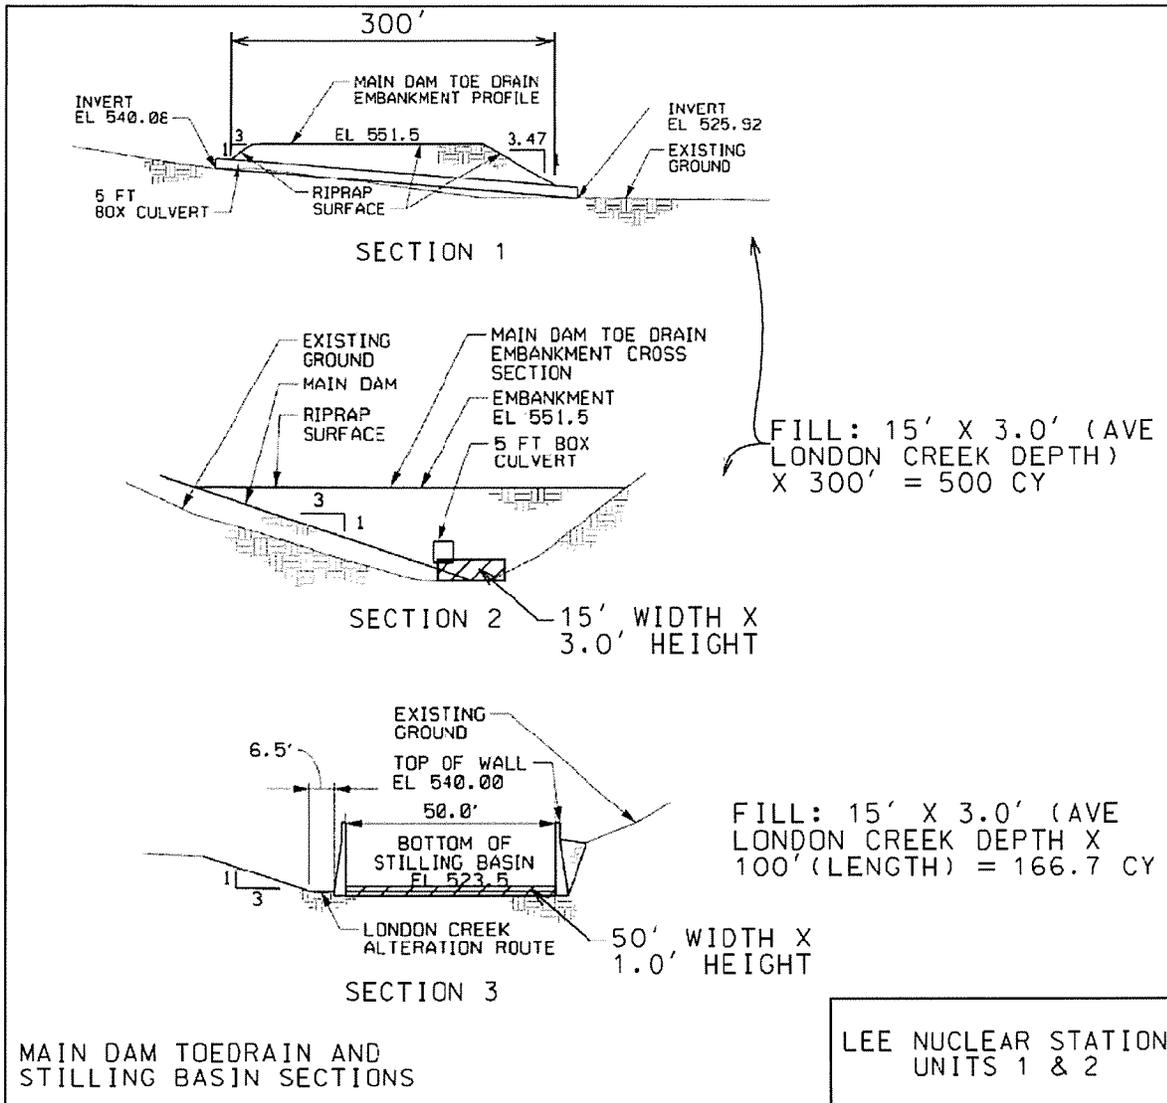
Pond C Main Dam Spillway, Stilling Basin and Toe Culvert Sections
