Project: William States Lee III Nuclear Station CHEROKEE COUNTY, SOUTH CAROLINA		
Title: KEY MAP		
Drawn By: Atkins	Scale: As Shown	KEY MAP
Job No. 100008697	Date: 11/9/2011

Project: William States Lee III Nuclear Station CHEROKEE COUNTY, SOUTH CAROLINA		
Title: PERMIT AREA COMPONENT "D" OFFSITE TRANSMISSION LINE (WEST CORRIDOR)		
Drawn By: Atkins	Scale: As Shown	SHEET D30
Job No. 100008697	Date: 11/9/2011

Page
PERMIT AREA COMPONENT A	
RIVER INTAKE STRUCTURE	1
SEDIMENTATION POND A INTAKE STRUCTURE	9
SEDIMENTATION POND A REFILL STRUCTURE.....	19
DROUGHT CONTINGENCY POND B INTAKE/REFILL STRUCTURE	29
DROUGHT CONTINGENCY POND B REFILL STRUCTURE	39
DISCHARGE DIFFUSER PIPE	47
PERMIT AREA COMPONENT B	
DROUGHT CONTINGENCY POND C MAIN DAM, SADDLE DIKES, SPILLWAY AND LONDON CREEK	
CHANNEL IMPROVEMENTS	55
DROUGHT CONTINGENCY POND C TEMPORARY HAUL ROAD	89
SC 329 REALIGNMENT	93
LAKE CHEROKEE DAM IMPROVEMENTS	111
PERMIT AREA COMPONENT C	
LONDON CREEK CULVERT REPLACEMENT	119

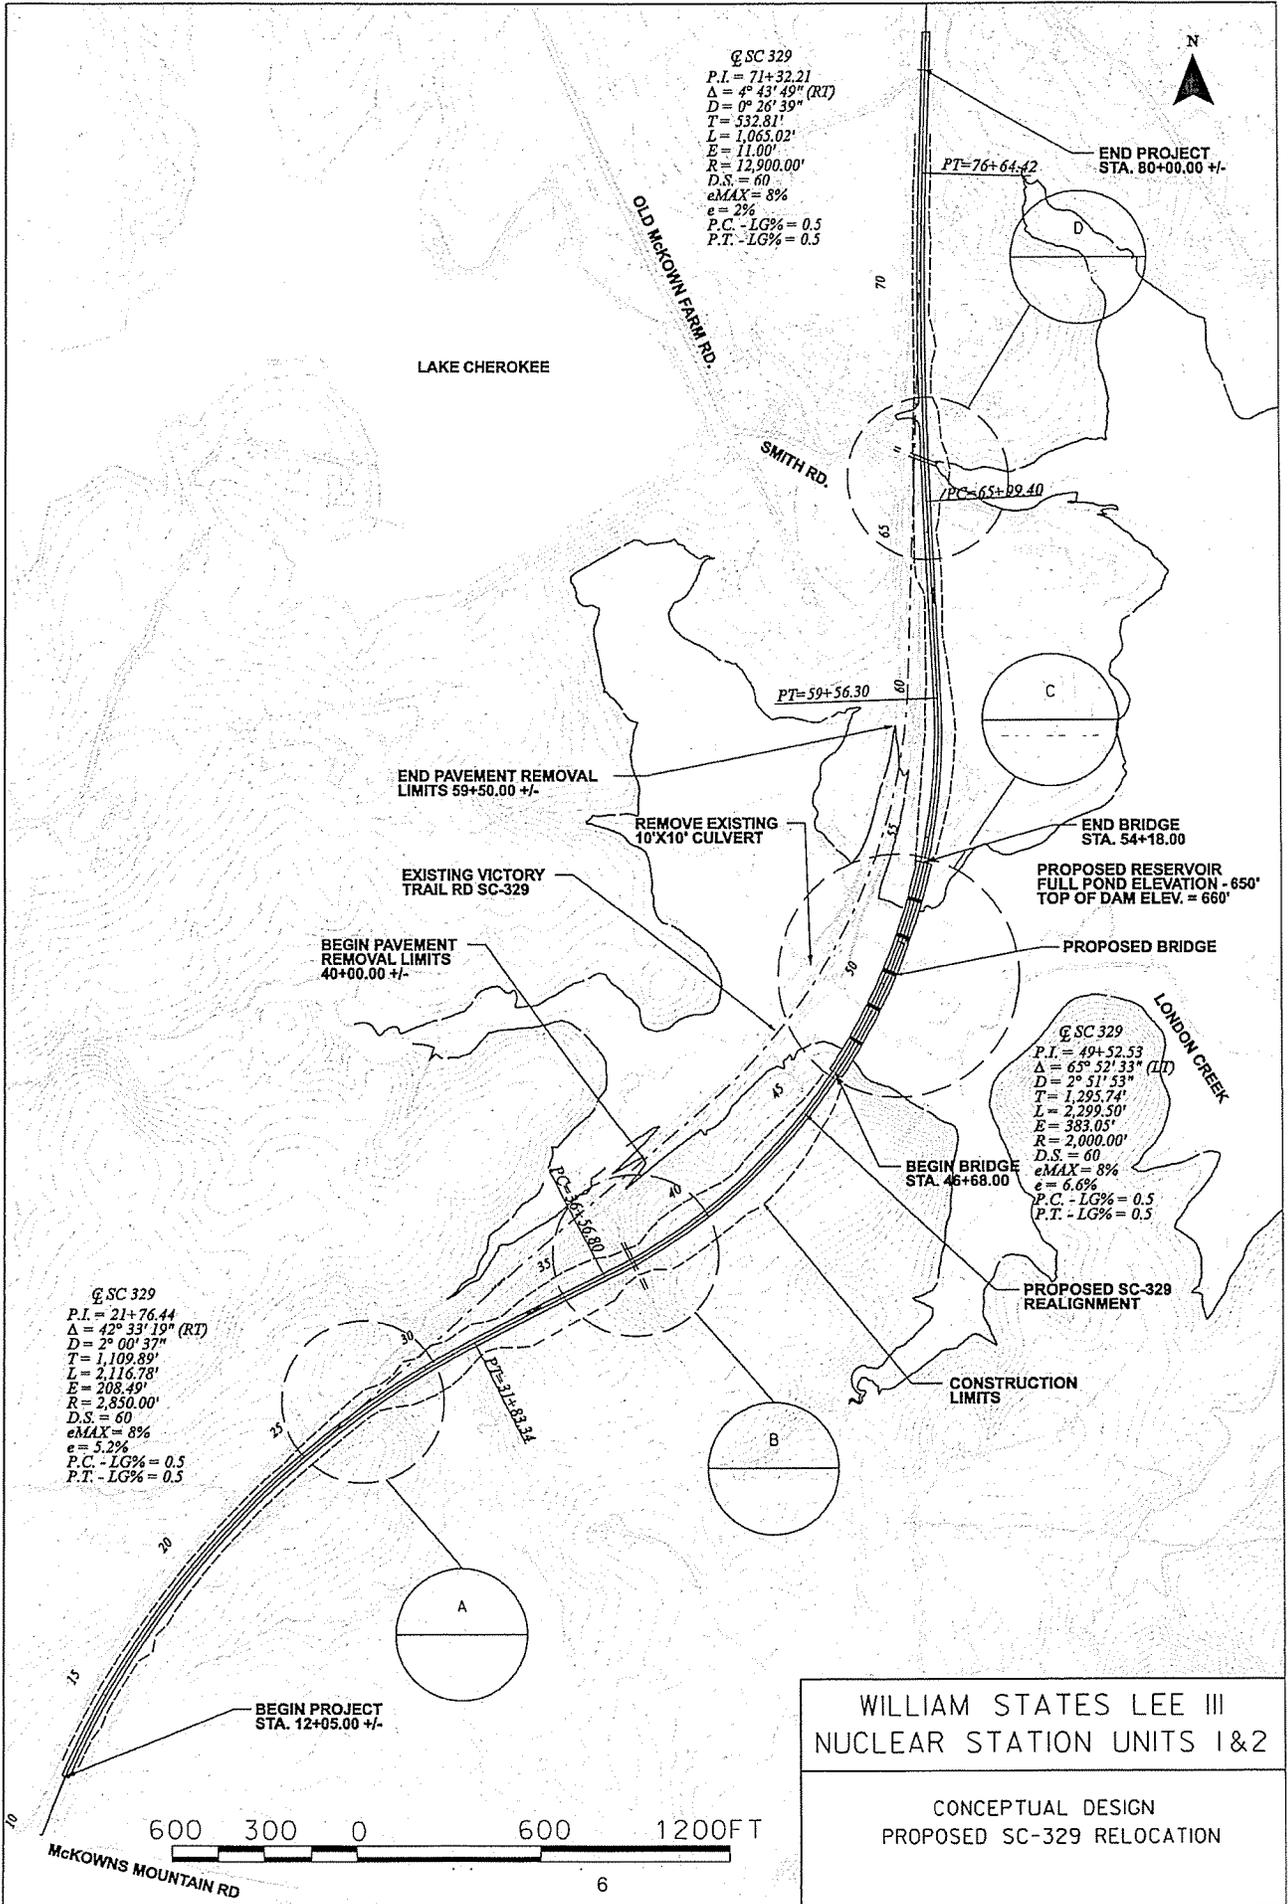
SC 329 REALIGNMENT

@ SC 329
 P.I. = 71+32.21
 $\Delta = 4^\circ 45' 49''$ (RT)
 D = 9' 26' 39"
 T = 332.81'
 L = 1,065.02'
 E = 11.00'
 R = 12,900.00'
 D.S. = 60
 eMAX = 8%
 e = 2%
 P.C. - LG% = 0.5
 P.T. - LG% = 0.5

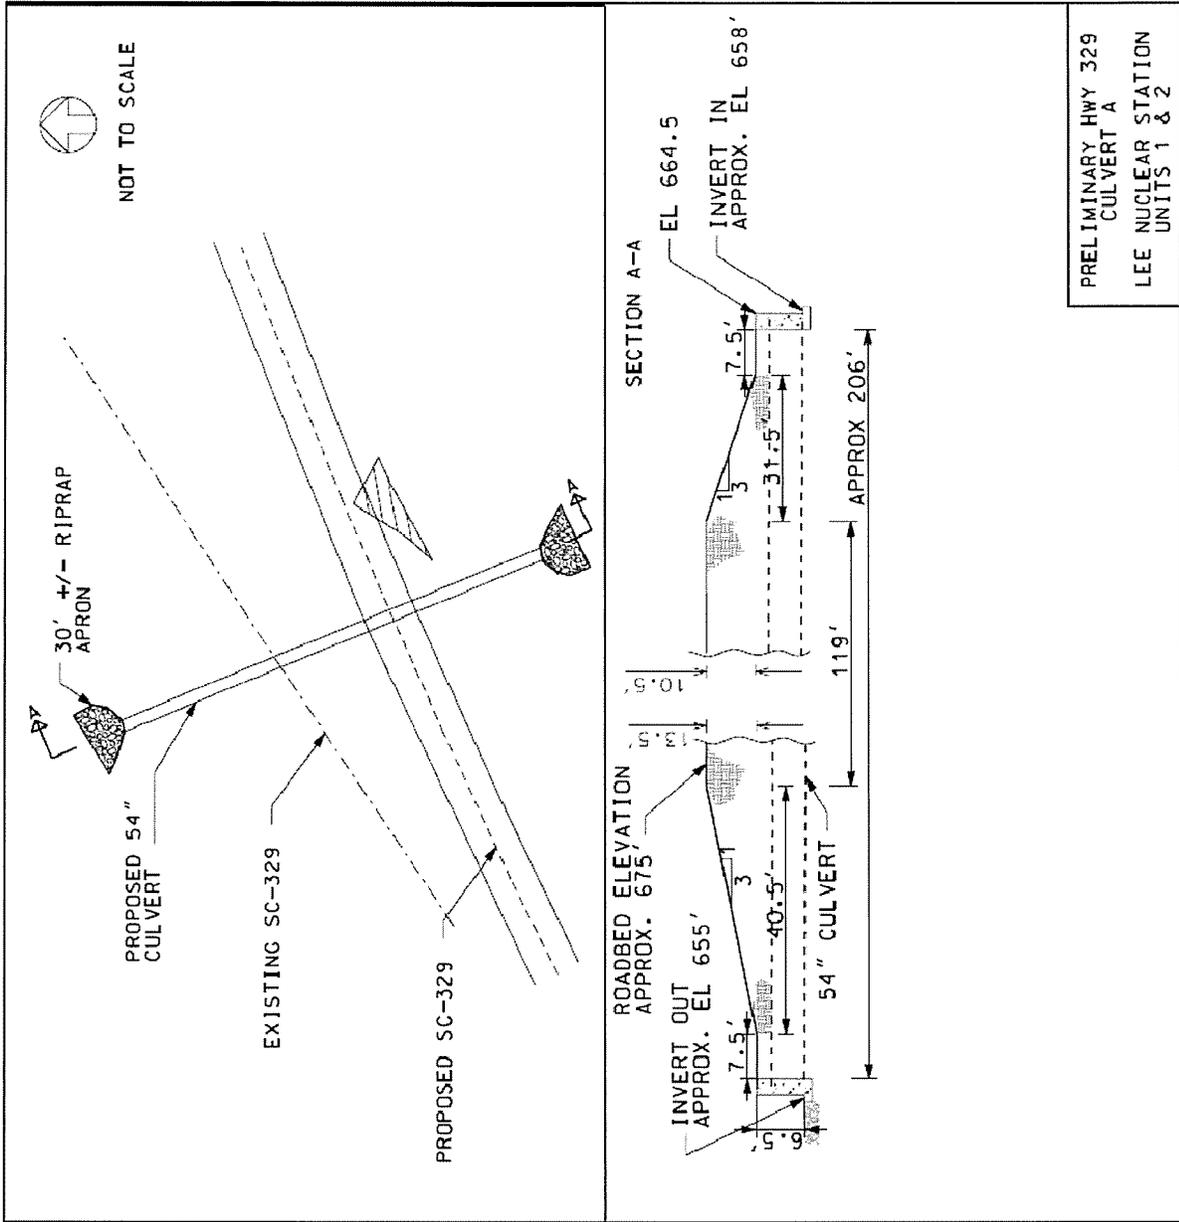
Pond C Highway 329 Culvert A Plan and Section

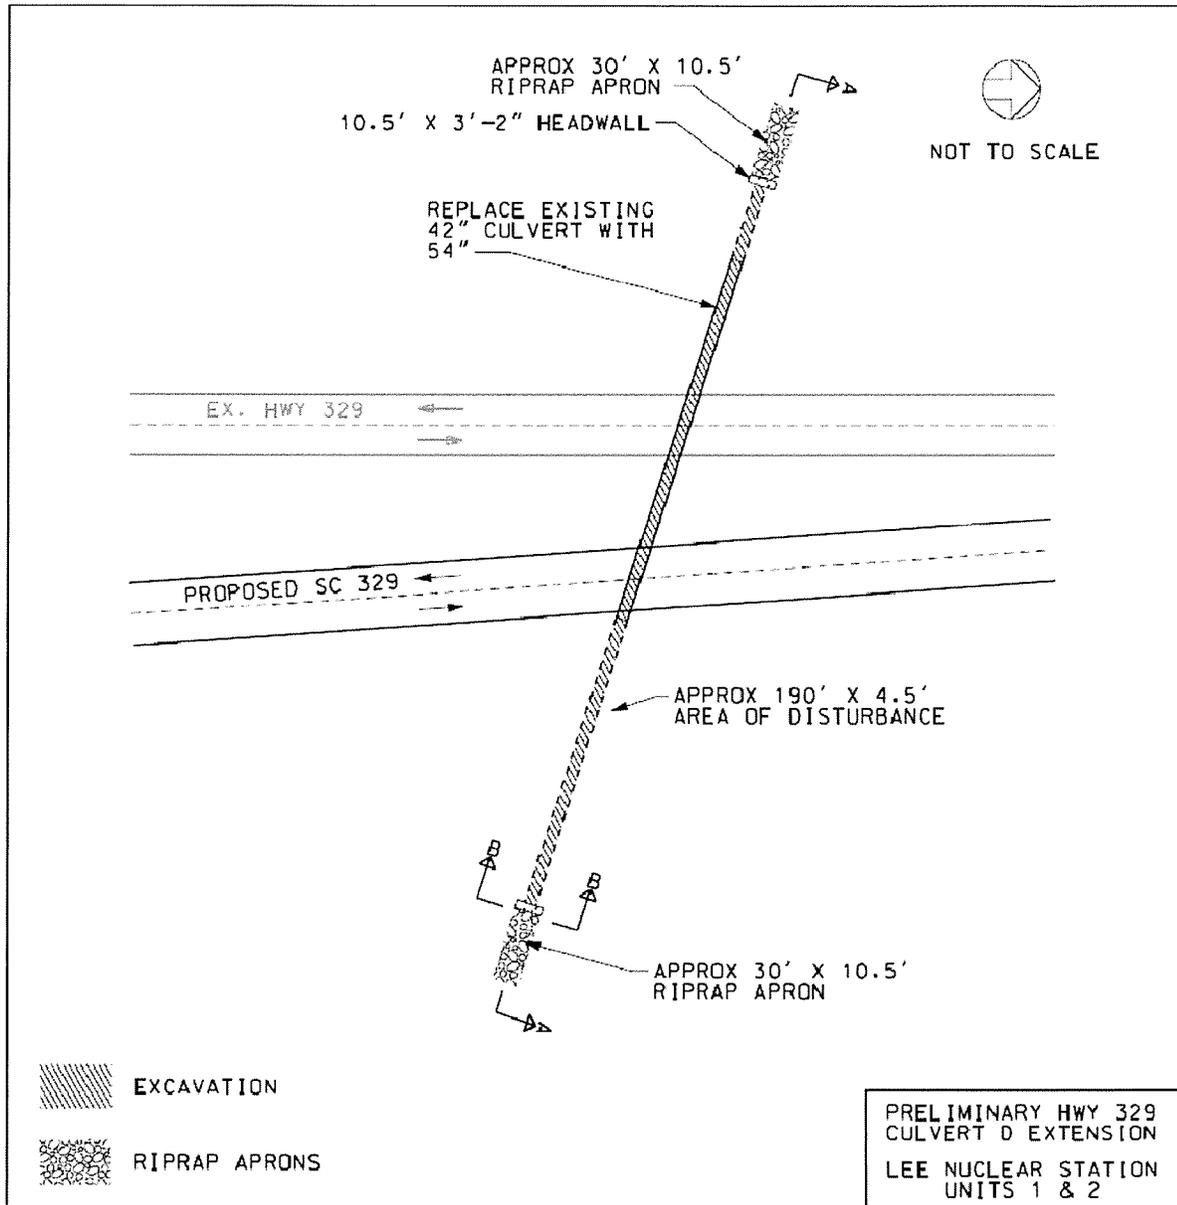
Pond C Highway 329 Culvert D Plan

Pond C Highway 329 Culvert D Sections

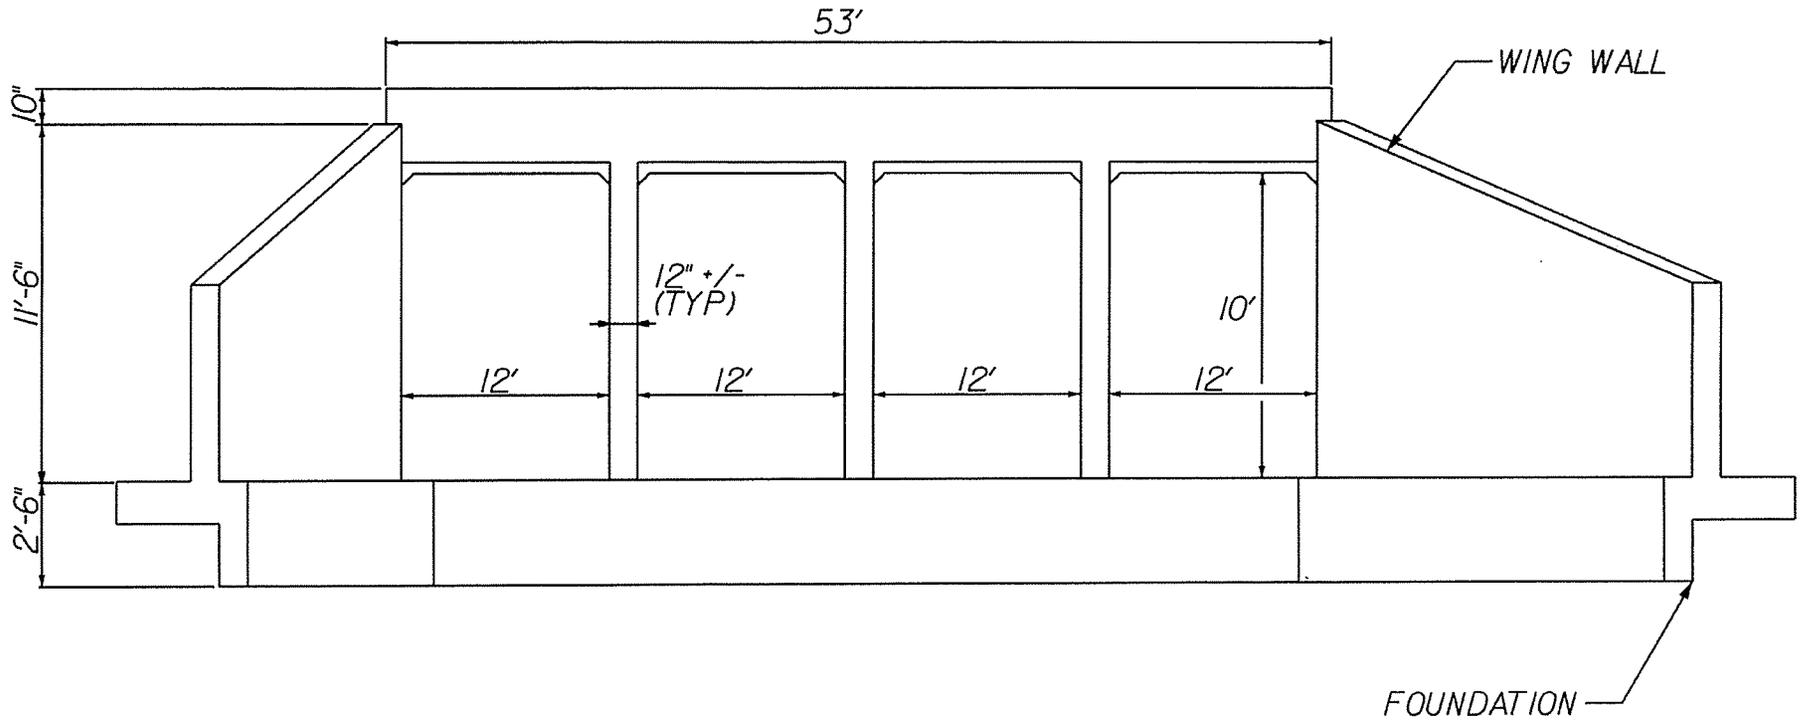
SECTION
SCALE: NTS

CONCEPTUAL DESIGN
CULVERT E
BOX CULVERT END ELEVATION

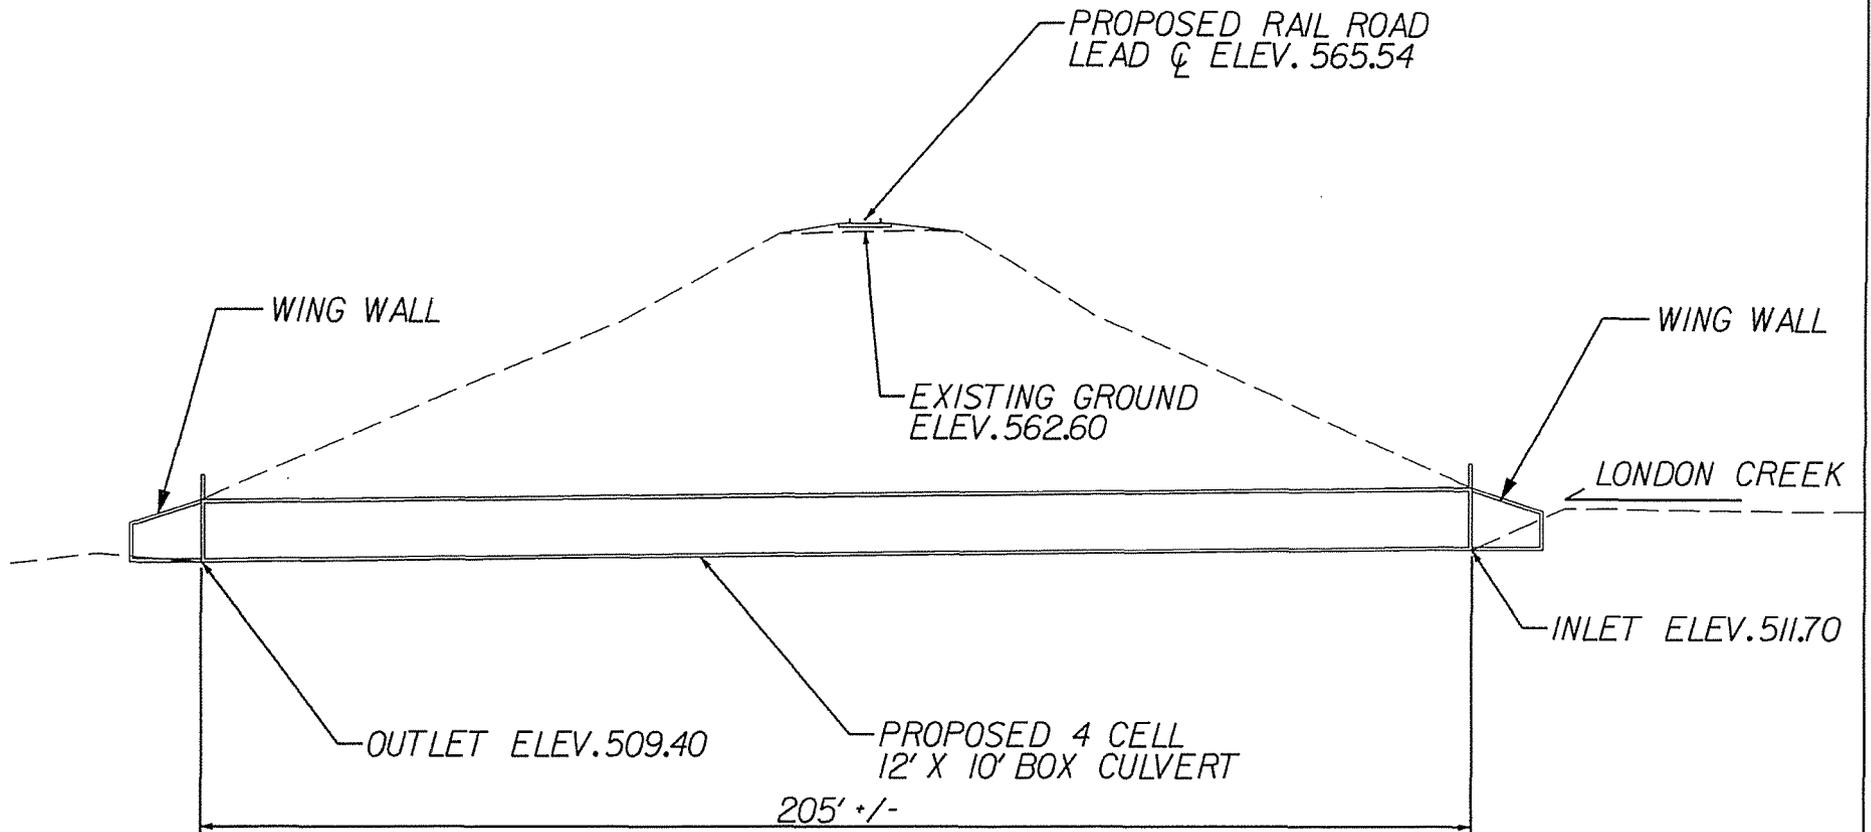
CULVERT SECTION
