- NOTES:**
1. SOUNDINGS ARE IN FEET AND TENTHS AND REFER TO MEAN LOW WATER.
  2. DATE OF CONDITION SURVEY: 7.8 JULY 2003

NAD 83	
CODE IDENT. NO.	DRAWING NO.
TS-0N	8952
SCALE: 1" = 200'	CONDITION SHEET 13 OF 24
PORT ROYAL HARBOR	CONDITION

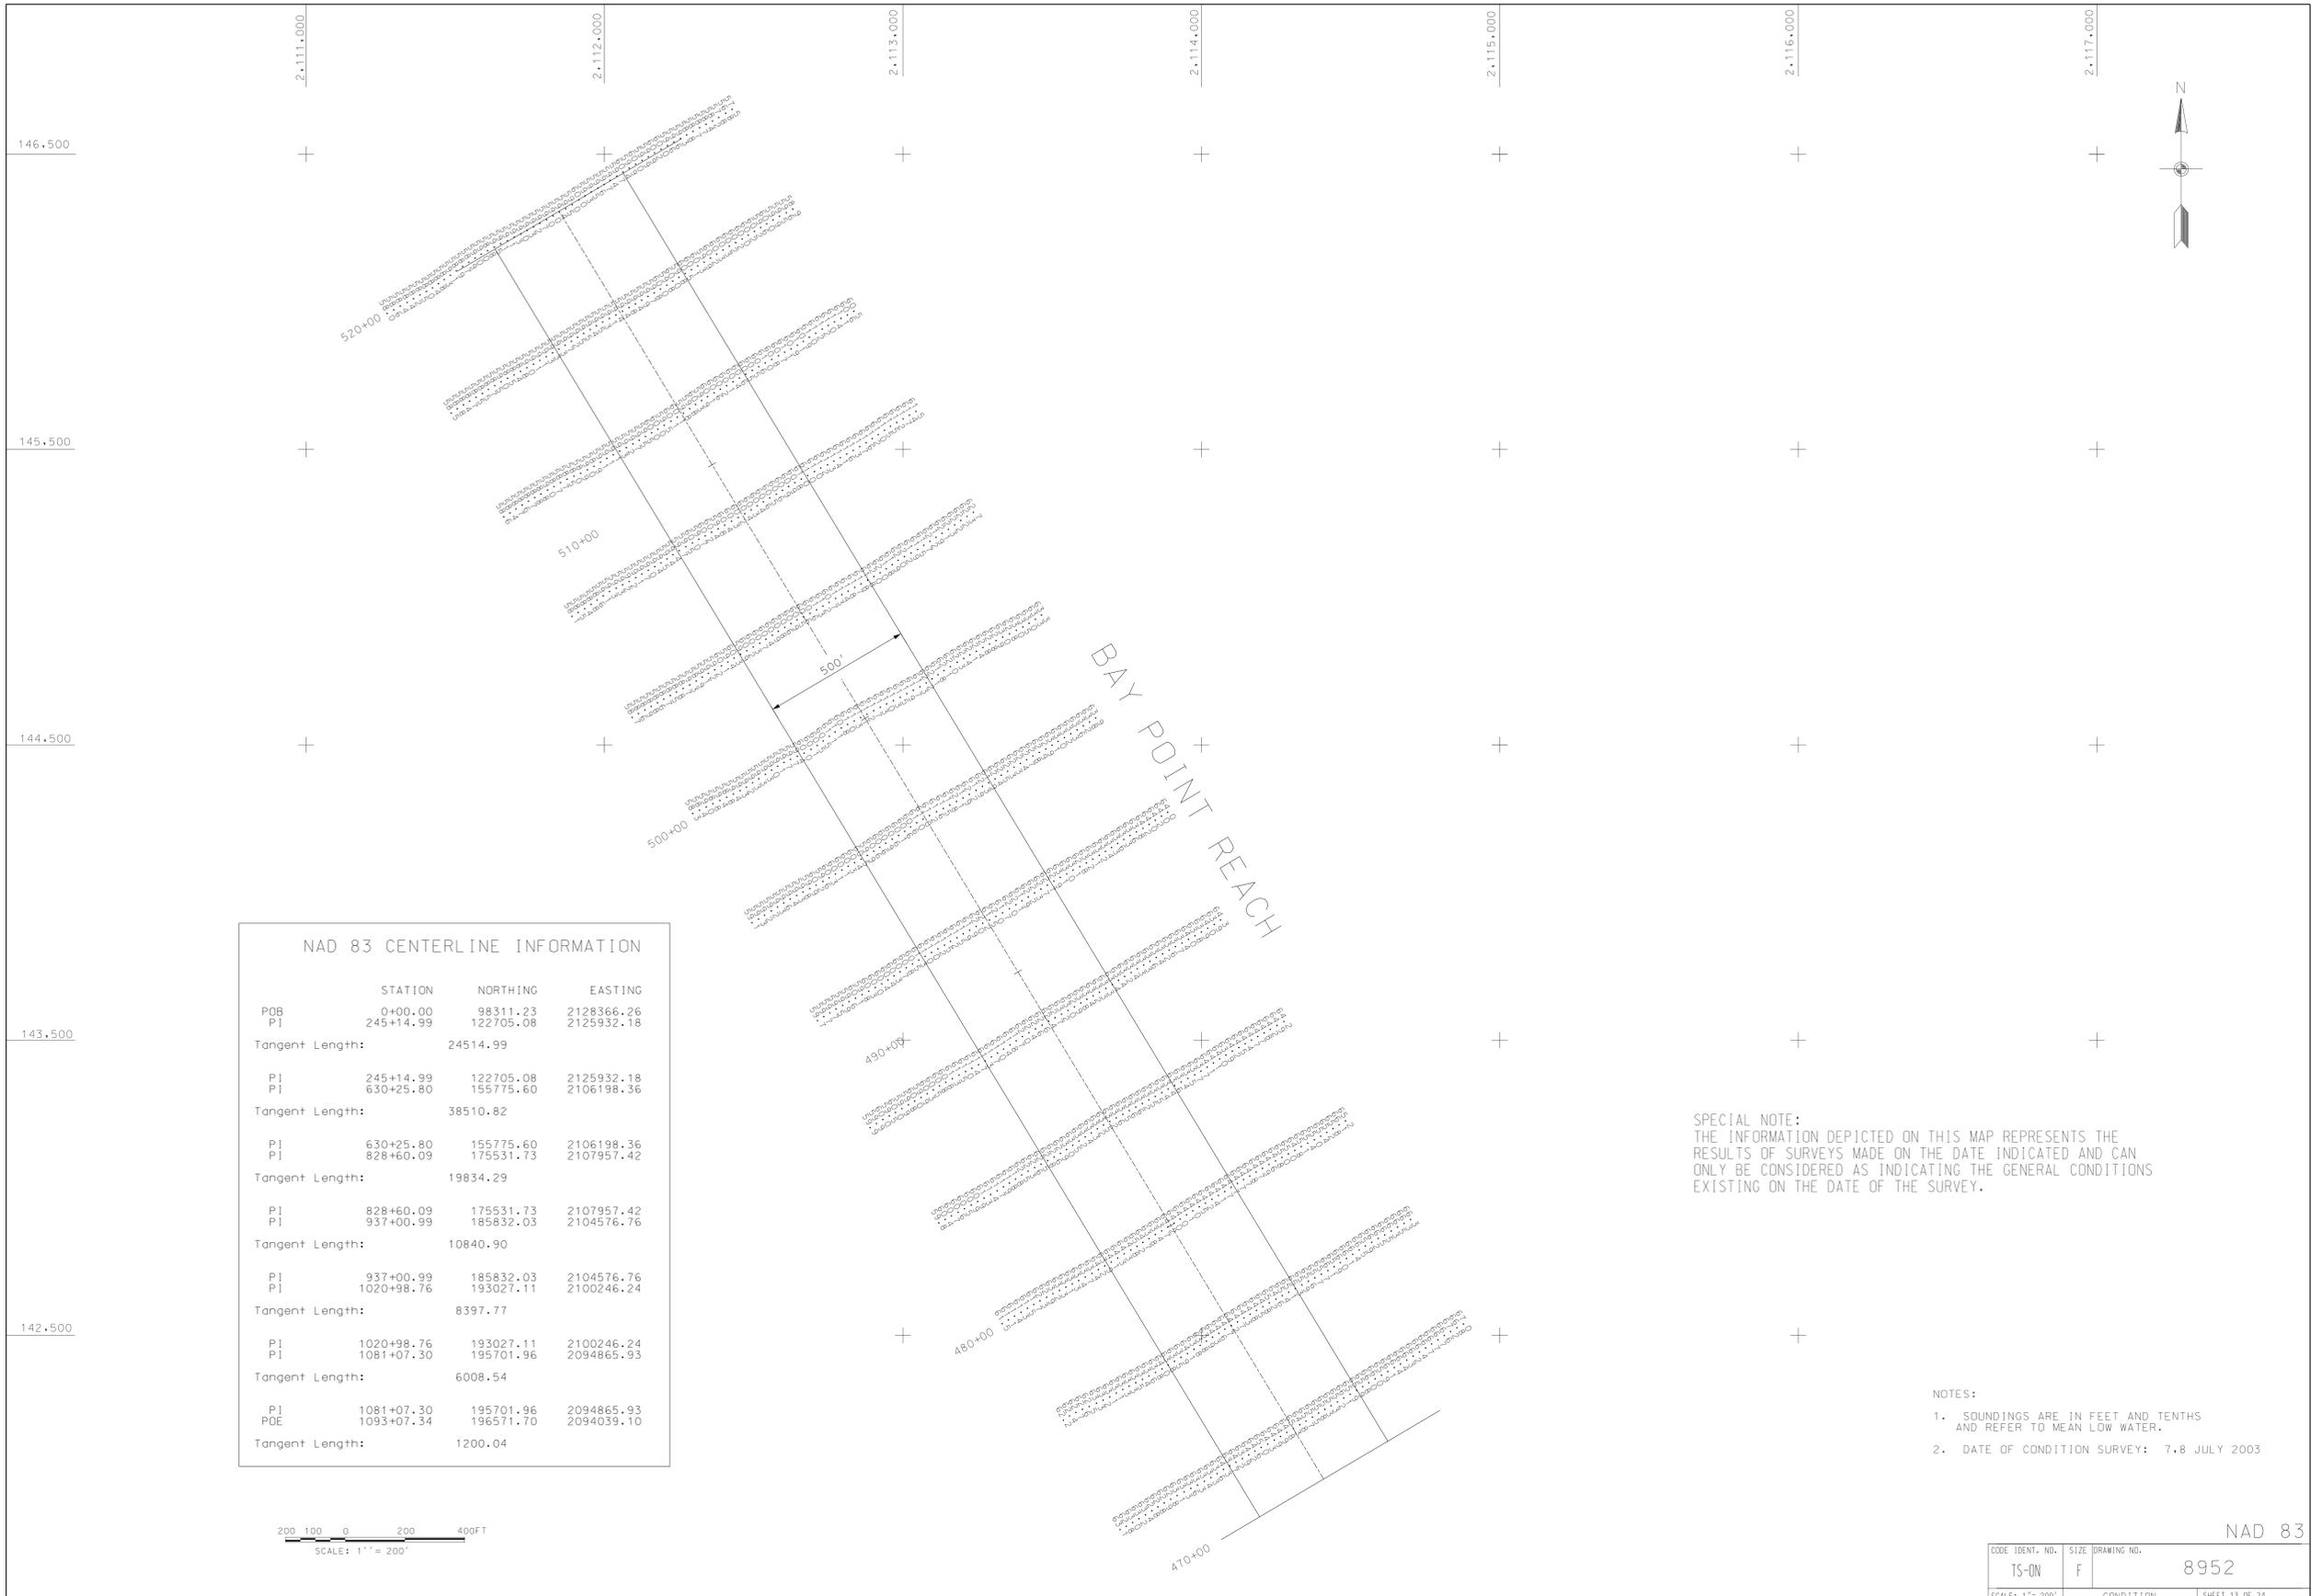
**SPECIAL NOTE:**  
 THE INFORMATION DEPICTED ON THIS MAP REPRESENTS THE RESULTS OF SURVEYS MADE ON THE DATE INDICATED AND CAN ONLY BE CONSIDERED AS INDICATING THE GENERAL CONDITIONS EXISTING ON THE DATE OF THE SURVEY.
