Charleston Entrance Channel

Condition Survey: September 2012

Survey Area:	Charleston Harbor Entrance Channel
Survey Date:	2012-09-27
Survey Crew:	USACE Survey Team
Survey File Name:	20120927_EC_SB_CS.xyz
Imagery/Background:	N/A
Mapped By:	Brewer

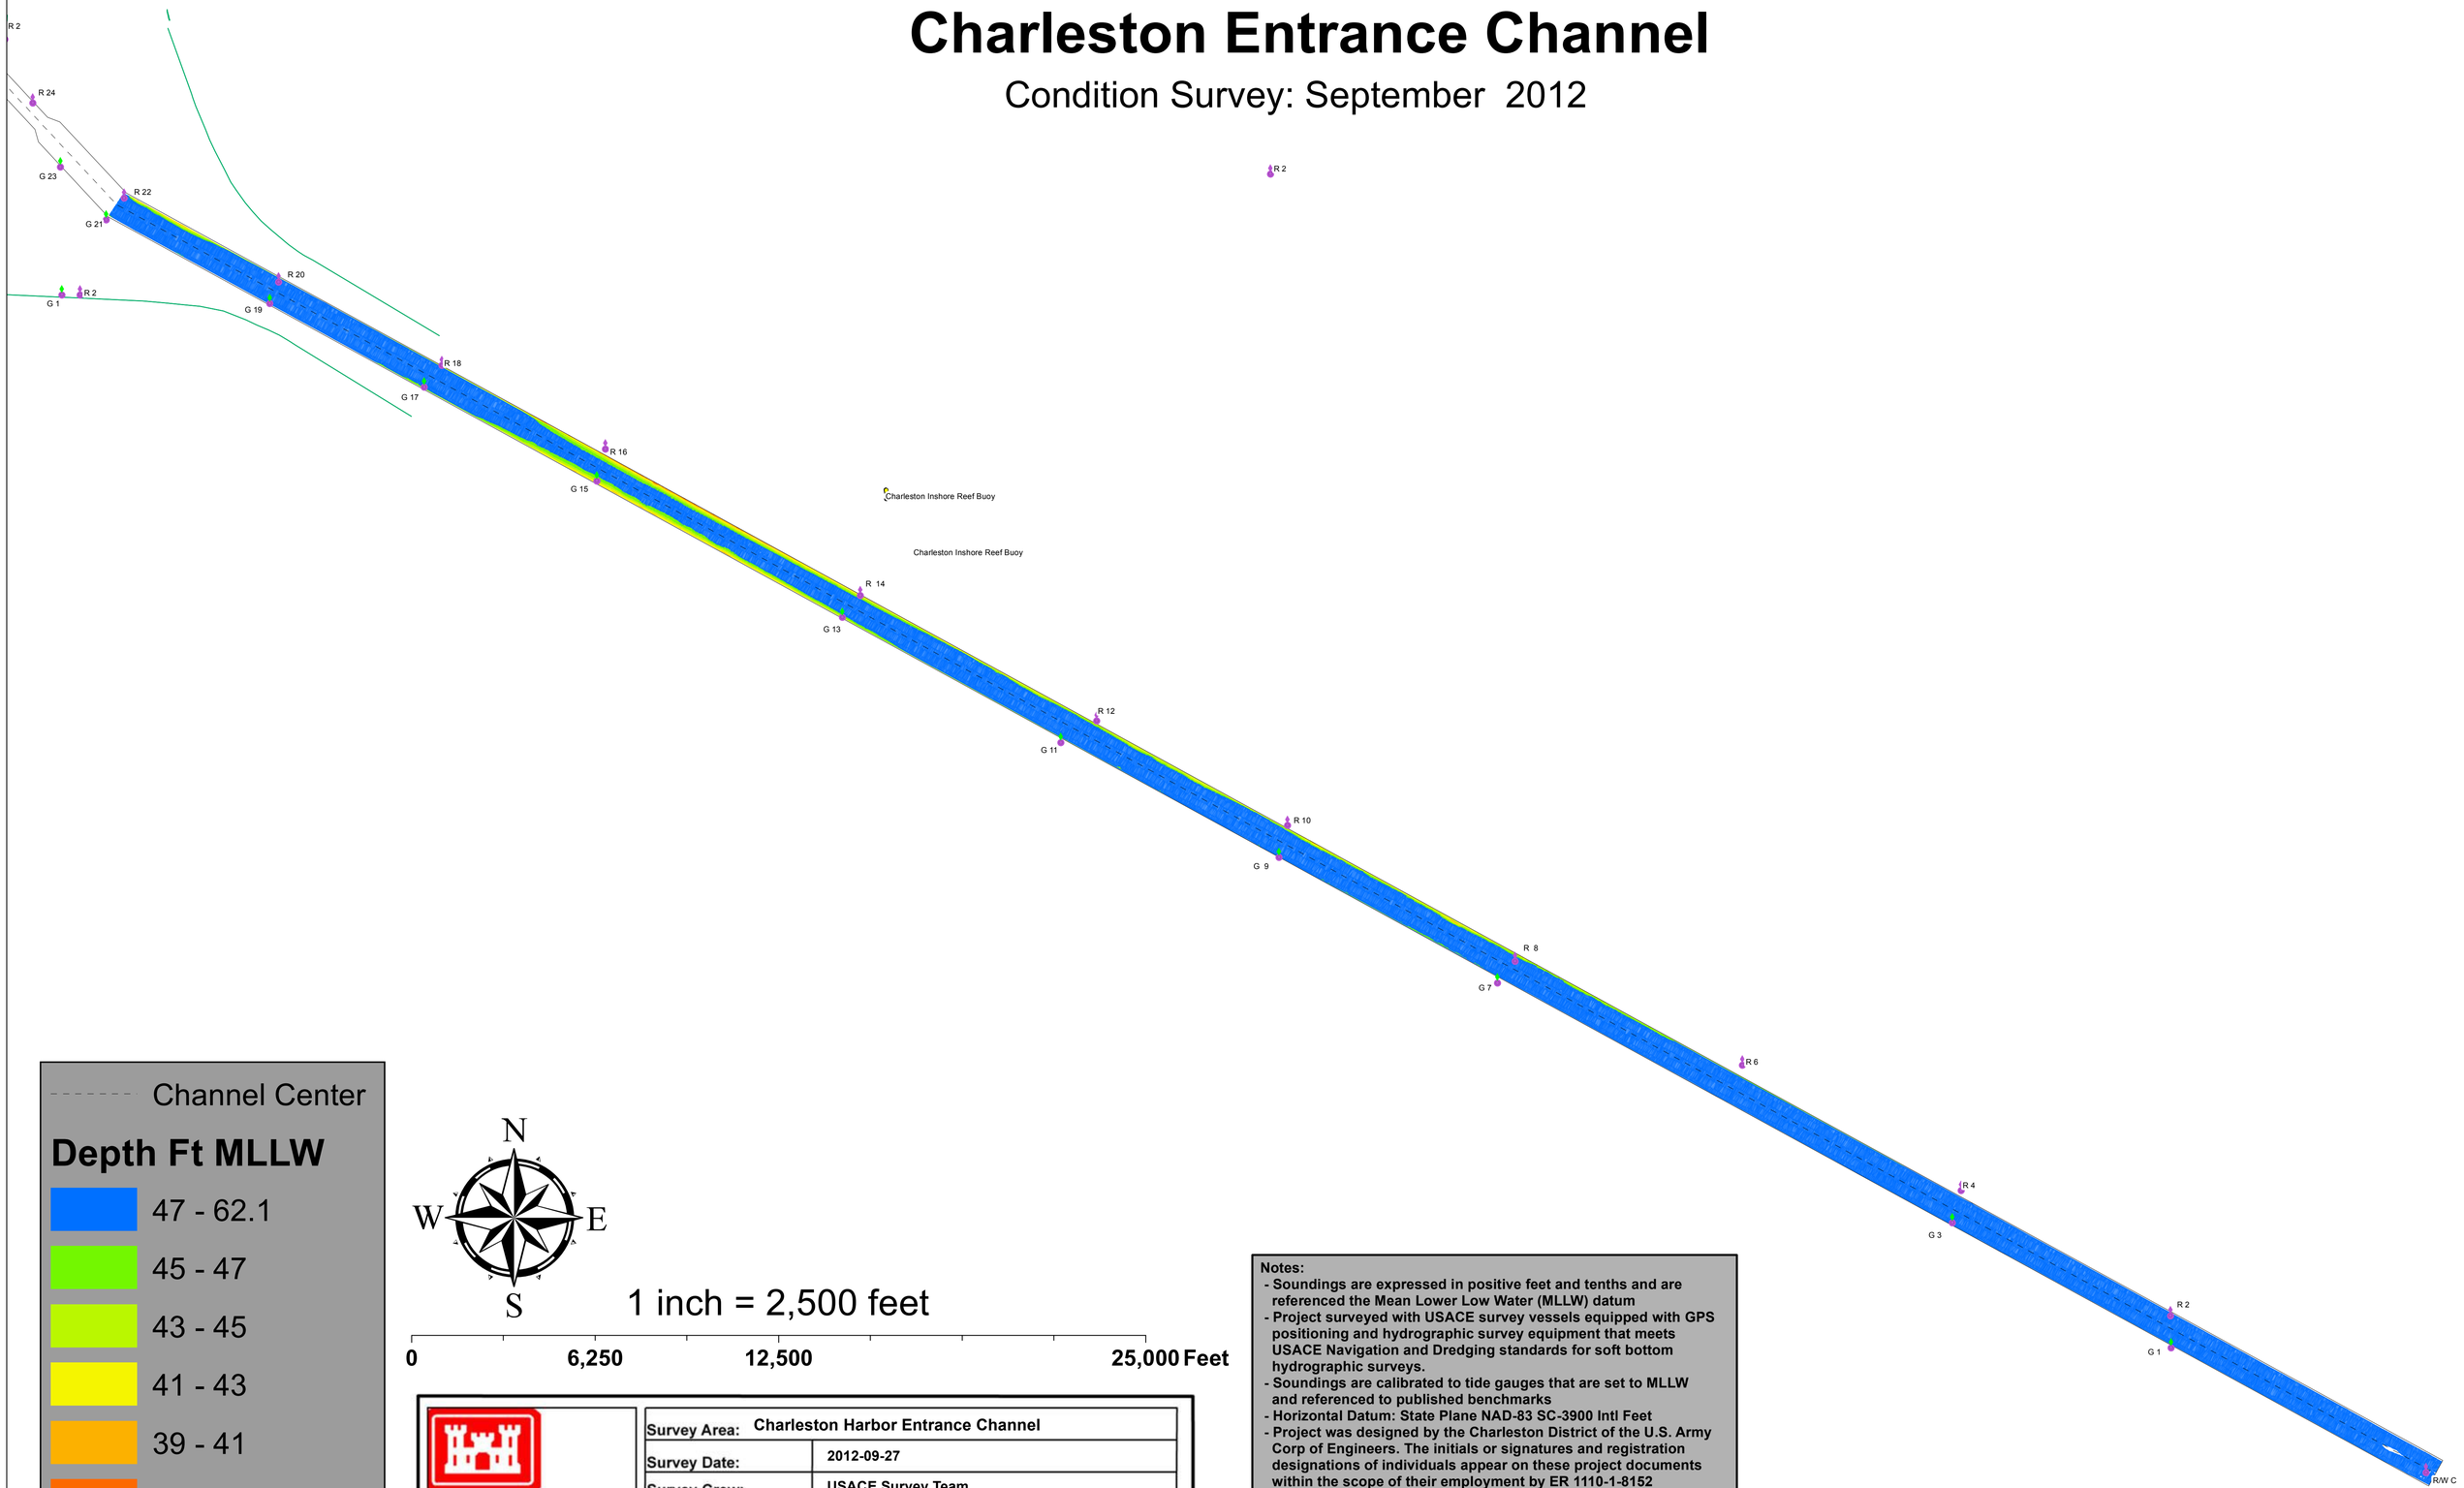
Channel Center

Depth Ft MLLW

- 47 - 62.1
- 45 - 47
- 43 - 45
- 41 - 43
- 39 - 41
- 37 - 39
- 33.1 - 37
