**CHARLESTON HARBOR POST 45  
BENEFICIAL USE OF DREDGED MATERIAL  
SUPPLEMENTAL ENVIRONMENTAL ASSESSMENT**  
*CHARLESTON, SOUTH CAROLINA*

# **Hardbottom Habitat Identification in Support of Artificial Reef Sites**

**HARDBOTTOM SURVEY OF  
OFFSHORE MITIGATION AREAS  
CHARLESTON HARBOR POST 45  
DEEPENING PROJECT**

**HARDBOTTOM SURVEY OF  
OFFSHORE MITIGATION AREAS**

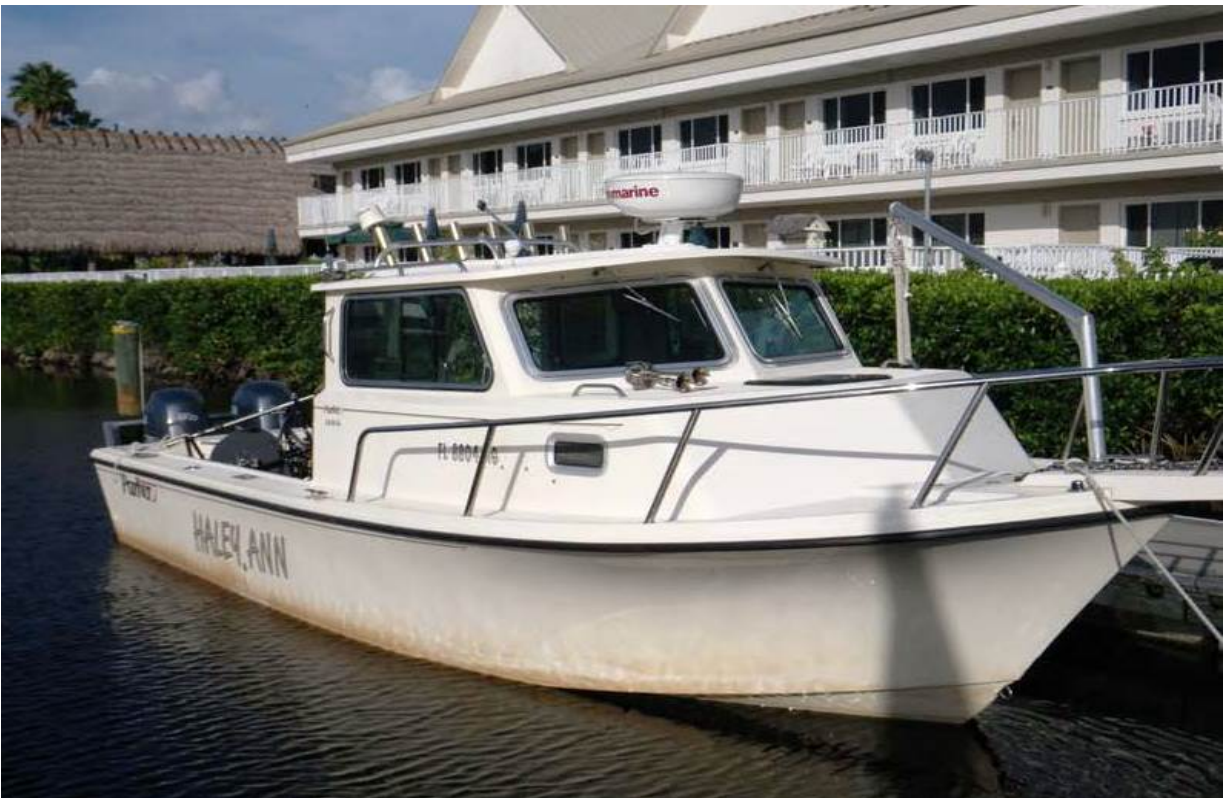
**Figure 4. RV/Haley Ann Used for Survey**

The vessel employed during the remote sensing survey was DC&A's 25-foot Parker 2520-XL *Haley Ann* (Figure 4) a modified "V"-hulled motor vessel powered by twin 125-horsepower Yamaha outboards. The vessel has a covered cabin and an ample, covered-deck area for the placement and operation of the necessary remote sensing equipment. The vessel conformed to all United States Coast Guard specifications, according to class, and had a full complement of safety equipment.

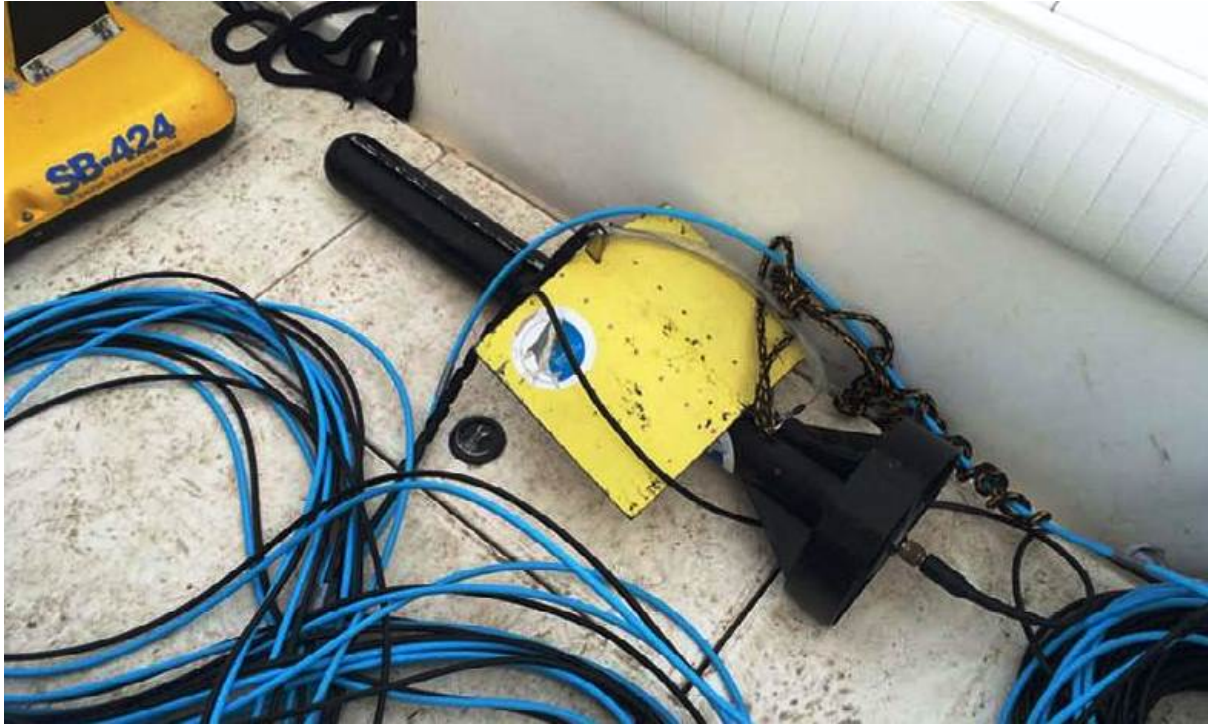
**Figure 5. Marine Sonics Sonar Fish Used for Survey**

The survey used a Marine Sonics Technology HDS sonar system with a dual-frequency [900-1800 kilohertz (kHz)] fish, interfaced with a differential global positioning system (DGPS) with accuracy levels that determine position to within one-meter (Figure 5). The side-scan sonar is an instrument that, through the transmission of dual fan-shaped pulses of sound and reception of reflected sound pulses, produces an acoustic image of the bottom. Under ideal circumstances, the side-scan sonar is capable of providing a near-photographic representation of the bottom on either side of the trackline of a survey vessel. HYPACK navigation software was used to locate the survey transects and maintain vessel tracking during data collection. Side-scan sonar data were collected along parallel transects, spaced at 30m intervals with a range of 45m, to achieve 120% percent overlapping coverage of adjacent survey lines (Figure 2). The sonar towfish was maintained at a height above the bottom that provided for the most accurate data collection (generally 10 to 30 feet).

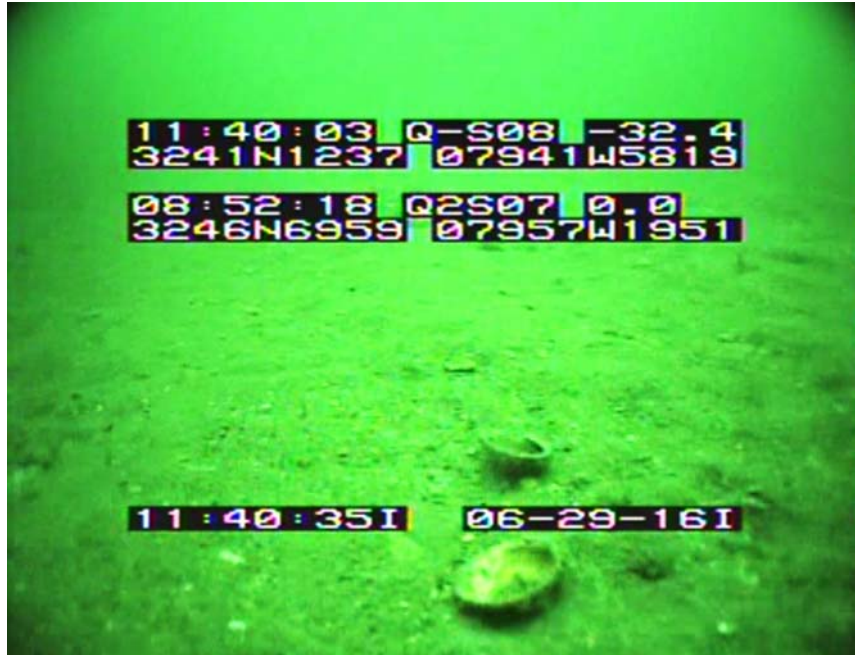
Figure 13. Image from Video Record of Typical Sand/Shell Hash Habitat within the North Mitigation Area

Low relief hardbottom areas are subjected to periods of a sand veneer covering the hardbottom and exposure of rock (Figure 13). Depending on multiple factors with emphasis on duration of hardbottom exposure, octocorals (*Leptogorgia virgulata*, *Lophogorgia hebes*, and *Titanideum frauenfeildii*), sponges (*Cliona spp.*, *Ircinia campana*, *Haliclona oculata*), macroalgae, bryozoans and ascidians (Burgess et al. 2011; Van Dolah et al. 1997), can grow large enough to withstand impacts from sand migration (Figure 14). Often the fringes of hardbottom and exposed rock rubble provide a transition between predominantly exposed and periodically exposed habitat. Burgess et al. (2011) state that nearshore hardbottom habitat is typically patchy and surrounded by large expanses of sand and that reef organisms are often exposed to sediment movement

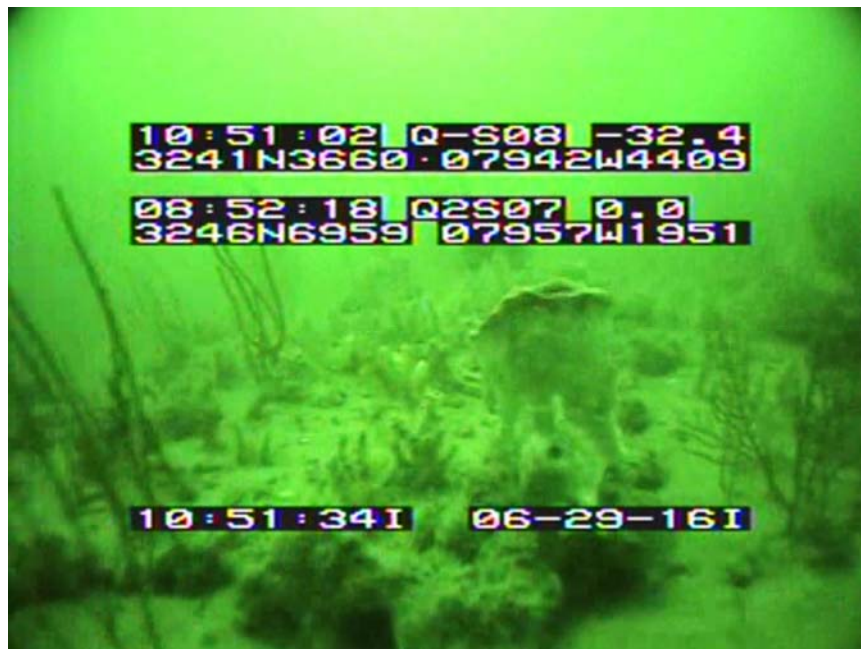
Figure 14. Image from Video Record of Typical Hardbottom Habitat within the North Mitigation Area

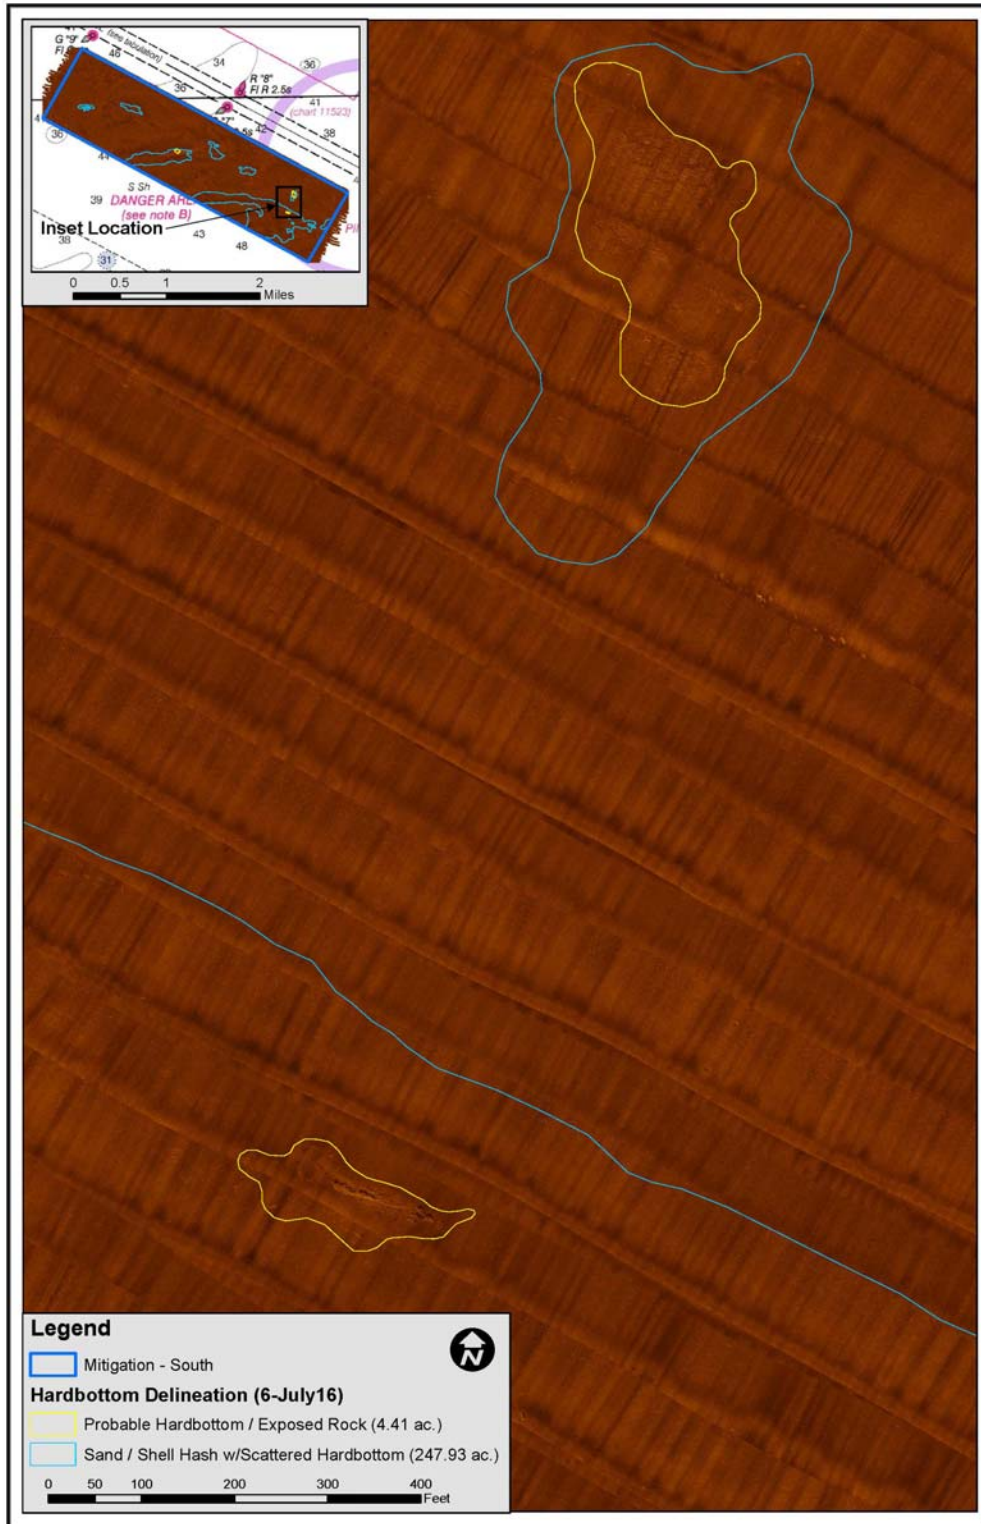
**Figure 15. Close-up View of Hardbottom Mosaic in Southeast Corner of South Mitigation Area**

The southern mitigation site is dominated by 1548.77 acres of Sand and Sand with Shell Hash, 247.93 acres of Sand/Shell Hash with Scattered Hardbottom, and 4.41 acres of Probable Hardbottom and Exposed Rock within the 1801.09-acre southern mitigation area (Figure 11). A close-up view of the hardbottom side-scan image in the southern north area is shown in Figure 15. Vertical relief was on average less than one foot.

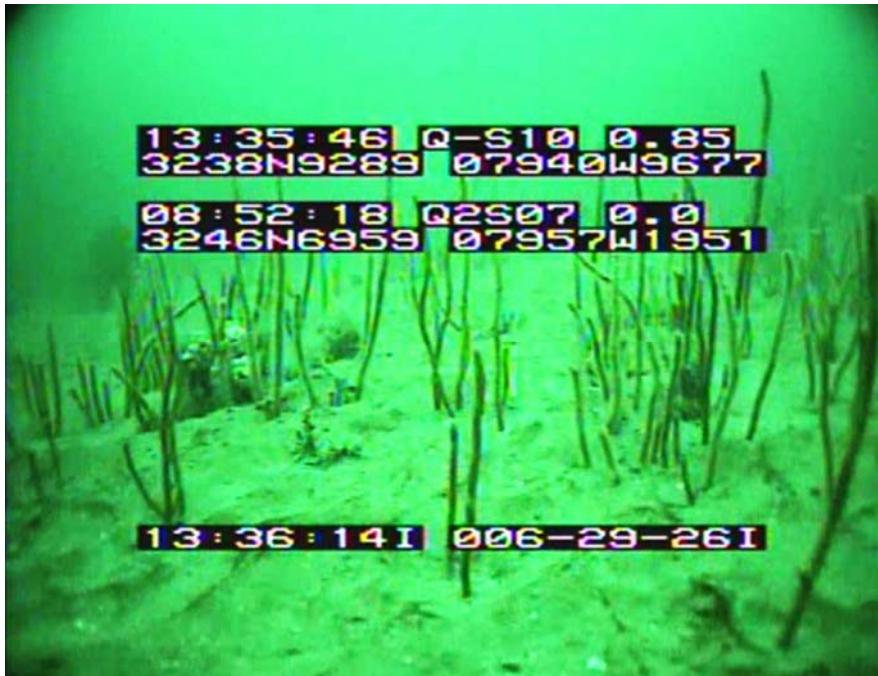
Figure 16. Image from Video Record of Sand/Shell and Scattered Hardbottom Habitat within the South Mitigation Area

Due to the dynamic nature of the low relief hardbottom habitats associated with the Charleston coast, a thin veneer of sand/sand with shell-hash causes some hardbottoms to have an ephemeral nature with scattered-periodically exposed rock. Due to temporal changes of hardbottom exposure in this area, established hardbottom communities consisting of octocorals (*L. virgulata*, *L. hebes*, and *T. frauenfeldii*), sponges (*Cliona spp*, *I. campana*, *H. oculata*), macroalgae, bryozoans and ascidians (Burgess et al. 2011; Van Dolah et al. 1997) protruding through a thin veneer of sand are prevalent (Figure 16). This habitat type encompassed 247.93 acres of the southern mitigation area. Hardbottom areas with a slightly higher relief are less effected by sand movement; which provide an important habitat and foraging grounds for a diverse array of invertebrate and fish species (Figure 17). Video records taken along the five transects provide evidence of the habitats included in this area

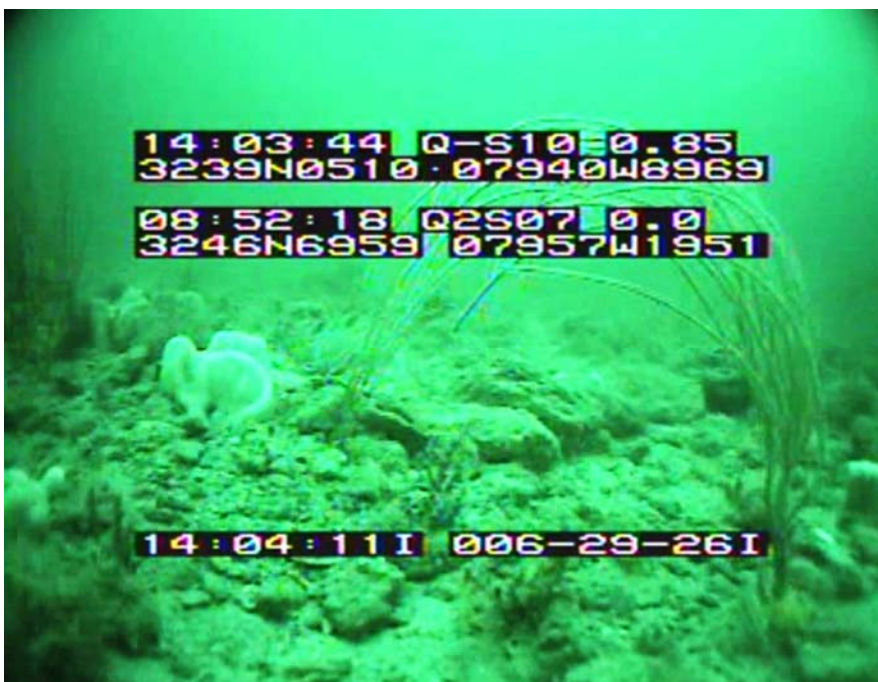
Figure 17. Image from Video Record of Typical Hardbottom Habitat within the South Mitigation Area
