EO 11988 Evaluation
WESTON LAKE DAM REPAIRS

Ft. Jackson, South Carolina

**FINDING OF NO PRACTICABLE ALTERNATIVE FOR
IMPROVEMENTS OF WESTON LAKE DAM
FORT JACKSON, SC**

Evaluation of the Biological Impacts to Endangered Species 2020 Weston Lake Dam Repairs Fort Jackson, Richland County, South Carolina

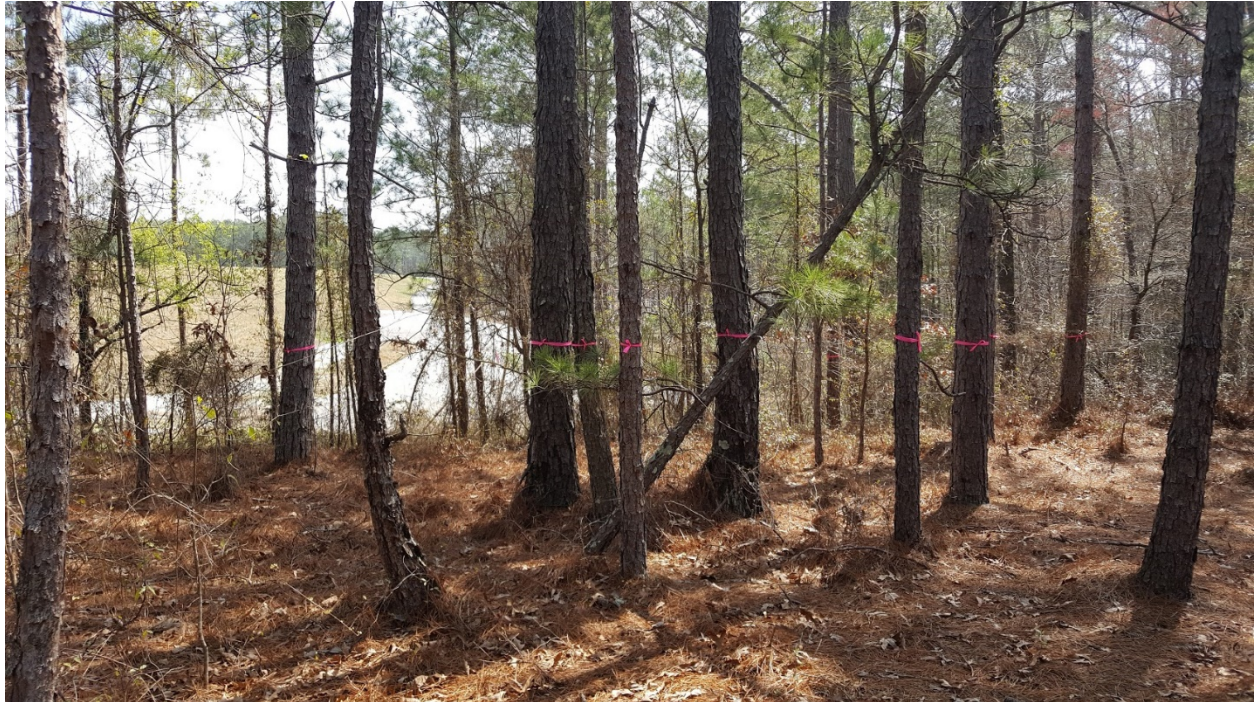
Figure 3 HMU removal, Weston lake dam in background, photo taken facing East. Photo of area to be clearcut, most of the large trees to be removed are flagged pink. The midstory is small diameter pine with ~25% hardwood stems.

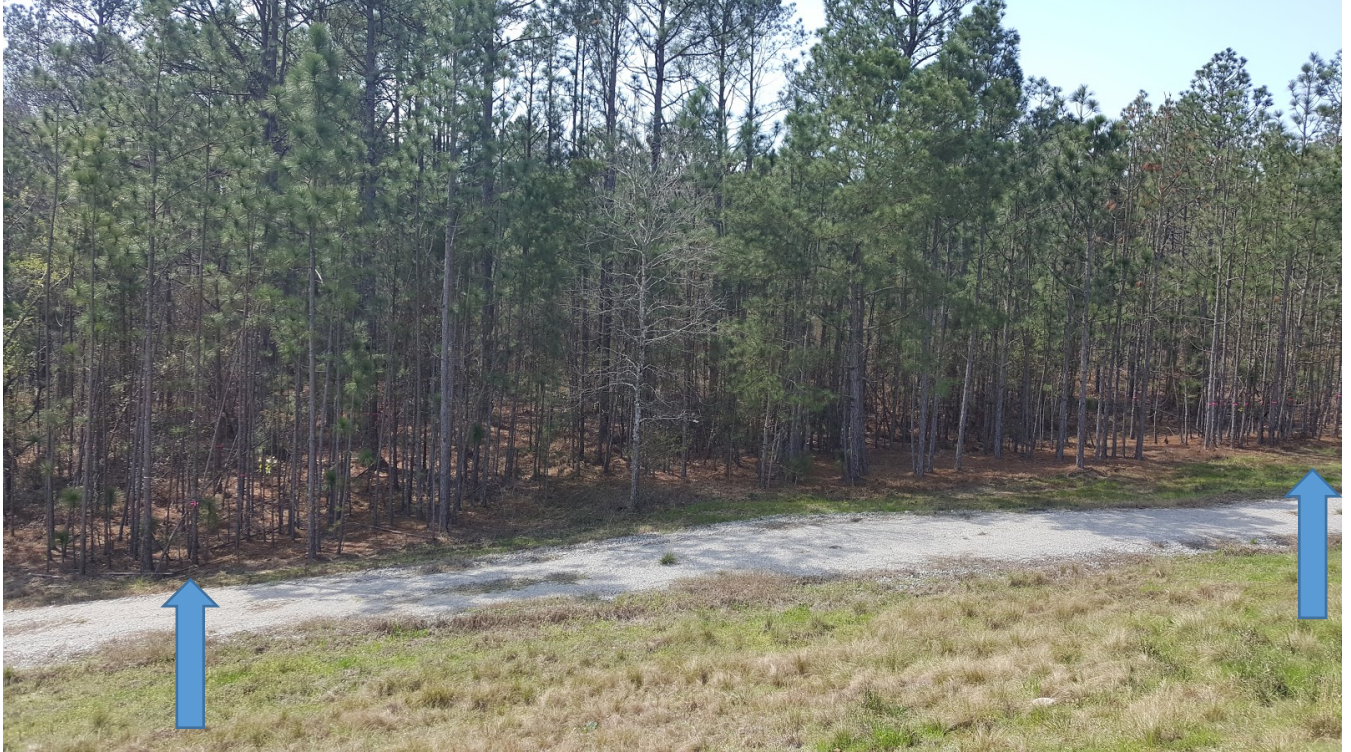
Figure 4 HMU removal bounded by pink flagged trees on left and right side of photo. Photo taken from on top Weston Lake dam facing south.

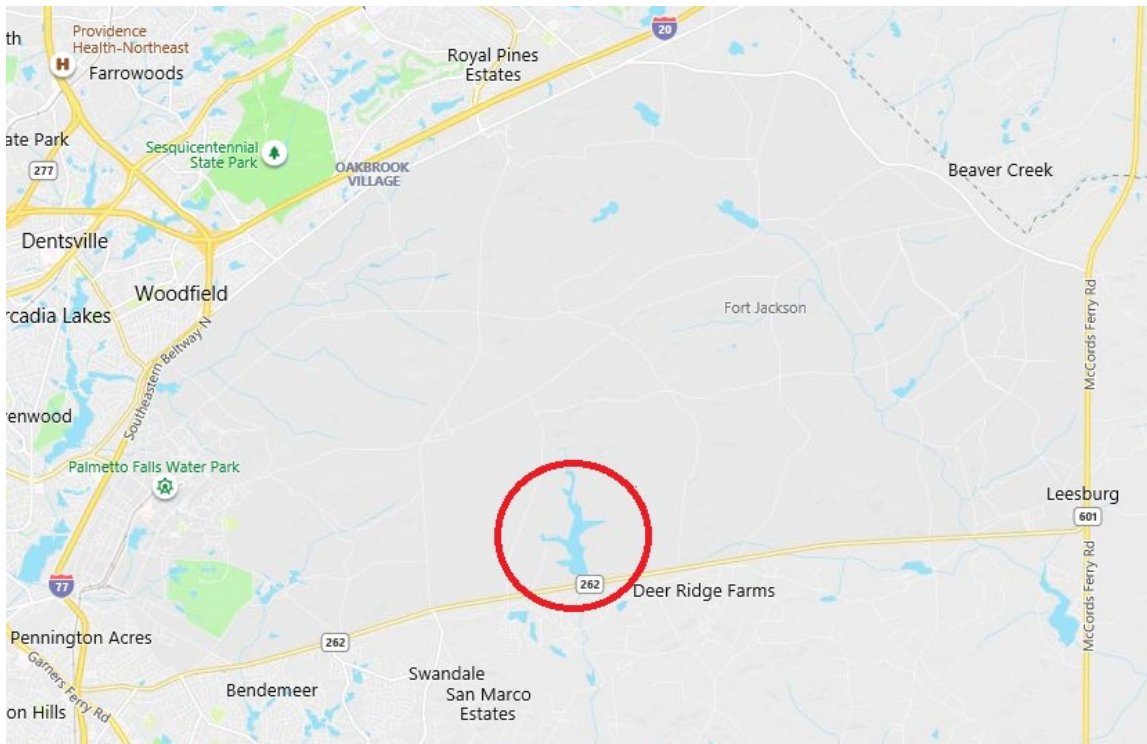
Figure 2 Weston Lake

Weston Dam Project Area Map

Weston Lake Dam is a high hazard dam located north of S.C. Highway 262, east of the Fort Jackson cantonment area and west of its intersection with Weston Lake Road, in Richland County, South Carolina (Latitude 34.0076°, Longitude -80.8313°) (Figures 1 and 2). The lake is located completely within the boundaries of Fort Jackson, and is owned by the Federal Government.

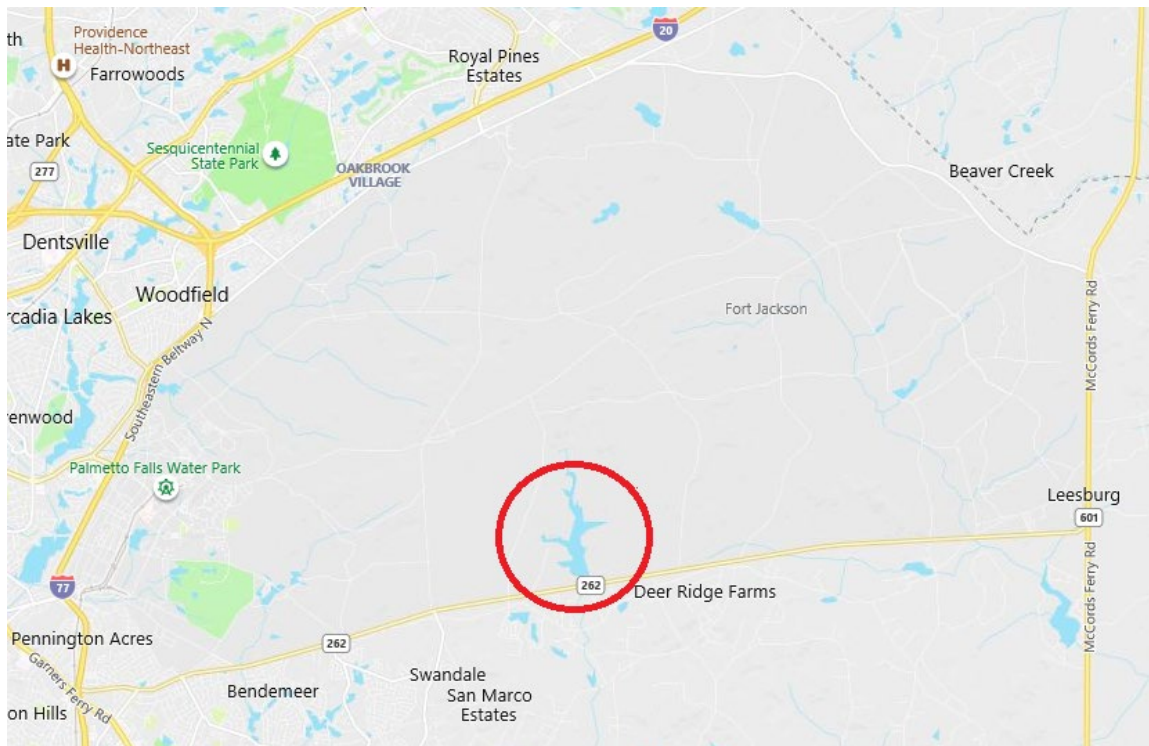
Figure 2 Weston Lake

Weston Dam Project Area Map

Weston Lake Dam is a high hazard dam located north of S.C. Highway 262, east of the Fort Jackson cantonment area and west of its intersection with Weston Lake Road, in Richland County, South Carolina (Latitude 34.0076°, Longitude -80.8313°) (Figures 1 and 2). The lake is located completely within the boundaries of Fort Jackson, and is owned by the Federal Government.
